Subject: Transmittal of the Cow Pen Creek Bank Stabilization and Floodplain Reconstruction Monitoring:
2021 Report
Lockheed Martin Corporation – Middle River Complex
2323 Eastern Boulevard, Middle River, Baltimore County, Maryland

**COW PEN CREEK
BANK STABILIZATION AND FLOODPLAIN
RECONSTRUCTION MONITORING: 2021 REPORT
LOCKHEED MARTIN MIDDLE RIVER COMPLEX
2323 EASTERN BOULEVARD
MIDDLE RIVER, MARYLAND**

Prepared by:
Tetra Tech, Inc.

January 2022

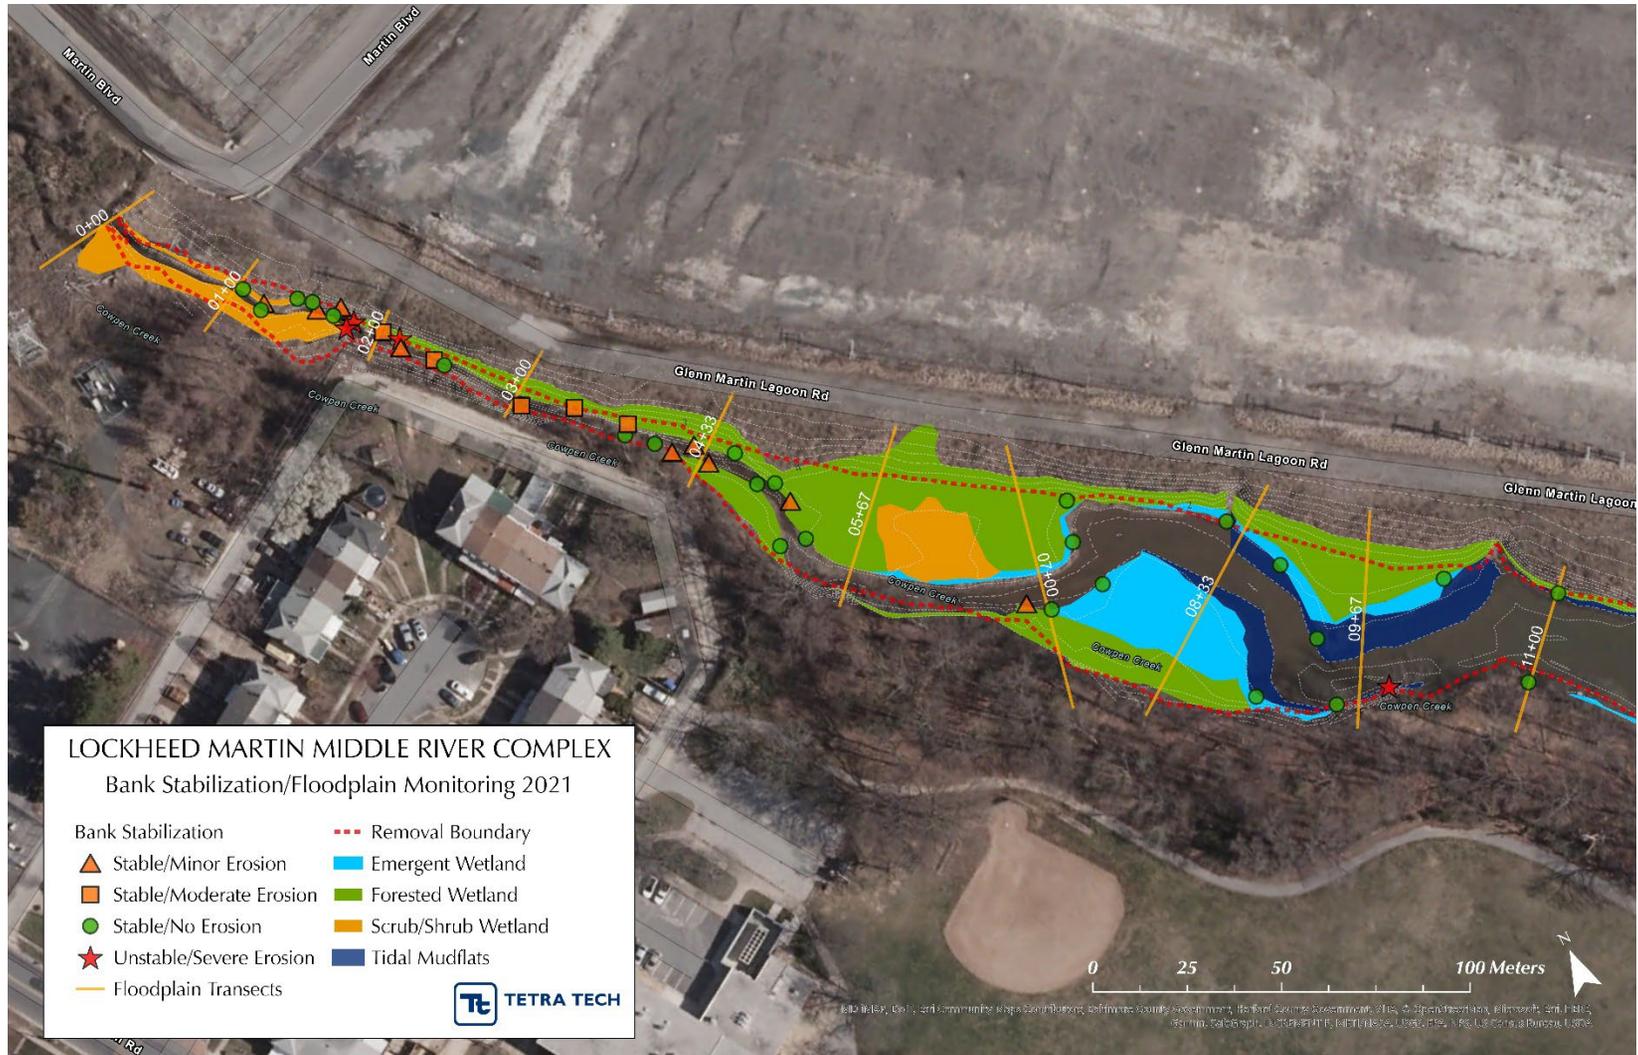
Bank conditions were rated as stable along 97% of total stream bank length (2,144 of 2,216 total feet) as shown in Figure 4-3. Areas with evident, severe, and active bank erosion were observed along 3% (72 feet) of total bank length, 36 feet of which was unvegetated and 36 feet of which was vegetated.

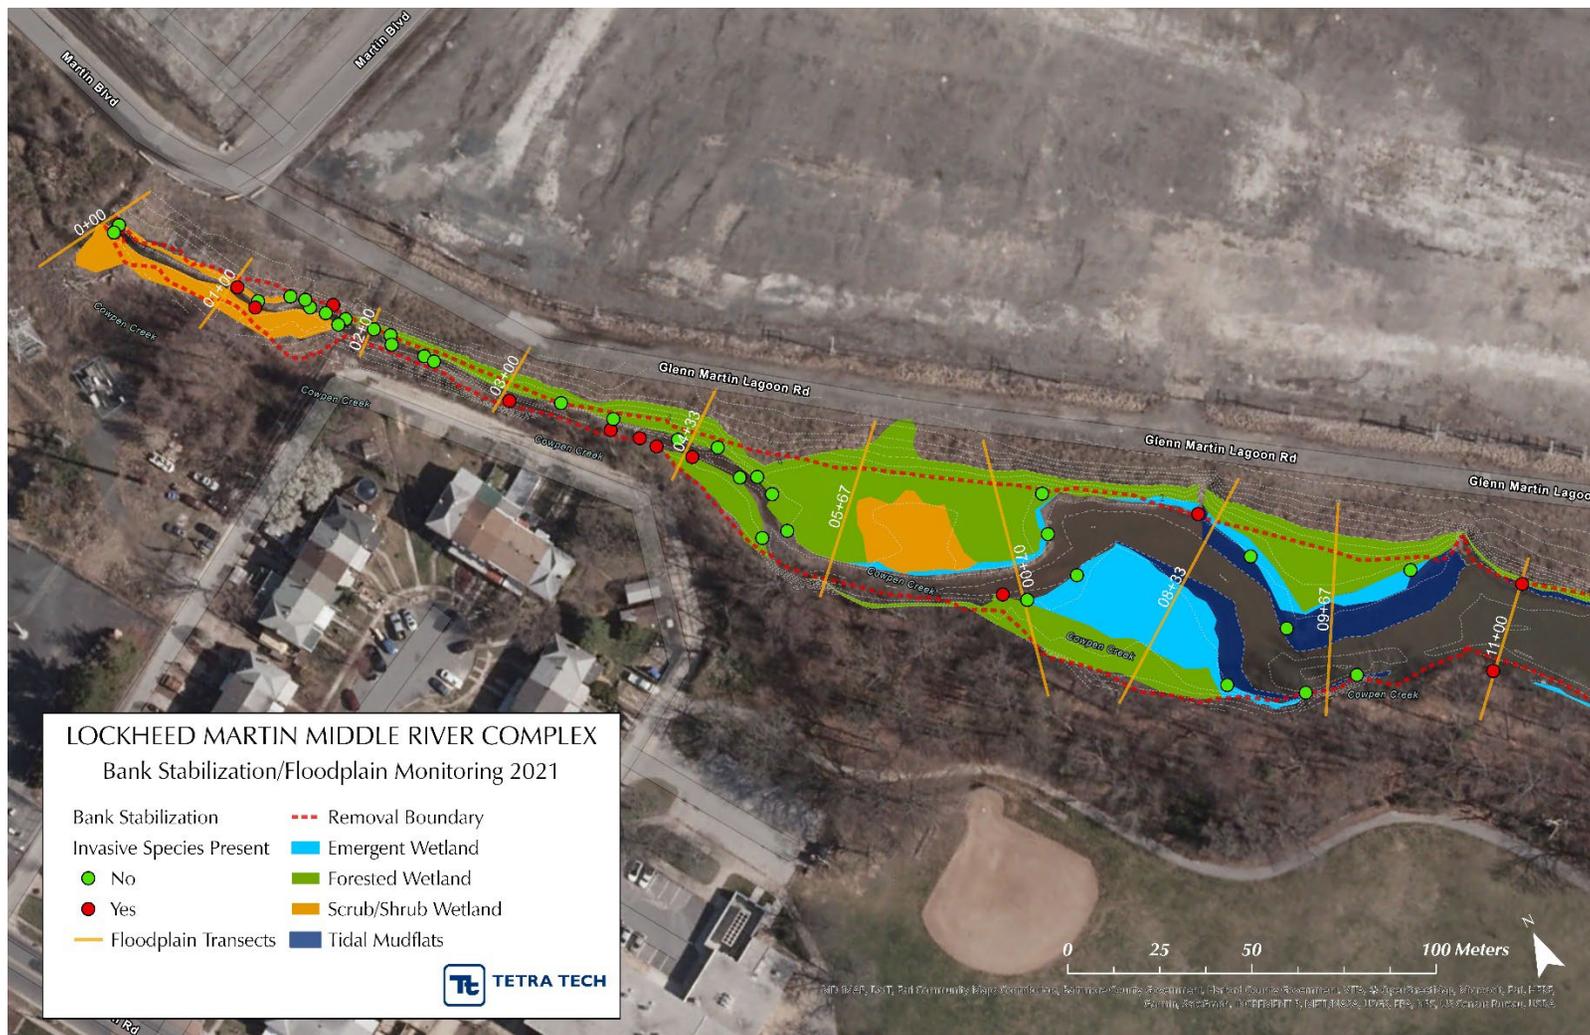
Figure 4-4. Observed locations of invasive plant species along Cow Pen Creek–2021

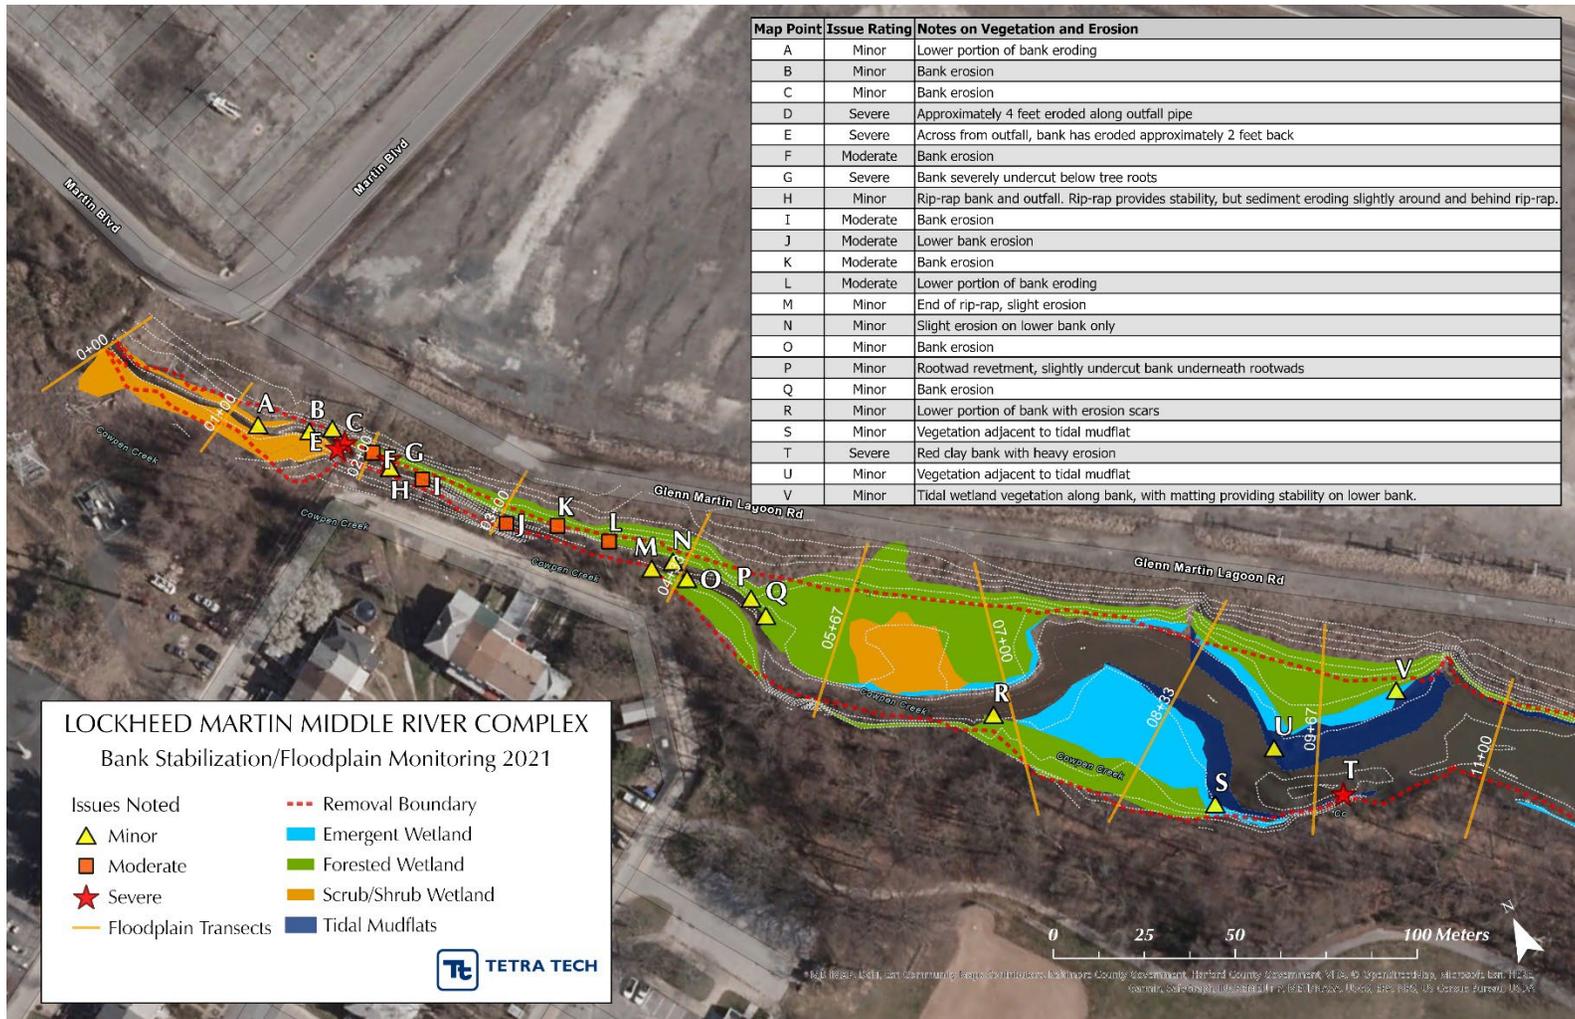
Figure 4-5 Noted areas of concern for erosion/vegetative cover along Cow Pen Creek–2021
[Upland and wetland vegetation types are from the 2021 wetland survey.]

The lowermost, tidal portion of the project area was stable, except for a small portion (36 feet) of the right bank that was unvegetated and actively eroding (Figure 4-5, point location T). This area was not part of the restoration project and features a nearly vertical red clay bank influenced by an immediately adjacent bare earth footpath above. The footpath prevents the establishment of stabilizing vegetation, as its well-worn and compacted soils have been impacted by local residents that walk and bike along the path within this public area.

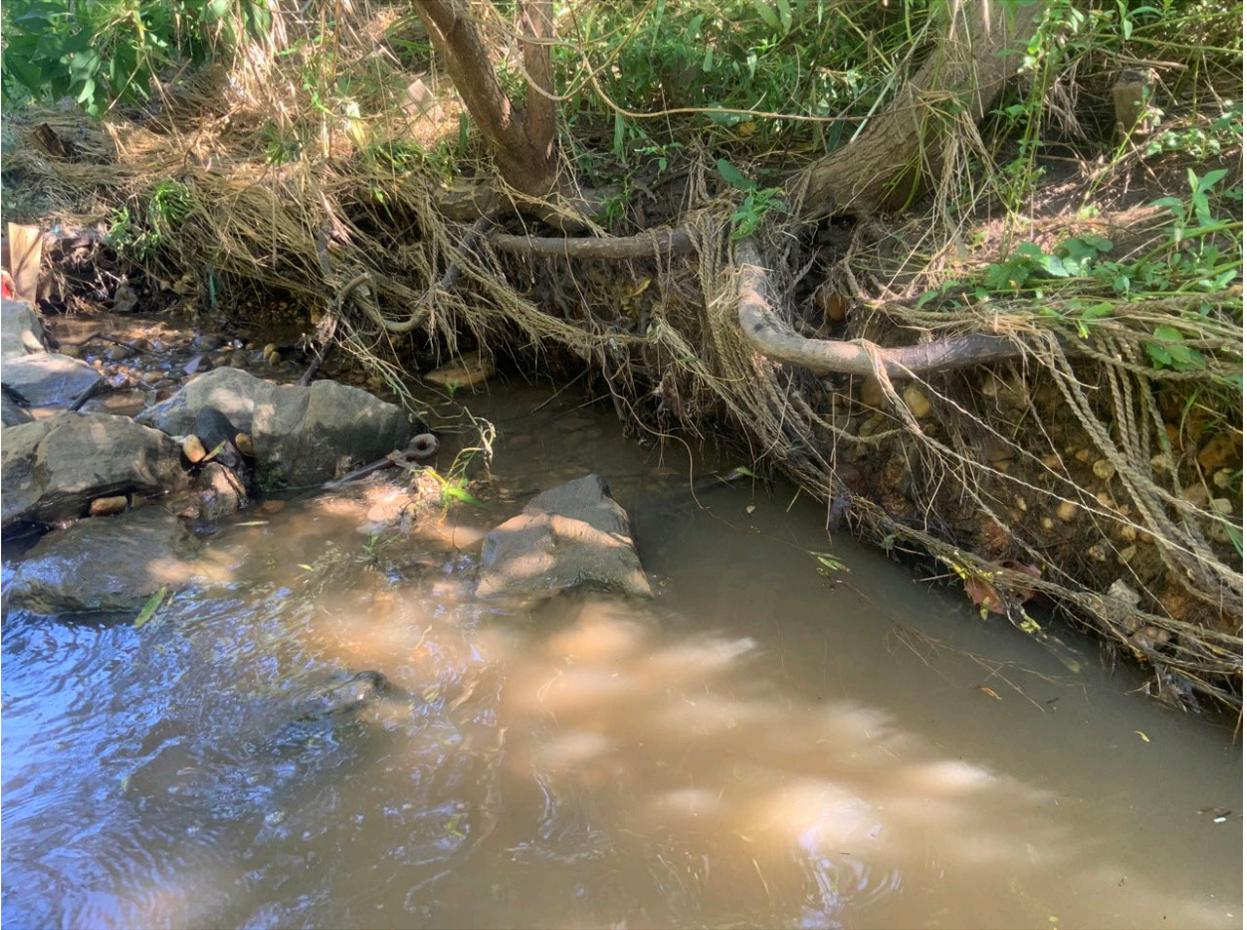
Photo A-12. Left streambank above station 02+18.

- Severe erosion was also noted in a 12-foot-long segment on the left bank (at station 02+18), the result of a stormwater outfall across the stream on the right bank. This segment was also noted in the 2020 monitoring report; the flow from this outfall has been cutting around the left side of boulders at a stone riffle structure in the channel causing increased erosion on the left bank (see Photo A-12). A comparison of the 2020 and 2021 conditions at this

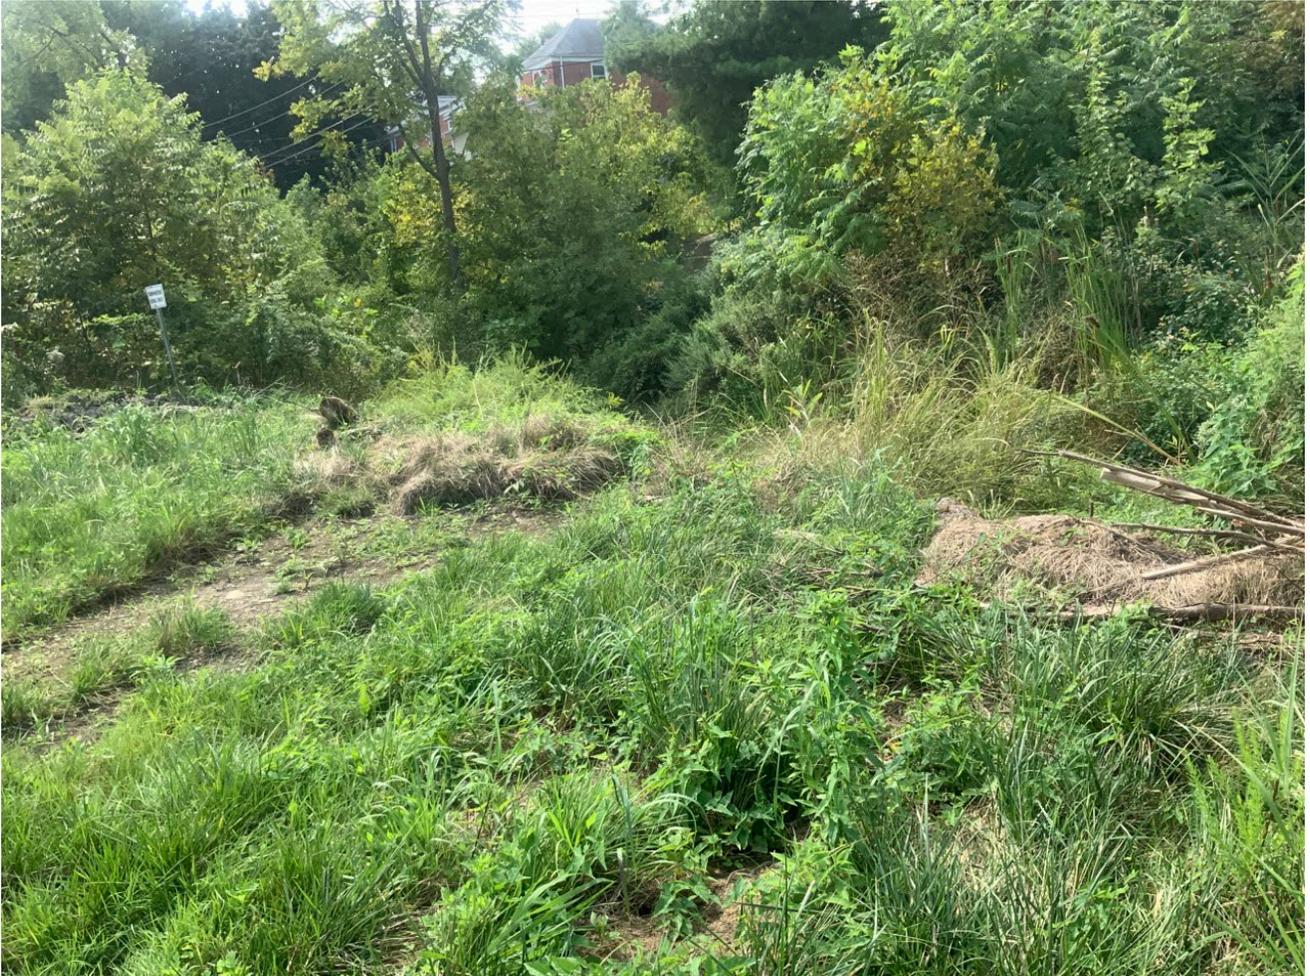
- One 13-foot-long section noted as unstable featured a stormwater outfall pipe running perpendicular to the stream (left bank above station 01+86, see Photos A-9 and A-118). At this location, the stream bank has eroded back approximately 4 feet along the pipe, a result of overland and streamflow during storm events. In January 2021, new coir logs were placed along the left bank about 20 feet upstream of this area to mitigate overland flow.

Photo A-118. Outfall pipe with erosion, left streambank at station 01+64, September 2021.
