Subject: Transmittal of the Block E Tree Mitigation Planting Report 2022
Lockheed Martin Corporation – Middle River Complex
2323 Eastern Boulevard, Middle River, Baltimore County, Maryland

**MIDDLE RIVER COMPLEX CRITICAL AREA 2022
BLOCK D ANNUAL MITIGATION PLANTING REPORT
2323 EASTERN BOULEVARD
LOCKHEED MARTIN MIDDLE RIVER COMPLEX
MIDDLE RIVER, MARYLAND**

**Project: Middle River Complex –
Critical Area Mitigation Planting, Block D**

Subject: End of Year 1 Growing Season Inspection Report

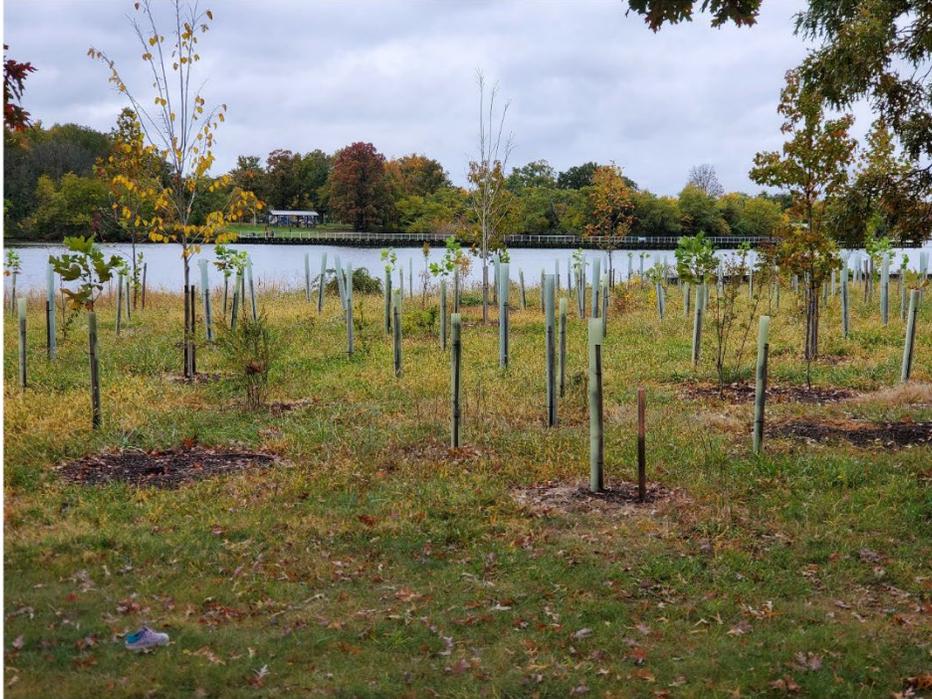
The plant survival rate for the “landscape stock” was 96%. No species was less successful than the others. Plant species, sizes, and quantities of dead material are documented in Appendix A. The plants that did not survive, along with any additional trees or shrubs that fail to survive the second growing season, will be replaced in late fall 2023.

Southern end of site. The two missing trees are associated with the mulch rings on left and right side of the foreground.

The site will continue to be monitored and maintained throughout the 5-year mitigation period and any changes or areas of concern will be documented and addressed. Landscape and flexible stock will be replaced in the late fall 2023 following the 2023 inspection and annually thereafter through 2027 for flexible stock.

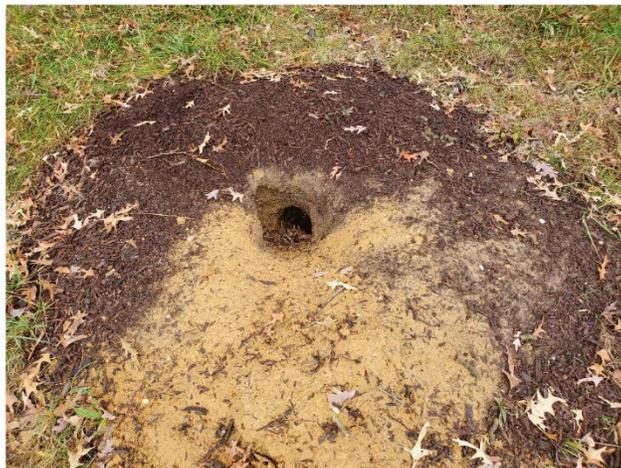
OVERALL THE SITE LOOKED VERY GOOD WITH A VERY HIGH SURVIVAL RATE OF JUST UNDER 96%. THOSE TREES/SHRUBS DETERMINED TO BE DEAD WILL BE REPLACED, ALONG WITH ANY ADDITIONAL MATERIAL THAT FAILS TO SURVIVE THE SECOND GROWING SEASON, IN LATE FALL 2023. THE CALCULATED SURVIVAL RATE INCLUDES THE LOSS OF 2 ADDITIONAL SMALL TREES, OF UNDETERMINED SPECIES, THAT ARE MISSING (APPEAR TO HAVE BEEN UPROOTED BY GOPHERS DURING THE CONSTRUCTION OF THEIR DEN).

Gopher hole and missing tree

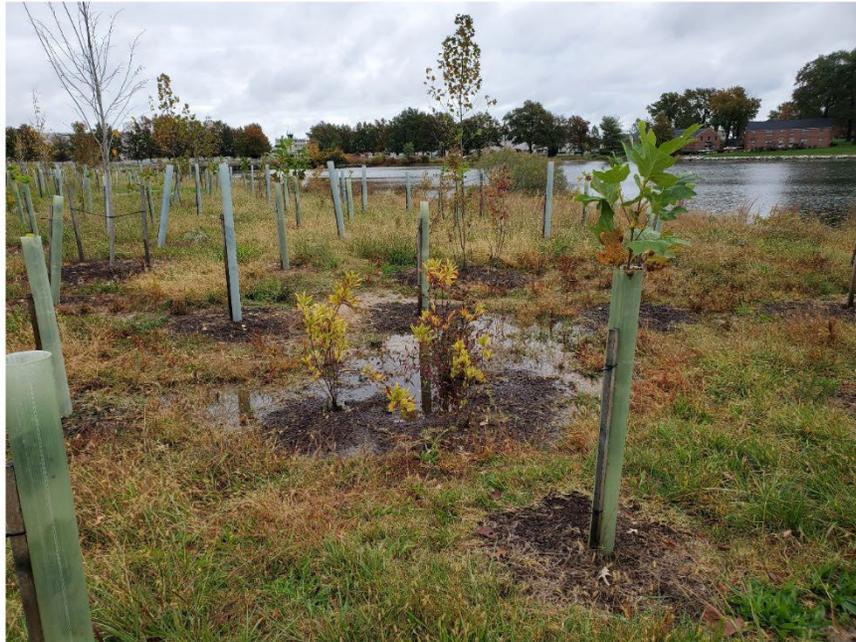
- There were no signs of mechanical damage. A total of 5 tree tubes (placed around the “Flexible Stock” had been blown over, snapping the support stake at its base. These will be reinstalled and staked.
- The soils are holding plenty of moisture, with water ponding in small depressions throughout the site.

Site soils are more than sufficiently moist.

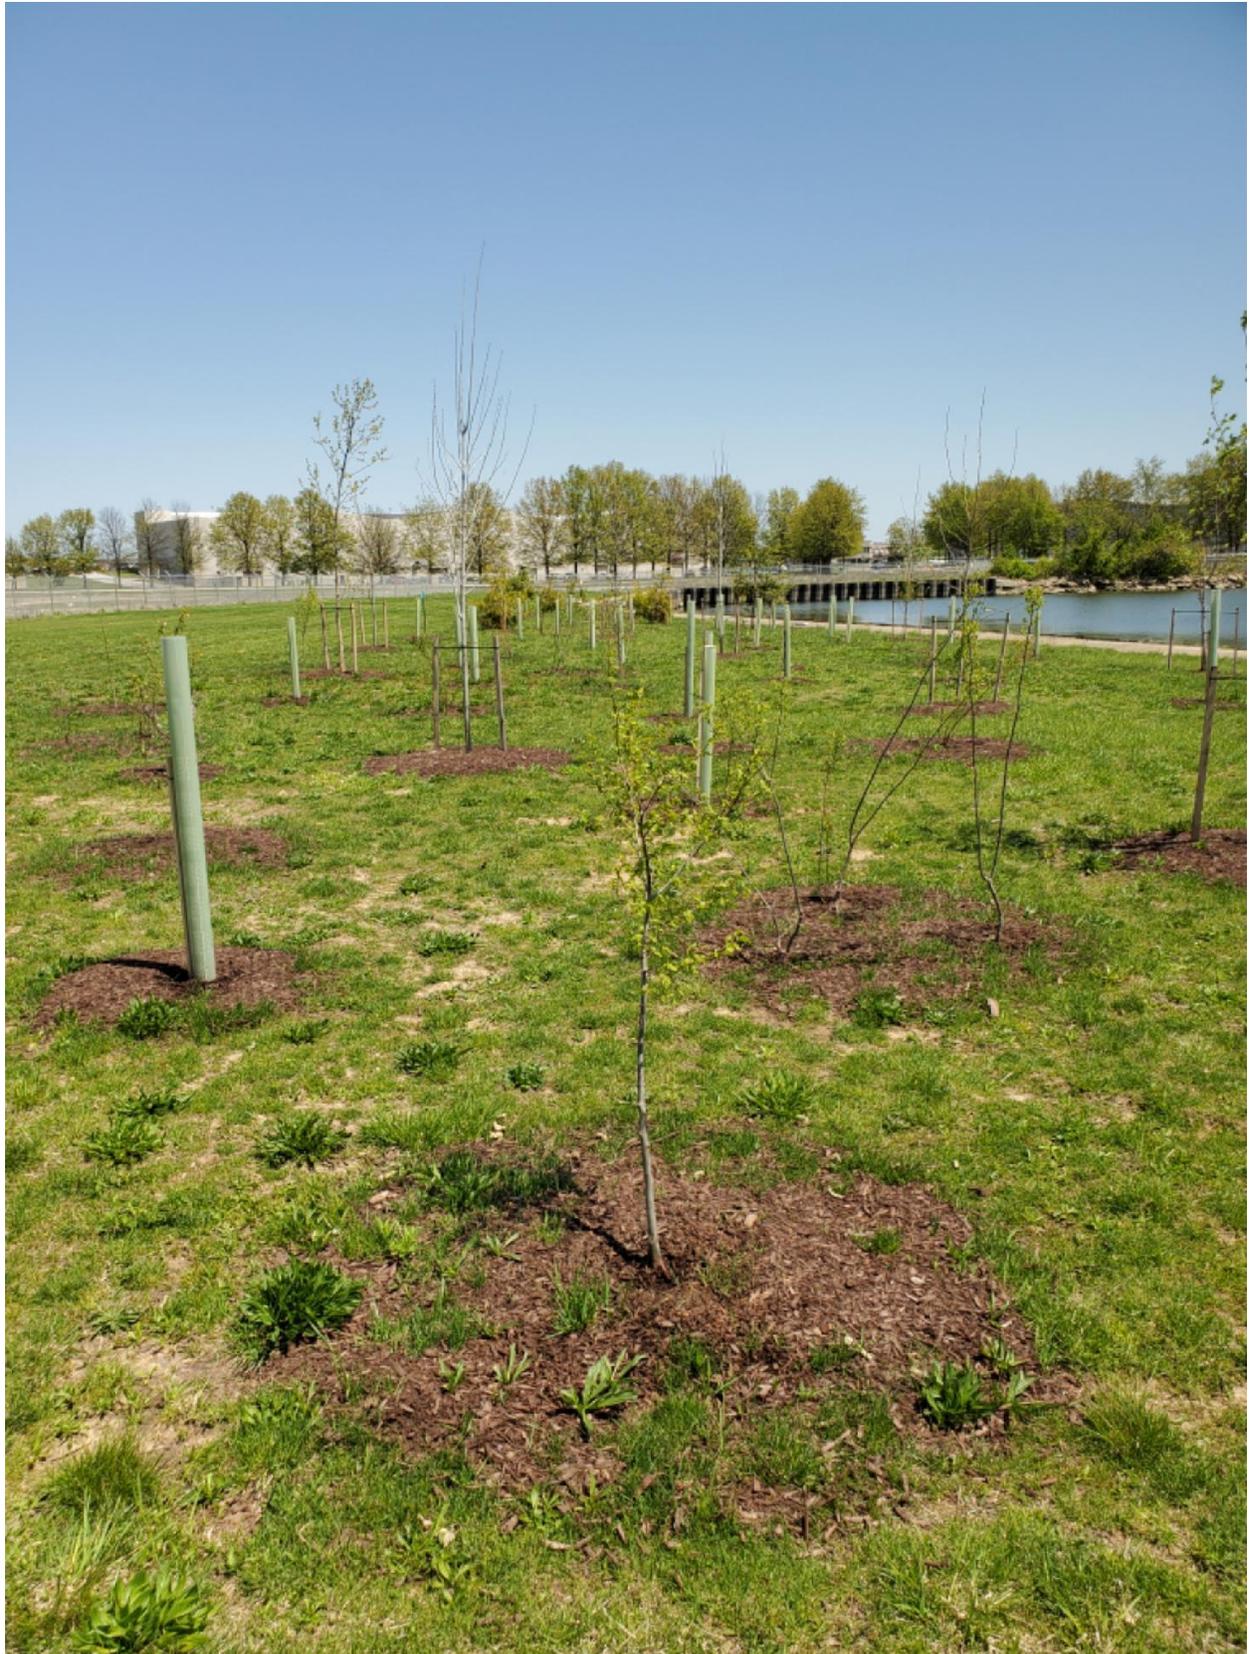
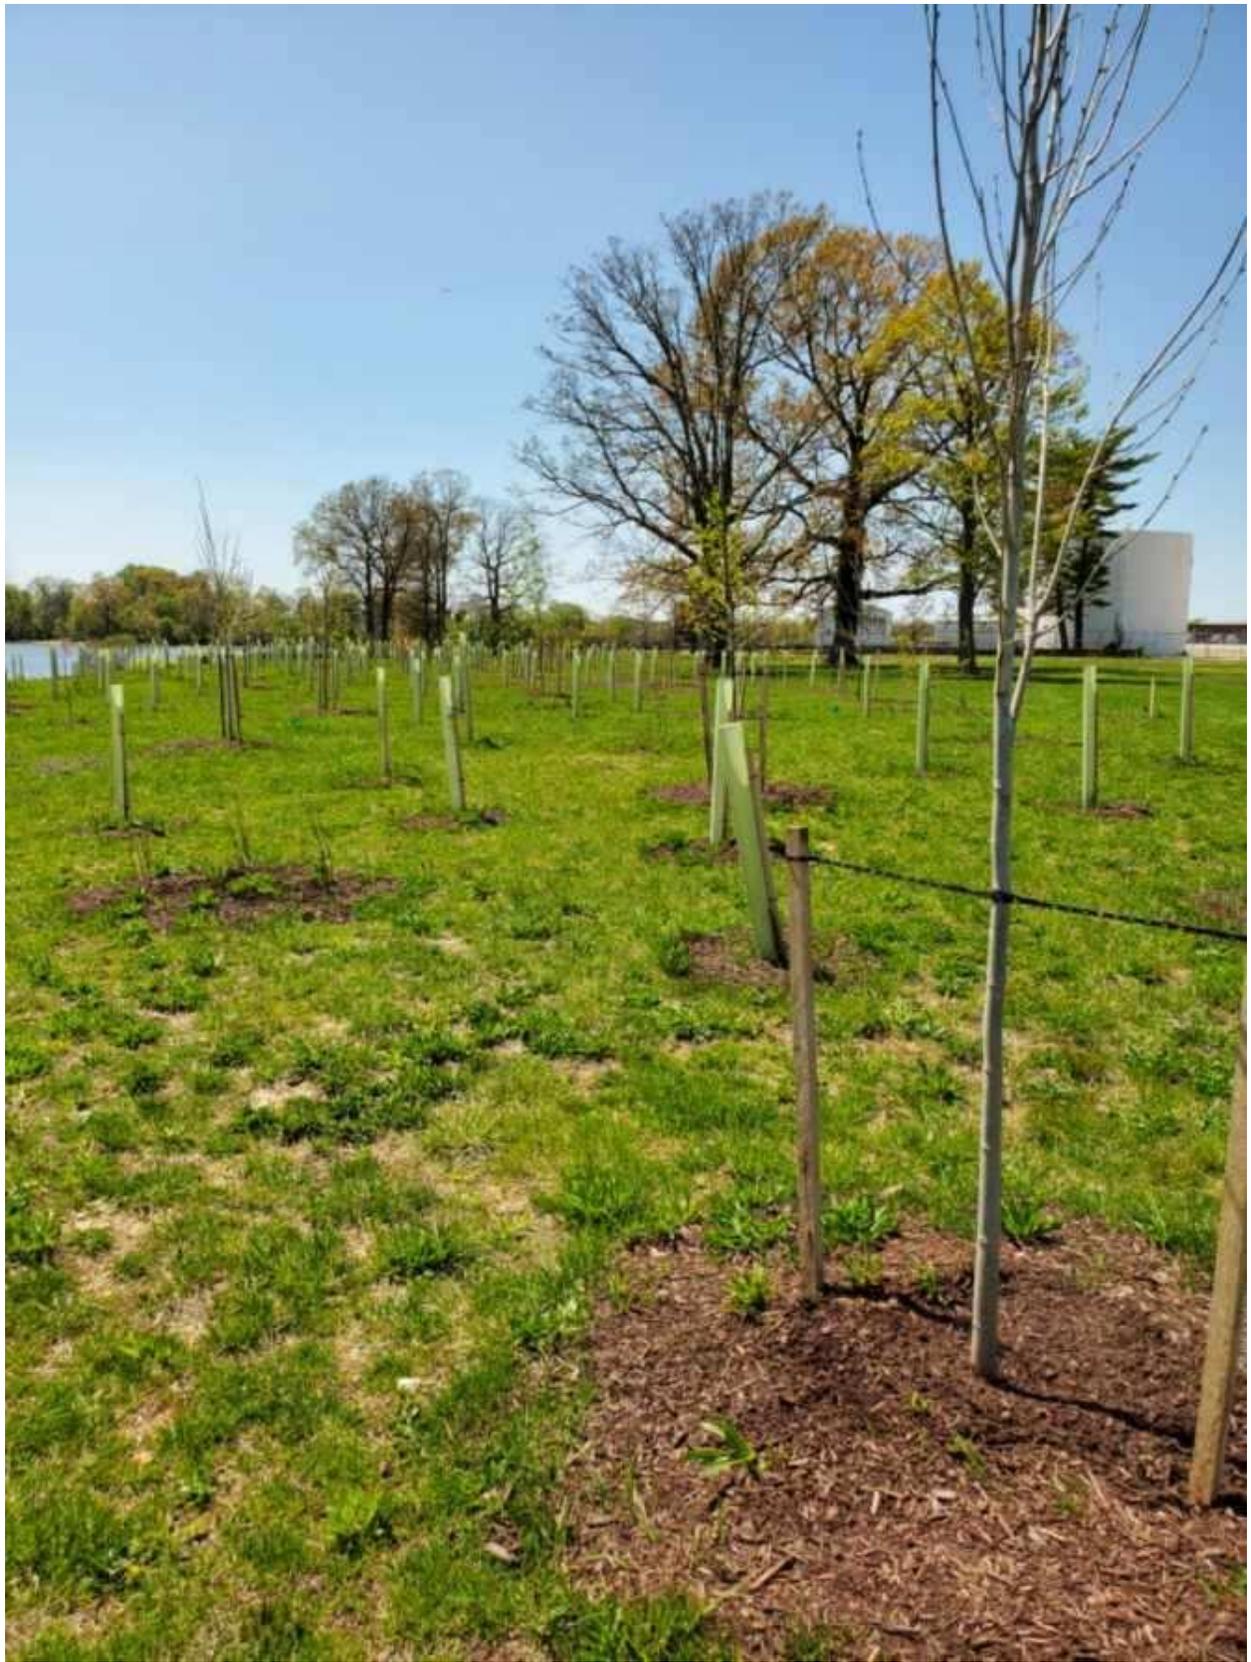
<p>OBSERVED AND SUSPECTED REASONS FOR ANY HIGH MORTALITY RATES (I.E. STANDING WATER, TOO DRY, ETC.)</p>	<p>Appears that due to several days of consistent high winds, following install, the tree was, rocked back and forth, with the roots breaking free from the rootball.</p>
<p>WEEDS IN PLANTING PITS? INVASIVE SPECIES?</p>	<p>Weeds appear to be established and far enough along to schedule first herbicide application.</p>
<p>ADDITIONAL AREAS OF CONCERN AND MEASURES TO BE TAKEN?</p>	<p>Place upright and stake small <i>Carpinus caroliniana</i> blown over.</p>
<p align="center">MAINTENANCE ACTIVITIES PERFORMED</p>	
<p>WATERING?</p>	<p>Watered all trees and shrubs per our work plan.</p>
<p>HERBICIDE APPLICATION/WEEDING PLANT PITS?</p>	
<p>TREE, TREE STAKE, TREE TUBE STRAIGHTENING?</p>	<p>Only a few were slightly out of plum. Will re-evaluate during next visit.</p>
<p>MISCELLANEOUS OBSERVATIONS?</p>	<p>Overall the site looks great. Time to schedule herbicide application to mulch rings.</p>

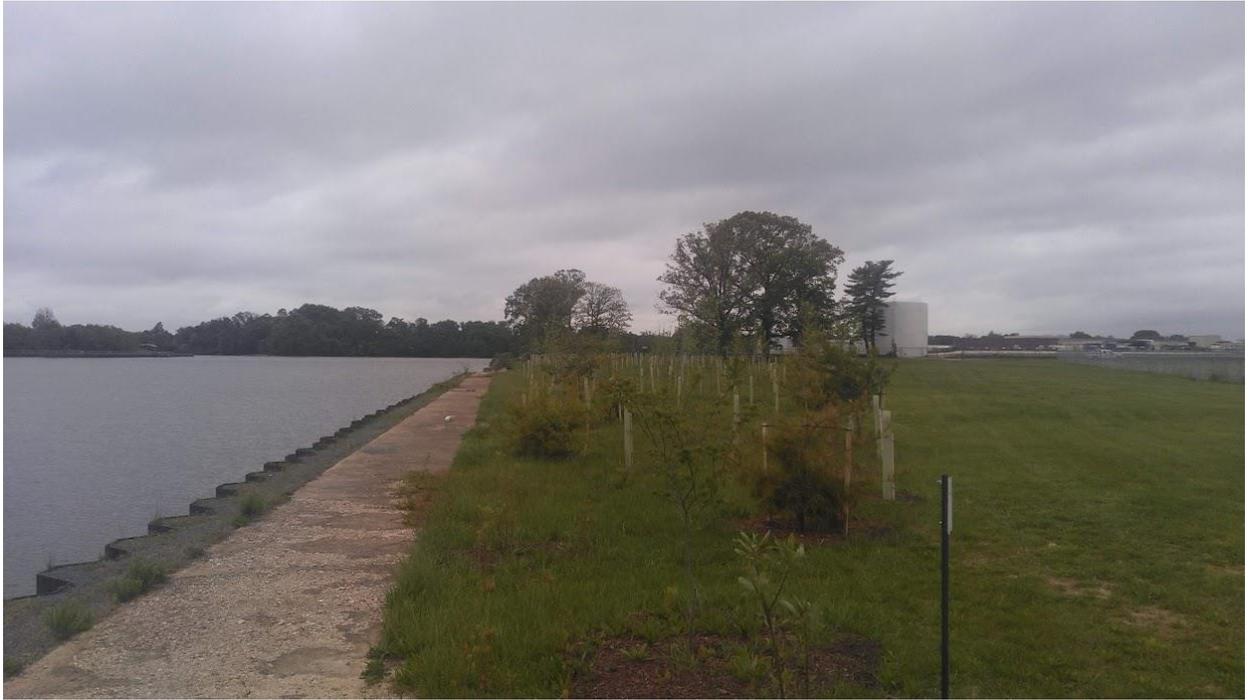
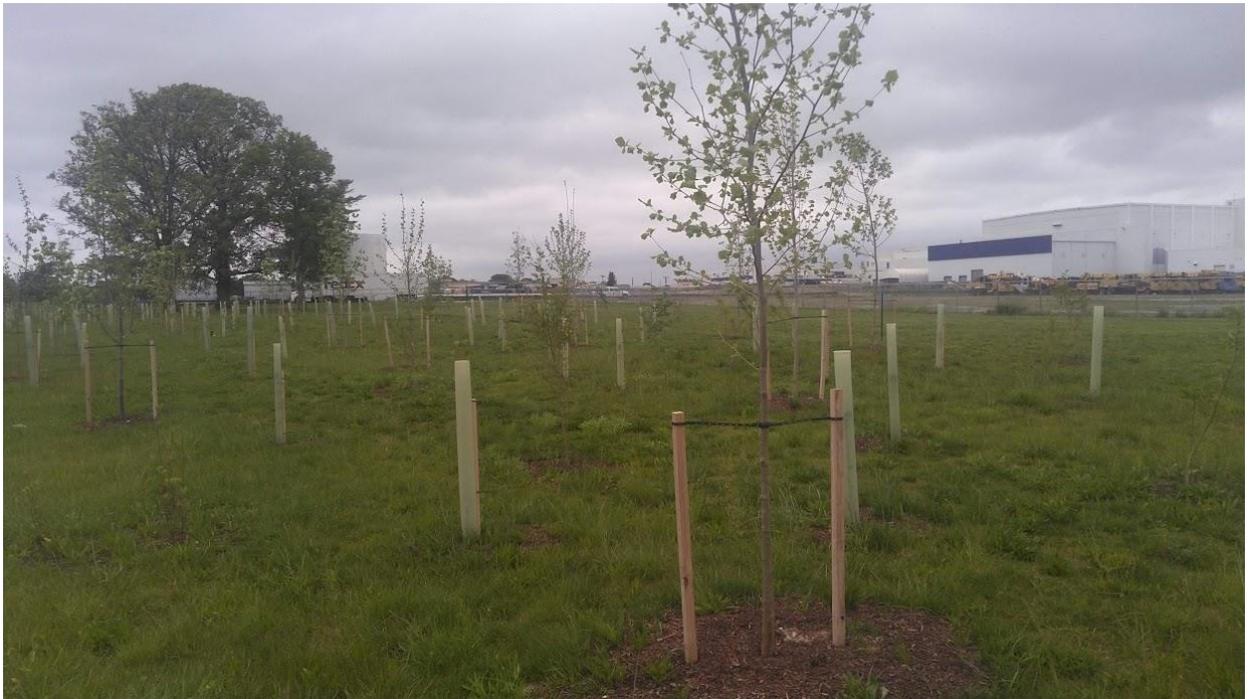
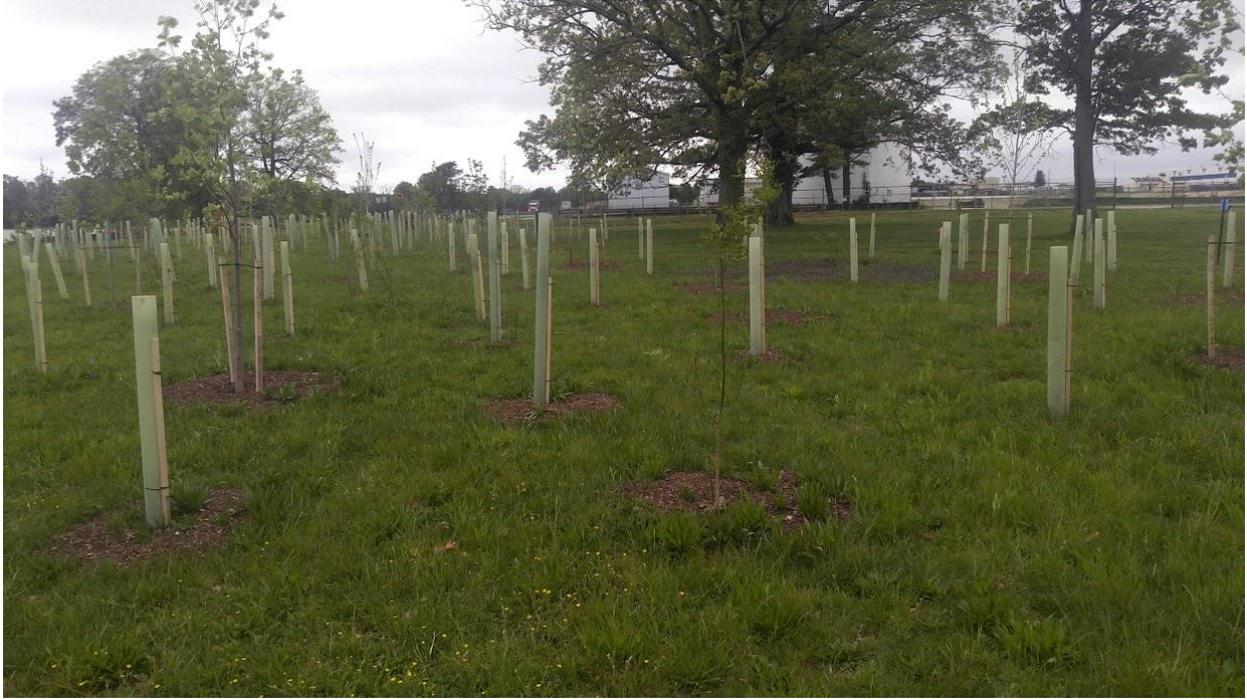
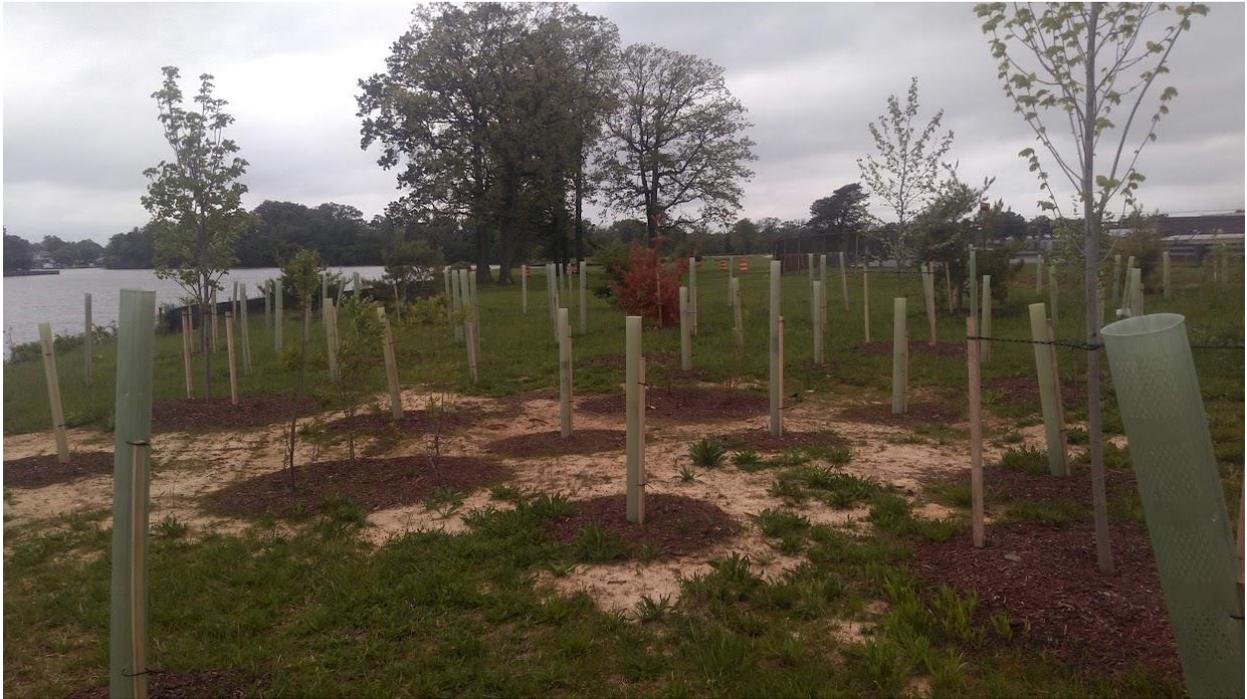
MAY 13, 2022

<p>OBSERVED AND SUSPECTED REASONS FOR ANY HIGH MORTALITY RATES (I.E. STANDING WATER, TOO DRY, ETC.)</p>	<p>No</p>
<p>WEEDS IN PLANTING PITS? INVASIVE SPECIES?</p>	<p>Weeds are starting to grow in pits. Time to apply herbicide to planting pits. Will need to schedule.</p> <p>Could not be performed during this inspection visit due to rain.</p>
<p>ADDITIONAL AREAS OF CONCERN AND MEASURES TO BE TAKEN?</p>	<p>Nothing at this time</p>
<p align="center">MAINTENANCE ACTIVITIES PERFORMED</p>	
<p>WATERING?</p>	<p>Not needed due to recent weather</p>
<p>HERBICIDE APPLICATION/WEEDING PLANT PITS?</p>	<p>N/A</p>
<p>TREE, TREE STAKE, TREE TUBE STRAIGHTENING?</p>	<p>Trees were straightened as needed</p>
<p>MISCELLANEOUS OBSERVATIONS?</p>	<p>Pines are having a difficult time. Several are yellowing and one is dead. Probable cause of mortality is due to their large surface area, heavy winds, and being separated from their rootball. Recommend replacing in the fall with smaller container-grown pines.</p>

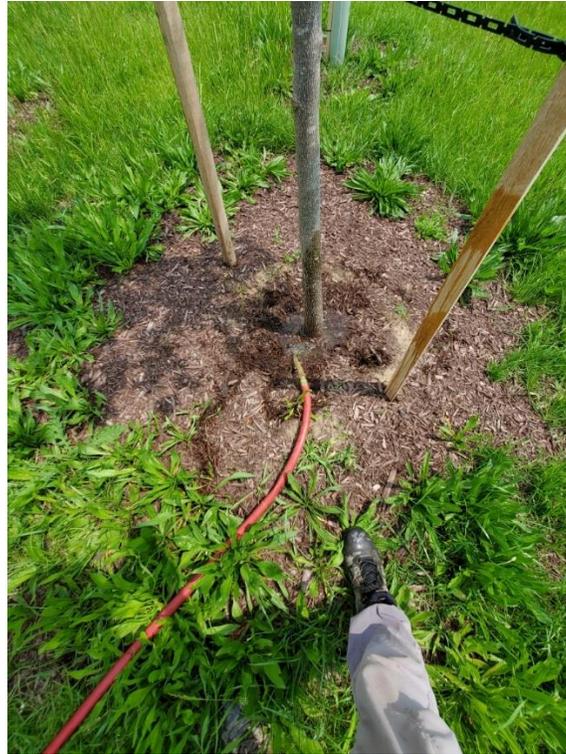
Gentle Watering/Soaking of Tree/Shrub Pits

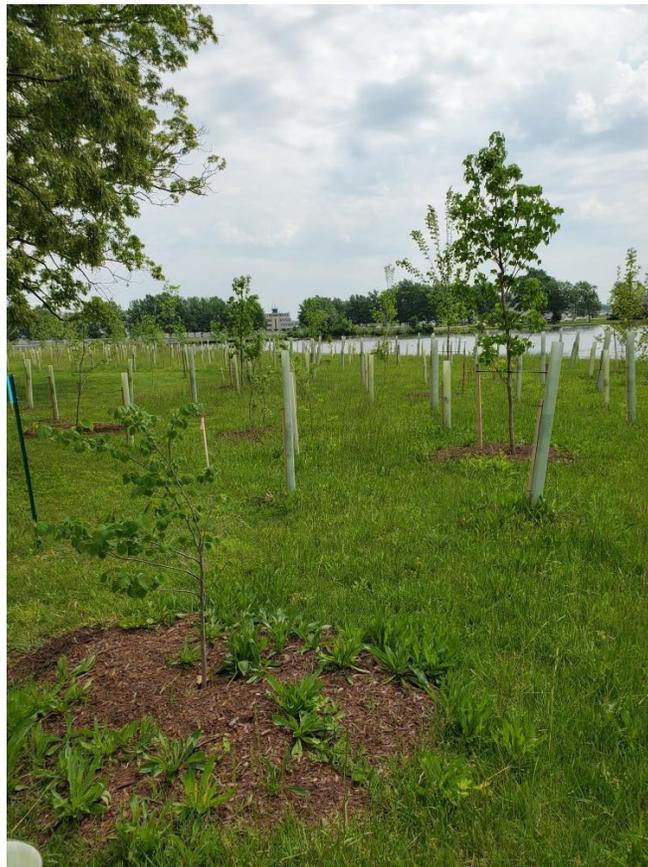
Overview of Site

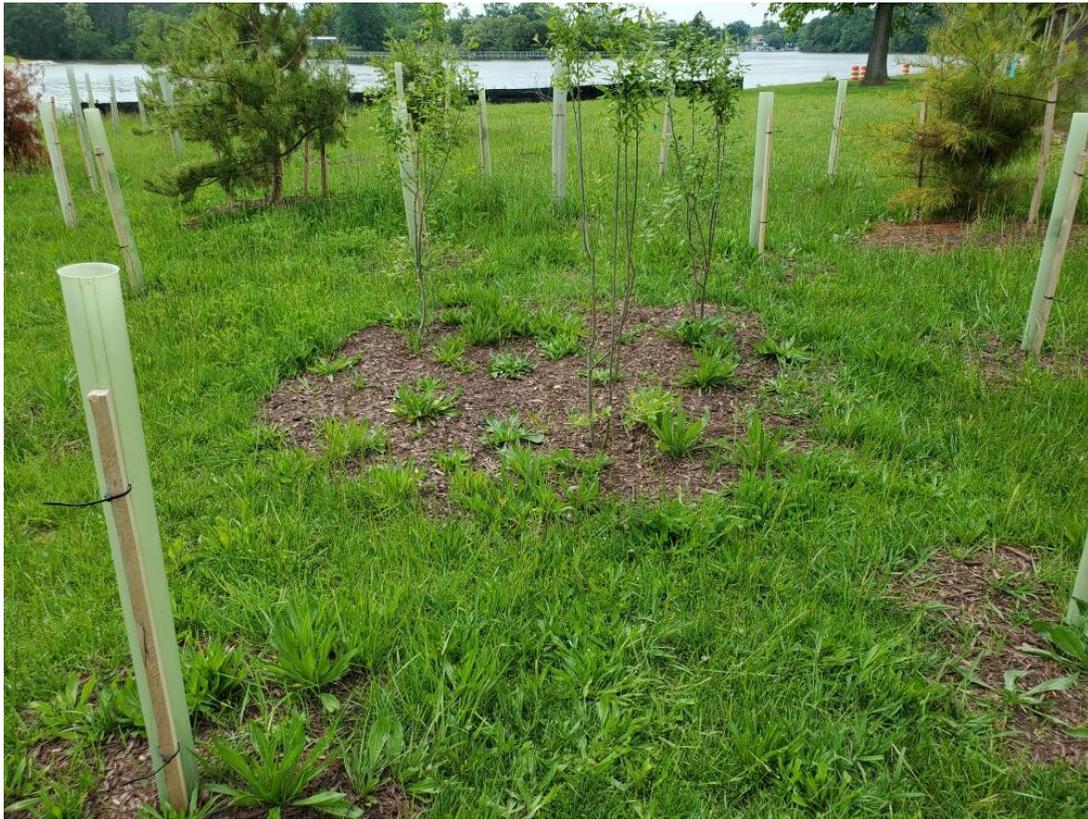
Typical Shrub Cluster Looking Good – Typical Weeds Established in Mulch

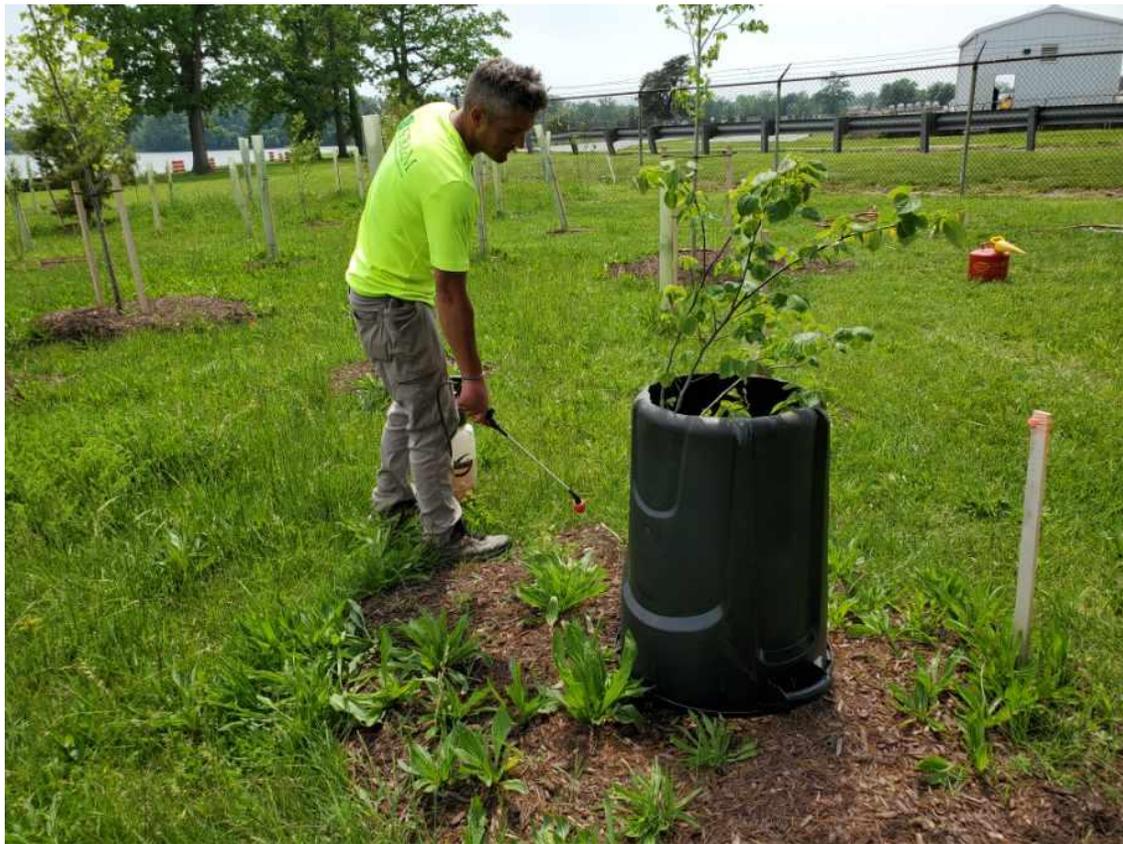
Selective Application of Glyphosate Herbicide of Glyphosate Herbicide to Mulch Beds
Illustrated Method of Protecting Small Trees and Shrubs from Herbicide Drift Damage

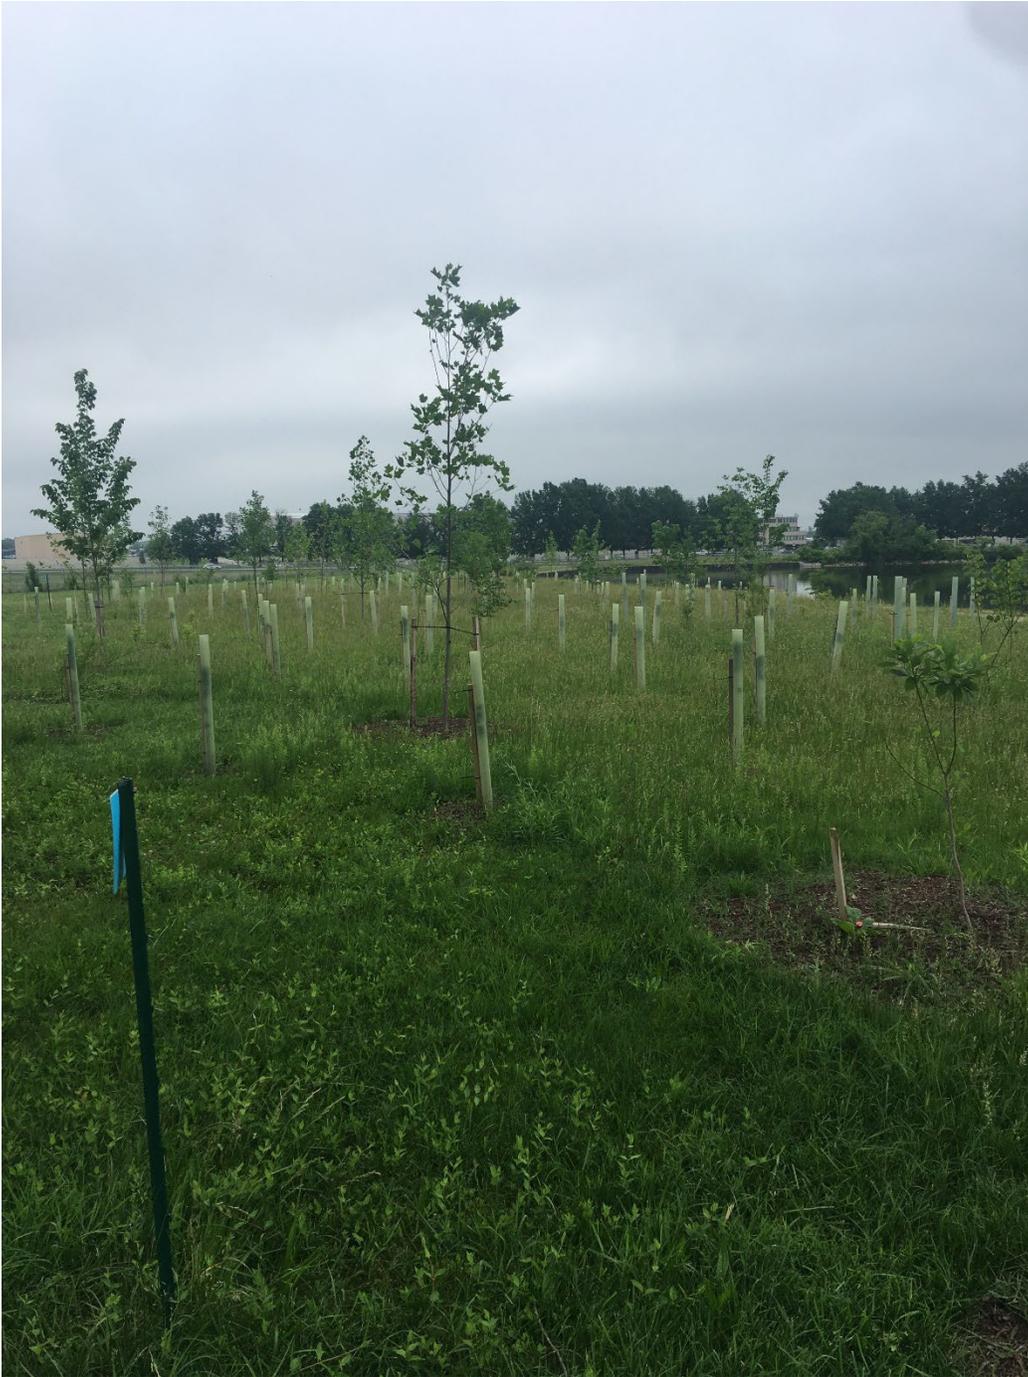
Overall site looking very good.

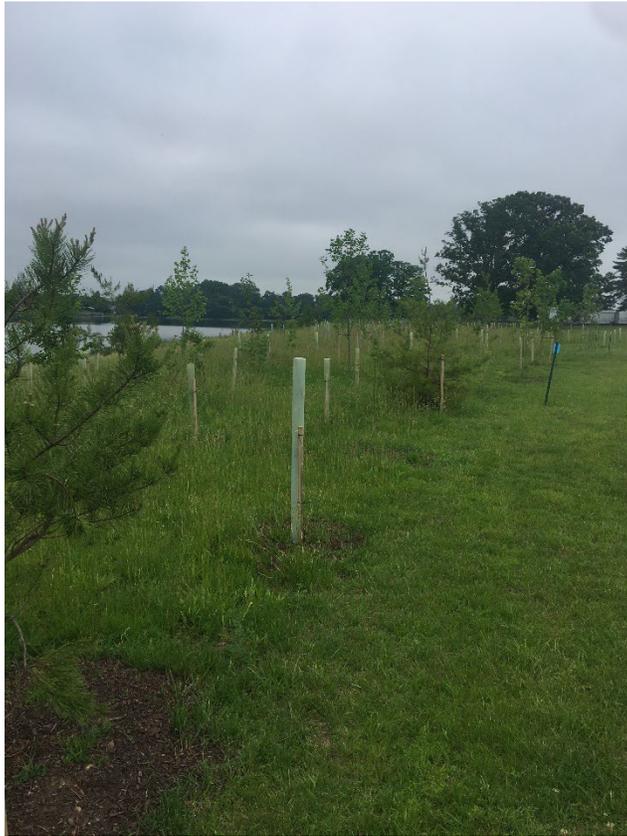
General site overview.

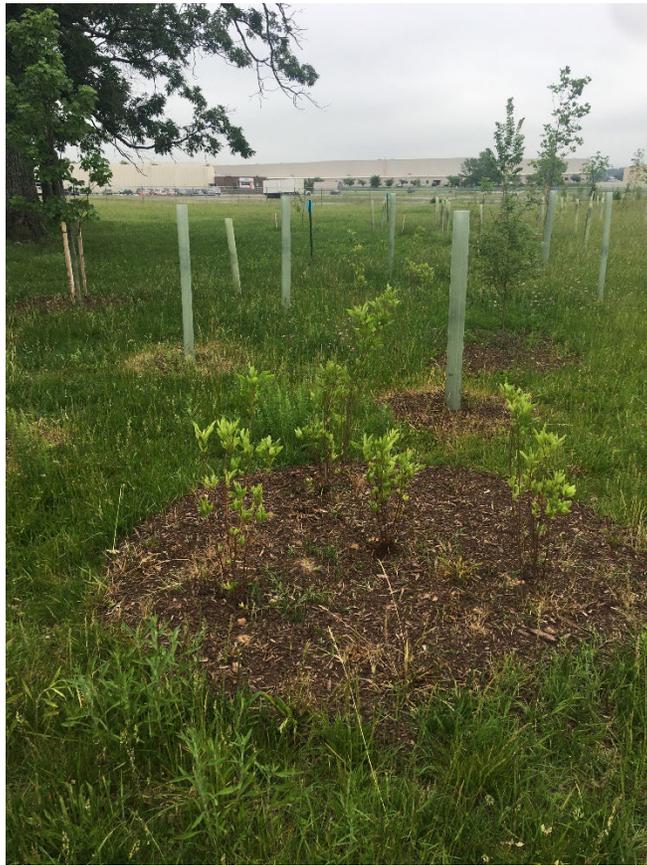
Weeds sprayed in shrub cluster dying off.

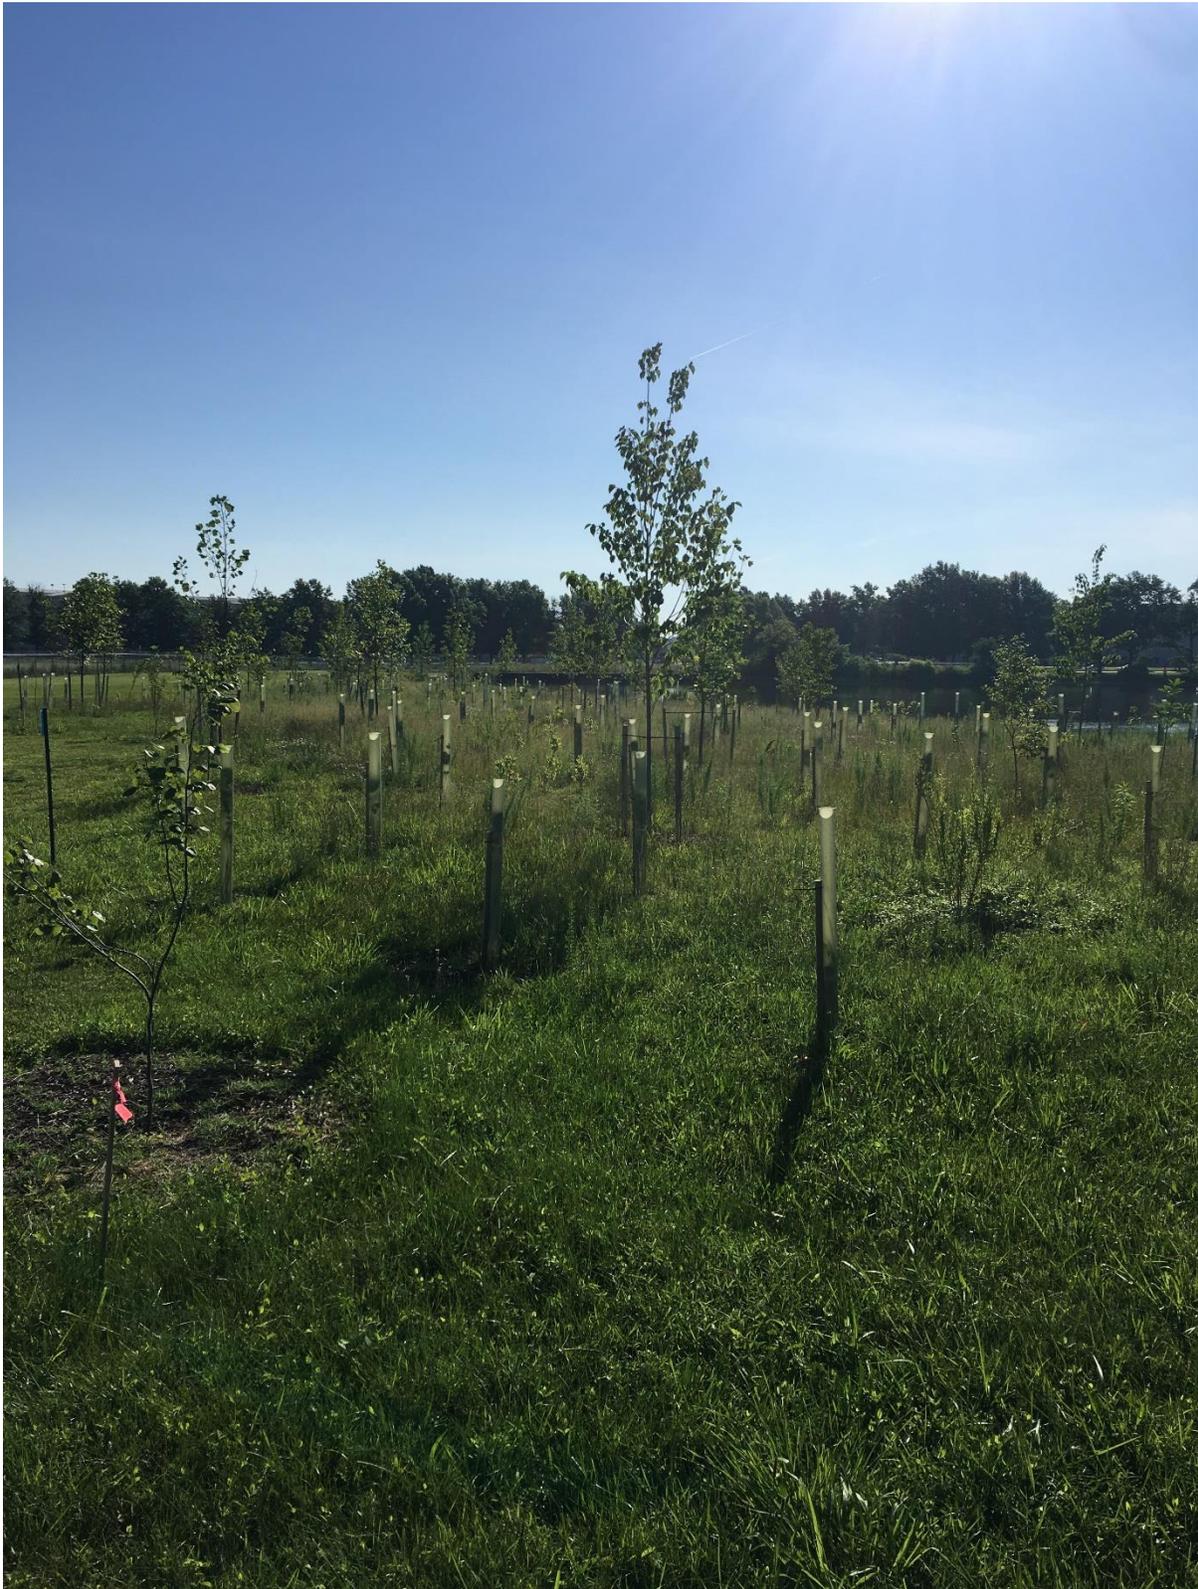
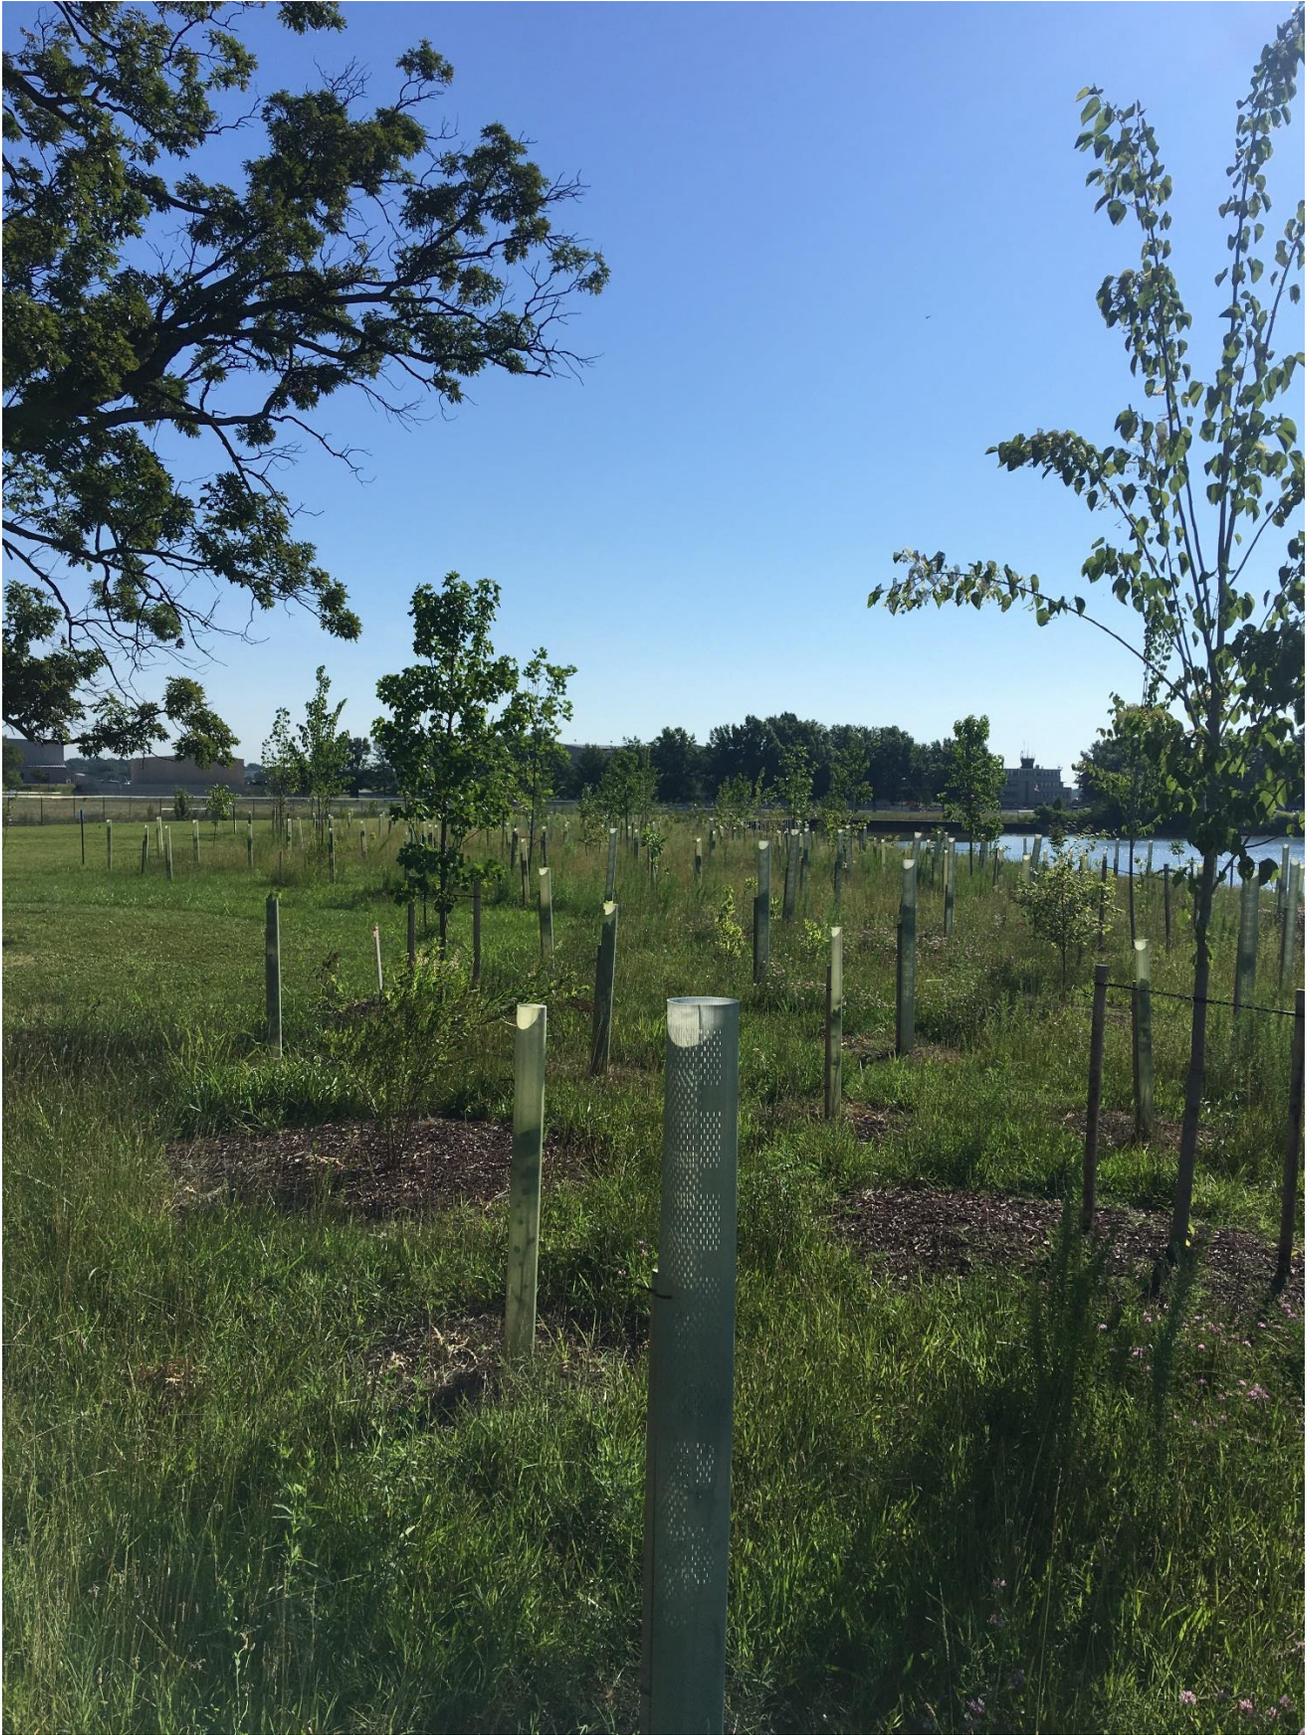
Overall site looking very good.

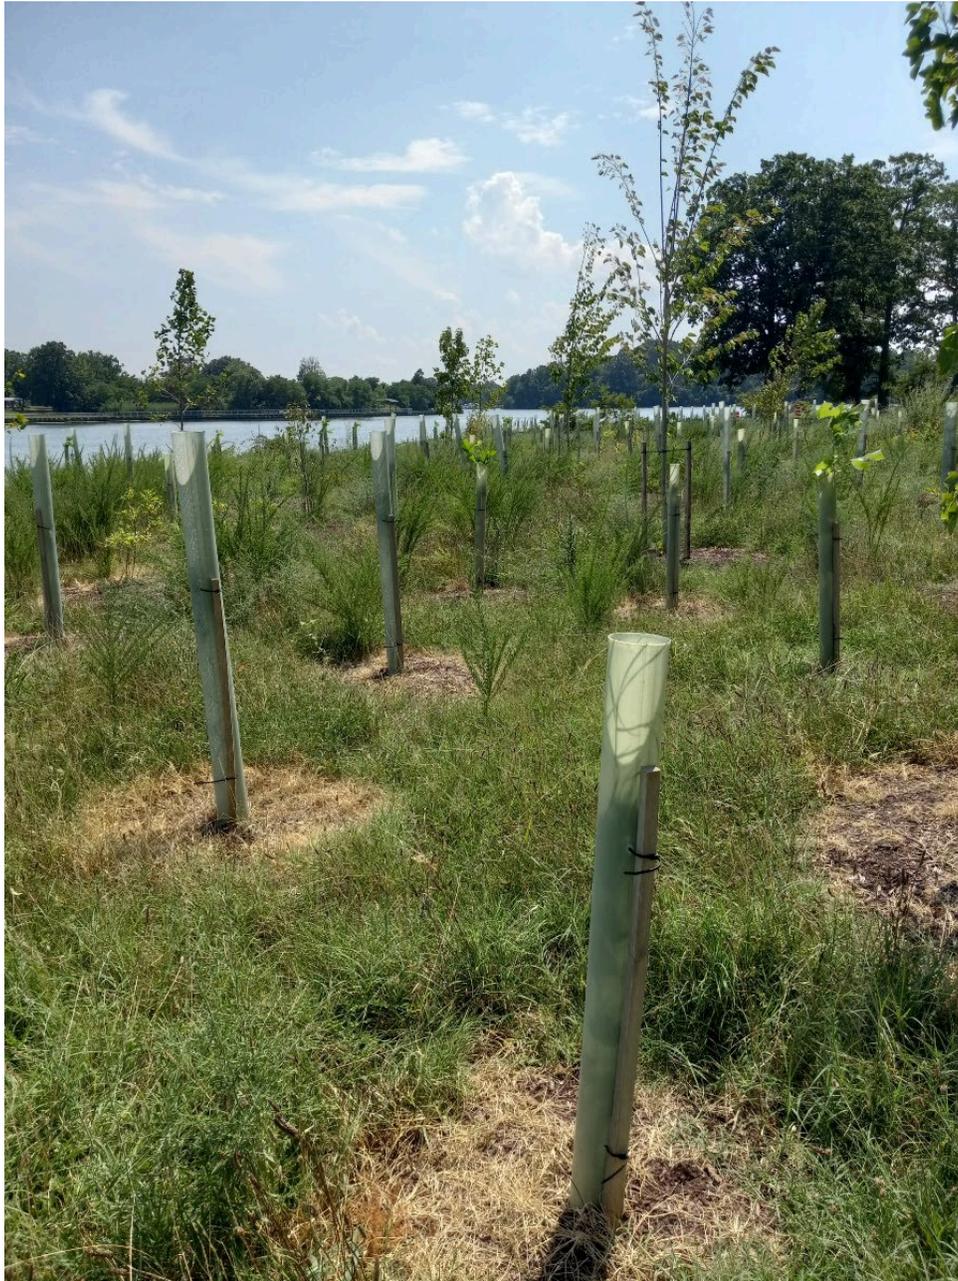
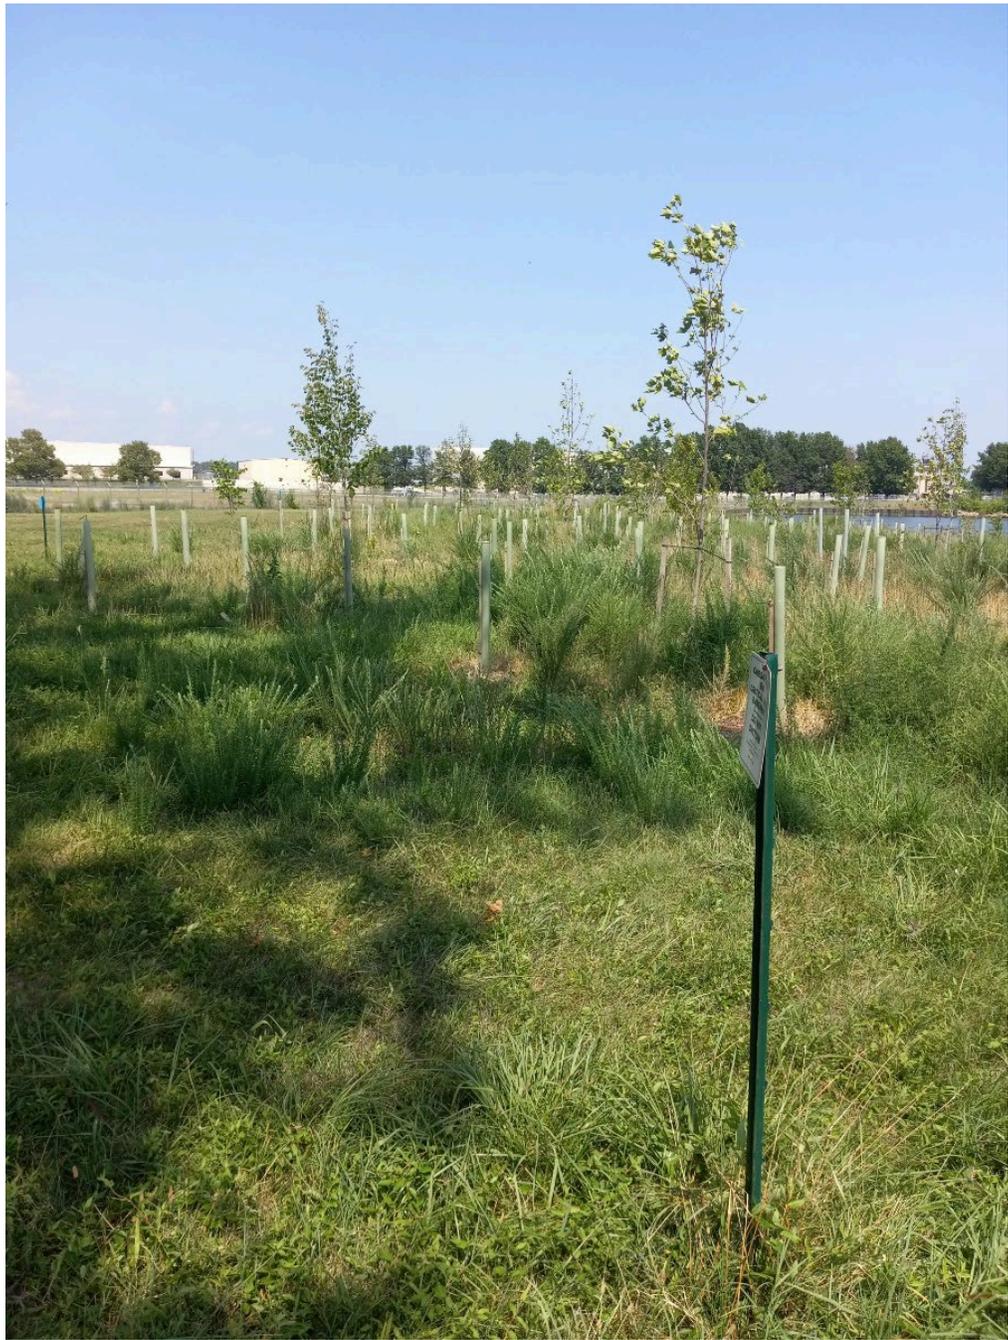
Overall plant material appears to be bouncing back from impact of extended period of heat and low precipitation. Chinese lespedeza is popping up throughout the site.
