Subject: Transmittal of the Block E Tree Mitigation Planting Report 2022
Lockheed Martin Corporation – Middle River Complex
2323 Eastern Boulevard, Middle River, Baltimore County, Maryland

**MIDDLE RIVER COMPLEX CRITICAL AREA 2022
BLOCK D ANNUAL MITIGATION PLANTING REPORT
2323 EASTERN BOULEVARD
LOCKHEED MARTIN MIDDLE RIVER COMPLEX
MIDDLE RIVER, MARYLAND**

**Project: Middle River Complex –
Critical Area Mitigation Planting, Block D**

Subject: End of Year 1 Growing Season Inspection Report

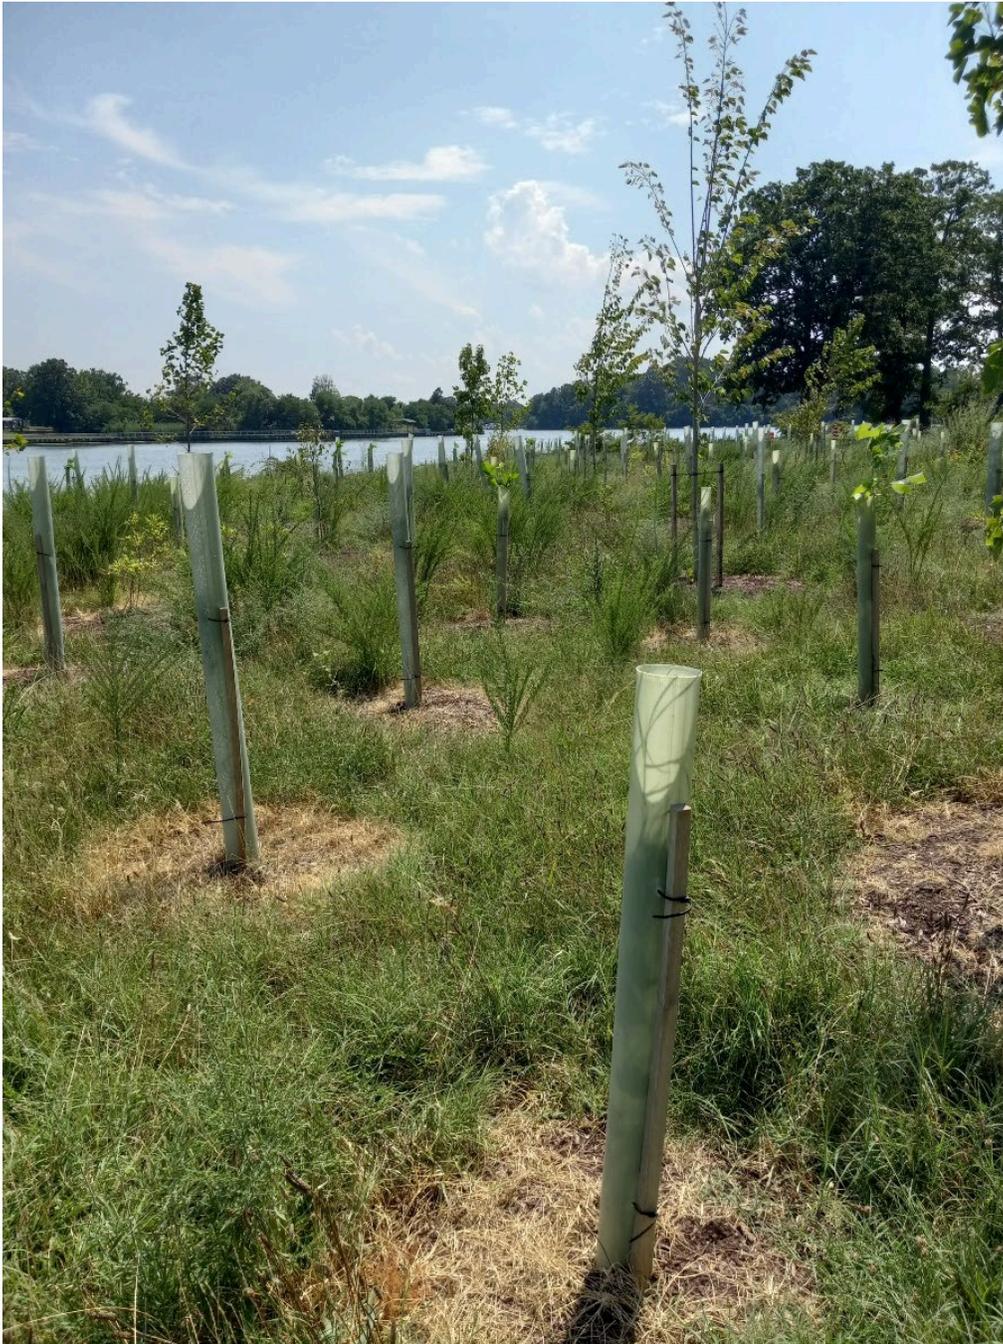
Installed trees and shrubs have rebounded well but regular watering remains necessary due to continuing stretch of dry weather. Chinese lespedeza was mowed, better exposing installed plant material.

Site prior to mowing

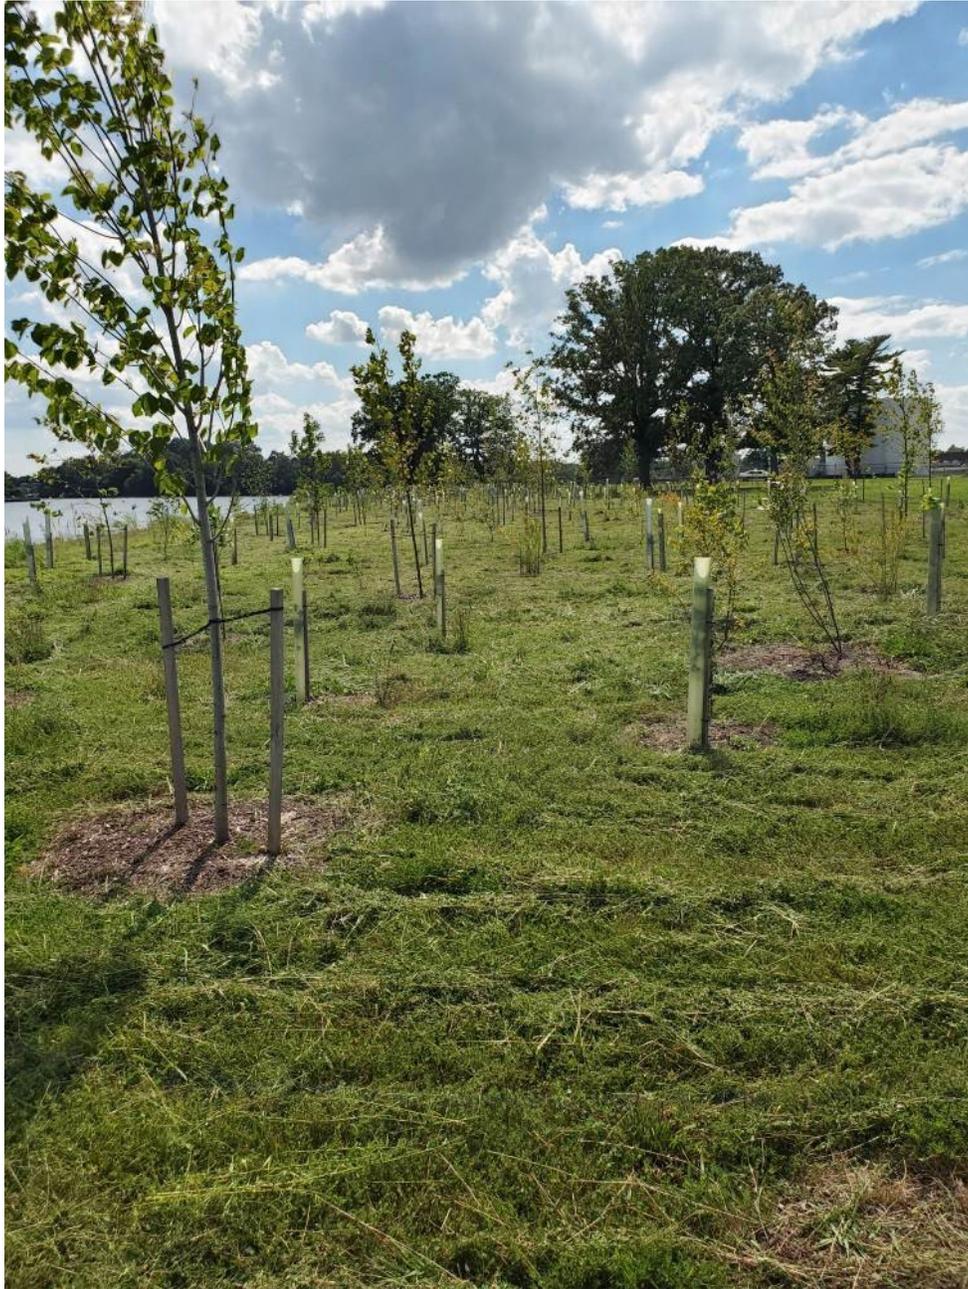
Site Post-Mowing and Before Watering

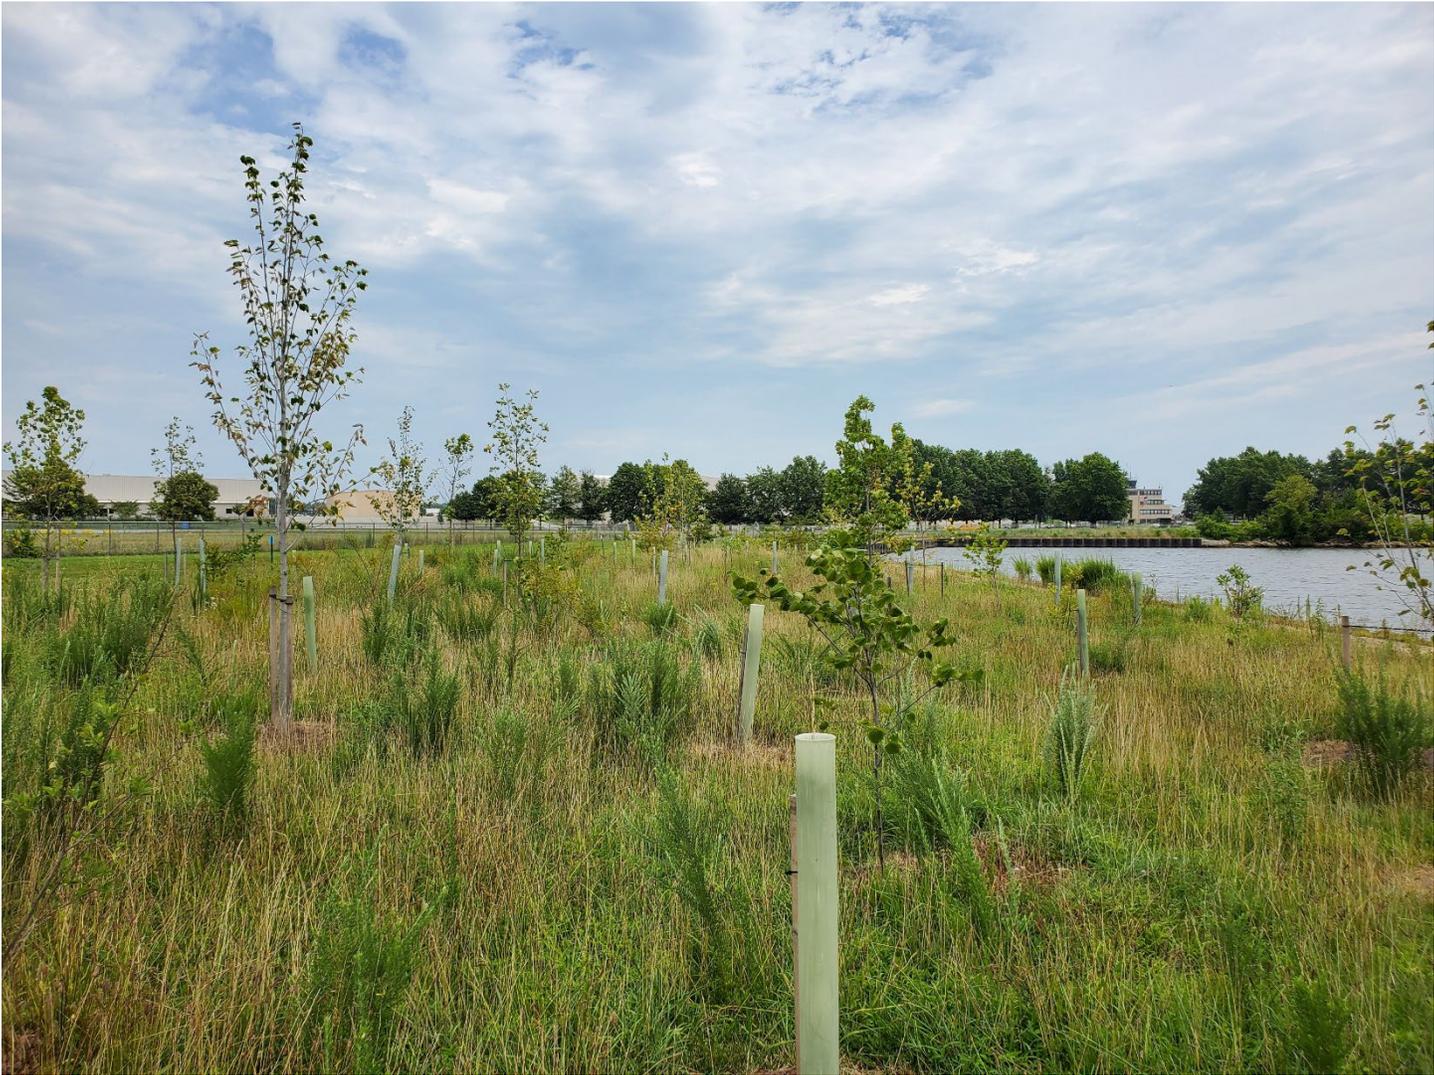
Plants look good but show heat stress despite watering
