**COW PEN CREEK WETLAND RESTORATION–
2022 MONITORING REPORT
2323 EASTERN BOULEVARD
LOCKHEED MARTIN MIDDLE RIVER COMPLEX
MIDDLE RIVER, MARYLAND**

Prepared by:
Tetra Tech, Inc.

November 2022

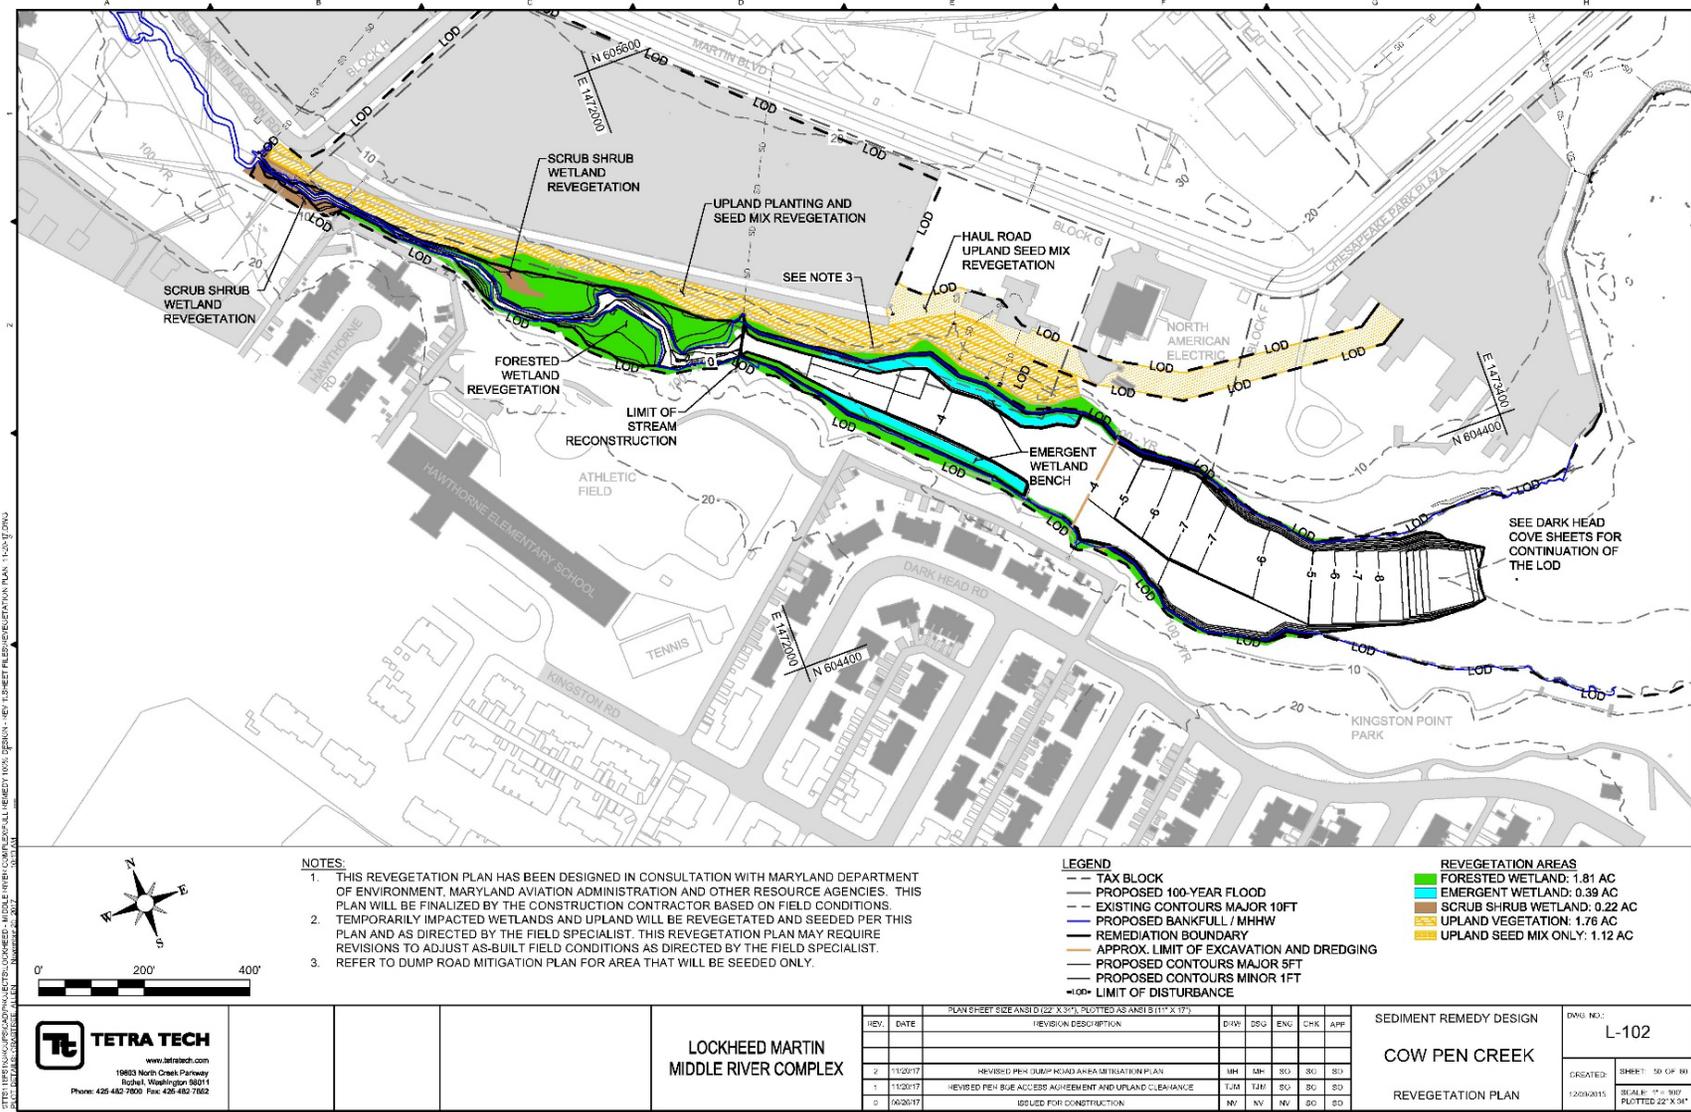
Figure 1-1. Wetland Restoration Monitoring Area and Revegetation Design.

The monitored restoration area in Cow Pen Creek is shown on Figure 1-1. The specific objectives of wetland monitoring were to:

Lockheed Martin started the removal of contaminated sediment from Dark Head Cove and Cow Pen Creek in 2014. Portions of Dark Head Cove and the lower reaches of Cow Pen Creek were conventionally dredged, and the sediment surface was restored by placing a six-inch-thick sand layer (residual management layer). During the remedial action in the upstream portion of Cow Pen Creek, approximately four acres of vegetated habitat including wetlands were damaged or removed. Wetlands are an important habitat for a variety of organisms, including ecologically important fish and invertebrate species (Brinson and Rheinhardt, 1996). In addition, wetlands provide an excellent food source for several waterfowl species, particularly in the freshwater and oligohaline portions of the Middle River and Chesapeake Bay. In response to the temporary loss of these ecosystems, and in compliance with a United States Army Corps of Engineers (USACE) permit and Maryland Department of the Environment (MDE) Tidal Wetlands Letter of Authorization (LOA), Lockheed Martin implemented a wetland restoration project in 2017-2018. After sediment removal and stream reconstruction was completed, seedlings were planted in the wetland areas along both banks of Cow Pen Creek (see Figure 1-1).

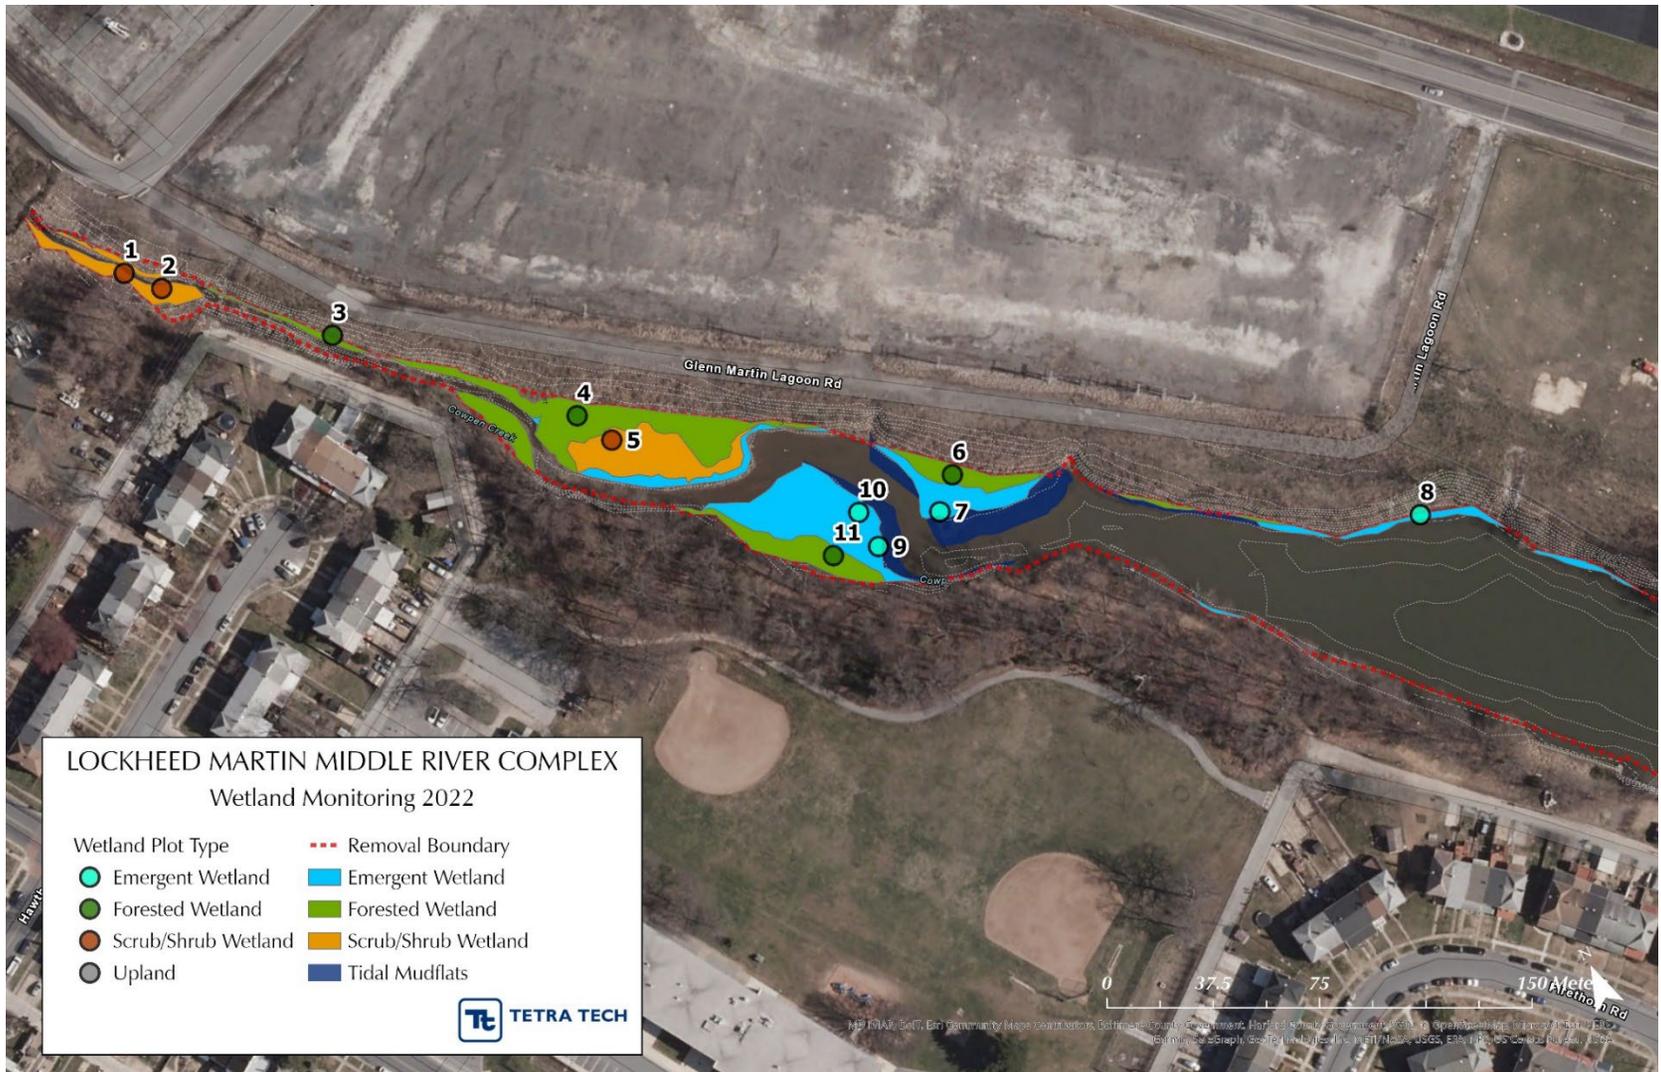
Figure 3-1. Map of 2022 Wetland Monitoring Plot Locations
(The wetland polygon areas are based on the August 2022 wetland delineation.)

The eleven sampling locations assessed for 2022 (numbered 1–11) are shown on Figure 3-1. Table 3-1 provides a summary of the vegetation observed and recorded at each site, per the monitoring and data collection objectives outlined in Section 3.1. No dead shrubs or trees were observed in the plots. Unless noted in the plot-specific descriptions below, both herbaceous and woody plants are thriving and expanding in coverage. Cattails are common in the scrub-shrub and emergent plots. Both broad leaf (*Typha latifolia*) and narrow leaf cattails (*Typha angustifoli*) are present. Narrow leaf cattail is abundant, but at this time does not appear to be crowding out other wetland vegetation.

- No observable sedimentation was noted in the restored wetland areas, other than possibly some sediment accretion on parts of the Hawthorne bar (where sampling plots 9, 10, and 11 are located; see Figure 3-1). Multi-year visual observations indicate that some sedimentation is occurring at the downstream bar where the channel widens, and water velocity (flow) slows. However, this area is within the stream channel and not within the boundary of one of the designed wetland types. At low tide, starting at the Hawthorne bar and moving downstream, are exposed mud flats that are outside of the wetland boundaries.

As shown on Figure 3-1, emergent wetlands are present along the downstream banks (Plots 7, 9, and 10) of the site (Figure 3-1). The monitoring team observed several patches of pickerelweed on the downstream wetland benches, but overall vegetation coverage on these benches was less than 25%. Farther upstream, the shallow water along most of the shoreline was vegetated with emergent vegetation.

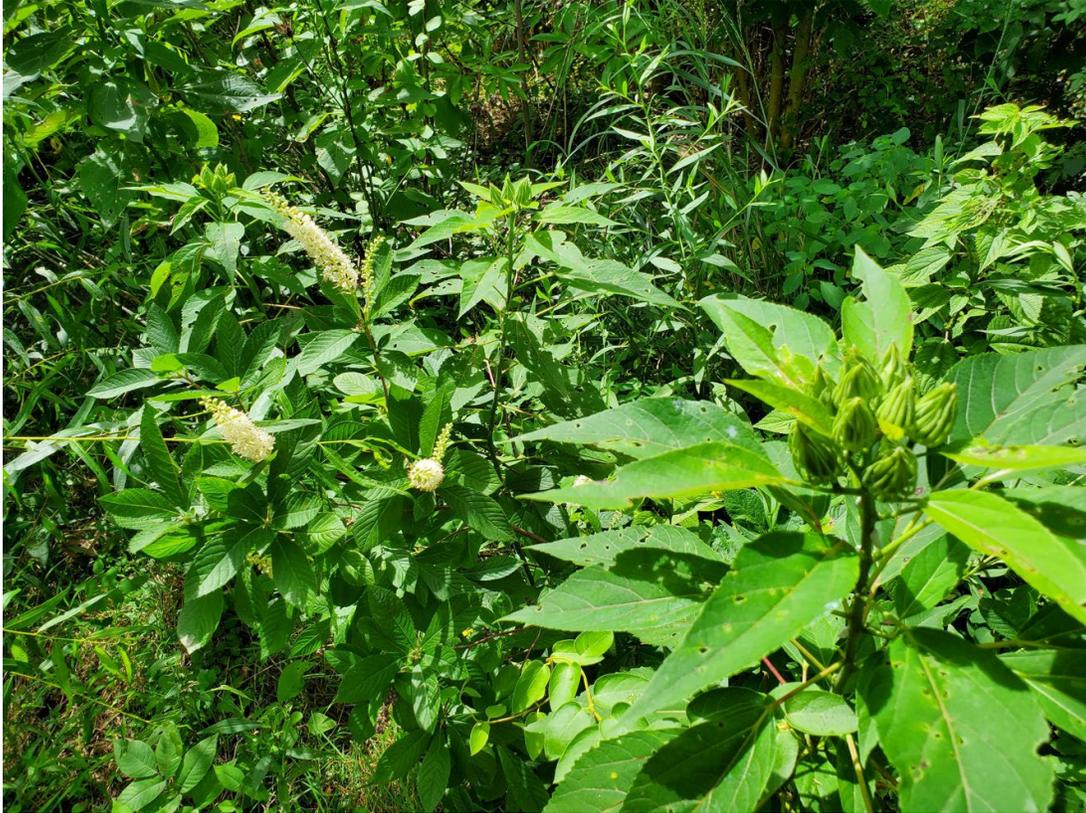
Figure 3-2. Plot 1– Scrub-shrub Wetland near Upstream Limit of Project Area.

Plot 1: This scrub-shrub location is farthest upstream area assessed in 2022. Ground cover is 100% with 48% creeping bentgrass (*Agrostis stolonifera*), 48% jewelweed (*Impatiens capensis*), and other rush species and mixed herbaceous plants adding to the coverage (Figures 3-1 and 3-2). Non-native creeping bentgrass was introduced here but was part of the approved restoration plan due to Maryland Aviation Administration (MAA) species restrictions. Eleven woody stems were counted in the plot including four sweet bay magnolia (*Magnolia virginiana*), five black willow (*Salix nigra*), one silver maple (*Acer saccharinum*), one green ash (*Fraxinus pennsylvanica*), and one sweet pepperbush (*Clethra alnifolia*). Soil at the monitoring location was wet or saturated at the surface and is hydric based on colors and features (Table 3-2). A small patch of invasive Japanese honeysuckle (*Lonicera japonica*) was observed on the edge of the plot and was treated with herbicide in October 2022. A patch of invasive common reed (*Phragmites australis*) observed near

Plot 1 was also treated with herbicide, but no reeds were observed within the sampling plot. A larger stand of phragmites was noted upstream of Plot 1 (and outside the restoration area).

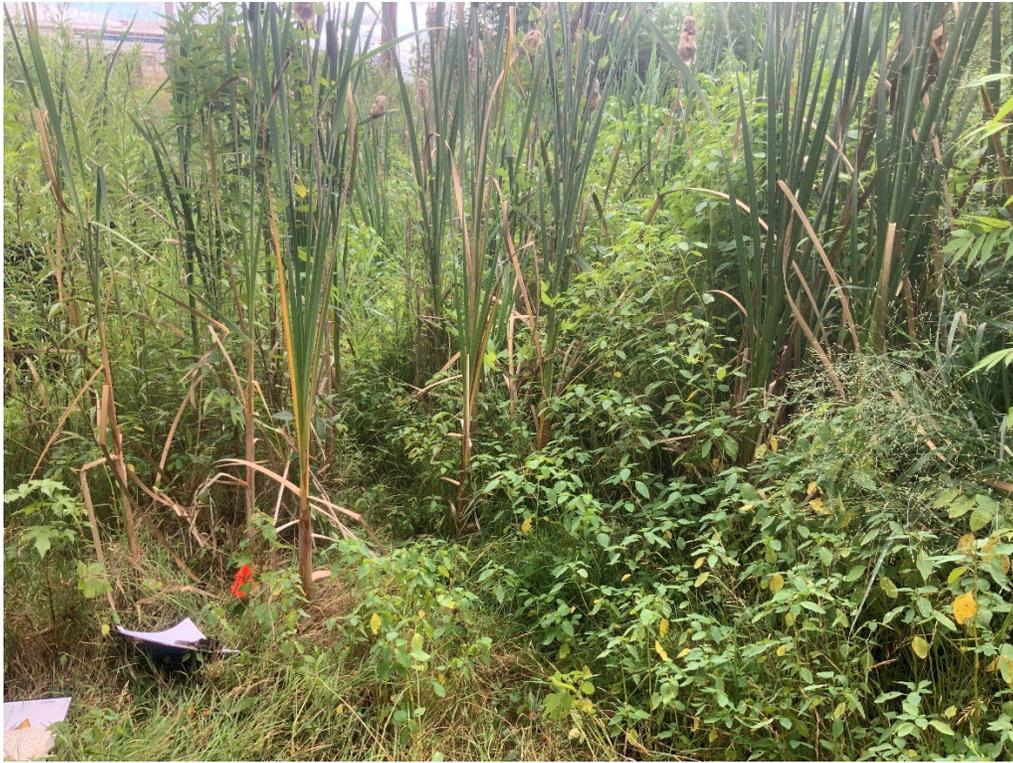
Figure 3-3. Plot 2– Scrub-shrub Wetland Along Upper Portion of Cow Pen Creek.

Plot 2: This scrub-shrub location is the next evaluated section downstream of Plot 1 (Figures 3-1 and 3-3). Ground cover is 100% with no bare spots. The dominant herbaceous vegetation is jewelweed (60% coverage) and creeping bentgrass (30% coverage). The remaining coverage (10%) is made up of broad and narrow leaf cattail (*Typha* spp.). Seven woody stems were counted including two black willow, one silver maple, one sweet gum (*Liquidambar styraciflua*), one slippery elm (*Ulmus rubra*), one sweet pepperbush, and one buttonbush (*Cephalanthus occidentalis*). Soil at the monitoring location was wet or saturated at the surface and is hydric based on colors and features (Table 3-2). No invasive plants were within the sampling plot in October 2022. A patch of Japanese honeysuckle was observed near this location and was treated with herbicide. Bordering the northern side of the plot is a stand of broad leaf cattail.

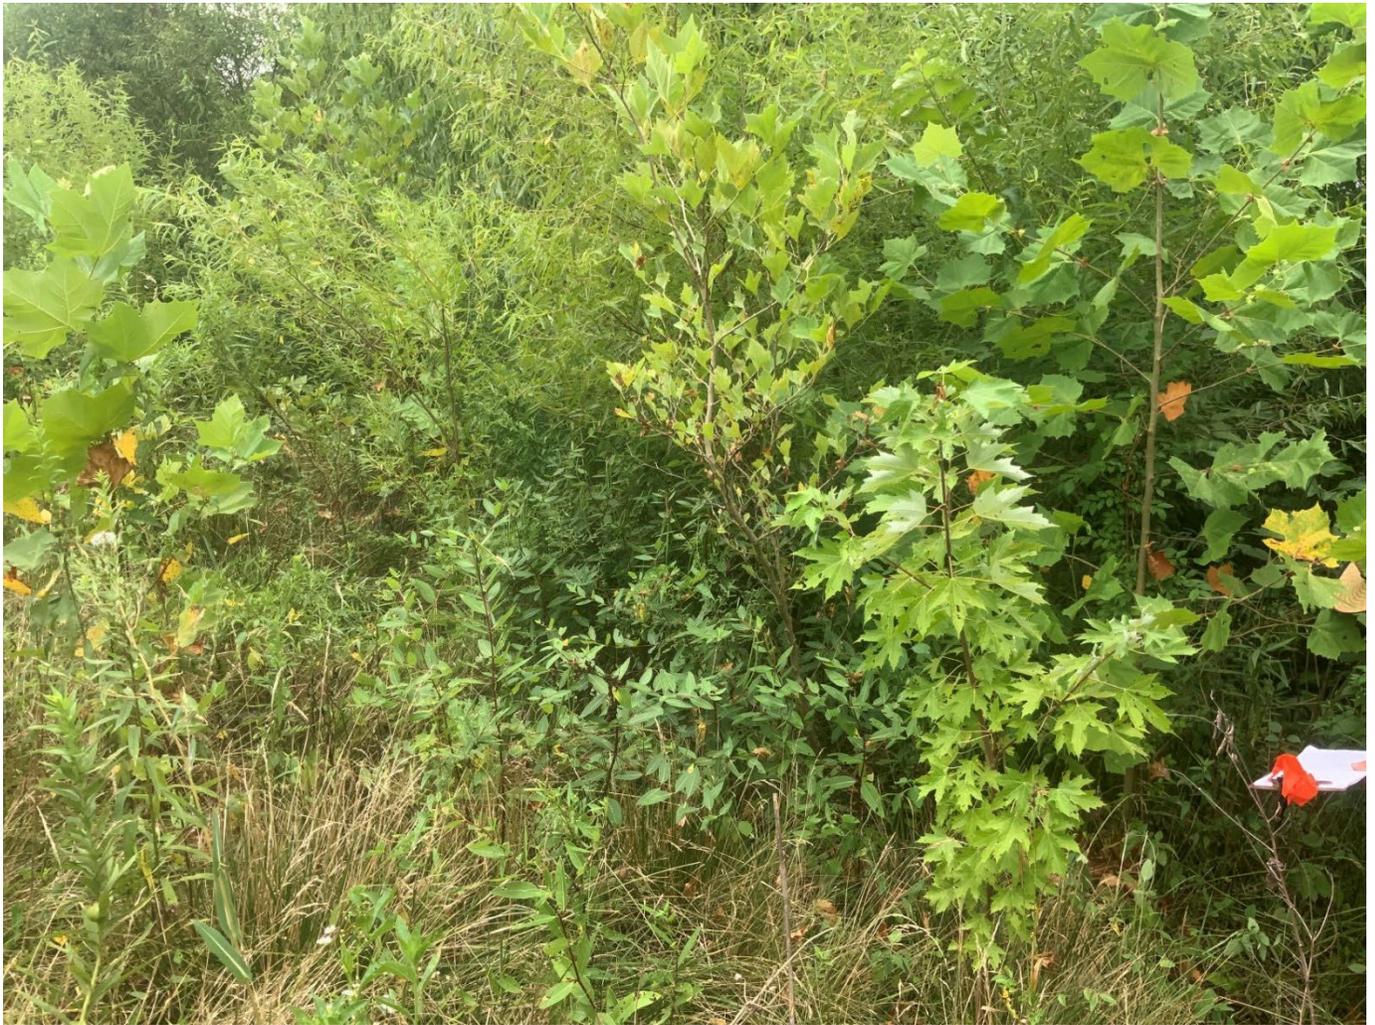
Figure 3-4. Plot 3– Forested Wetland Bordering Cow Pen Creek on Lockheed Martin Shoreline Including View of Willows, Sycamores, and Silver Maple.

Plot 3: This forested wetland location is downstream of Plot 2 on the Lockheed Martin (northern) side of the creek (Figures 3-1 and 3-4) and is within the wetland boundary. Ground cover is 95% with no bare spots, and the dominant herbaceous vegetation is jewelweed and creeping bentgrass (25% each), followed by goldenrod (*Solidago* sp.), and false nettle (*Boehmeria cylindrica*) each with 10% coverage. There is 5% cattail coverage of narrow leaf cattail on the wetter edge. A mix of common boneset (*Eupatorium perfoliatum*), sedges (*Carex* spp.) and grasses account for the remaining 20% coverage. Eleven plants with woody stems, including five black willows, five sycamores (*Platanus occidentalis*), and one sweet gum were observed in this plot. There is 100% survival of planted woody material, as no dead shrubs or trees were observed. Narrow leaf cattail, which is exotic and can be considered invasive, was observed within the plot. Soil in the monitoring location was moist at the surface and is hydric based on colors and features.

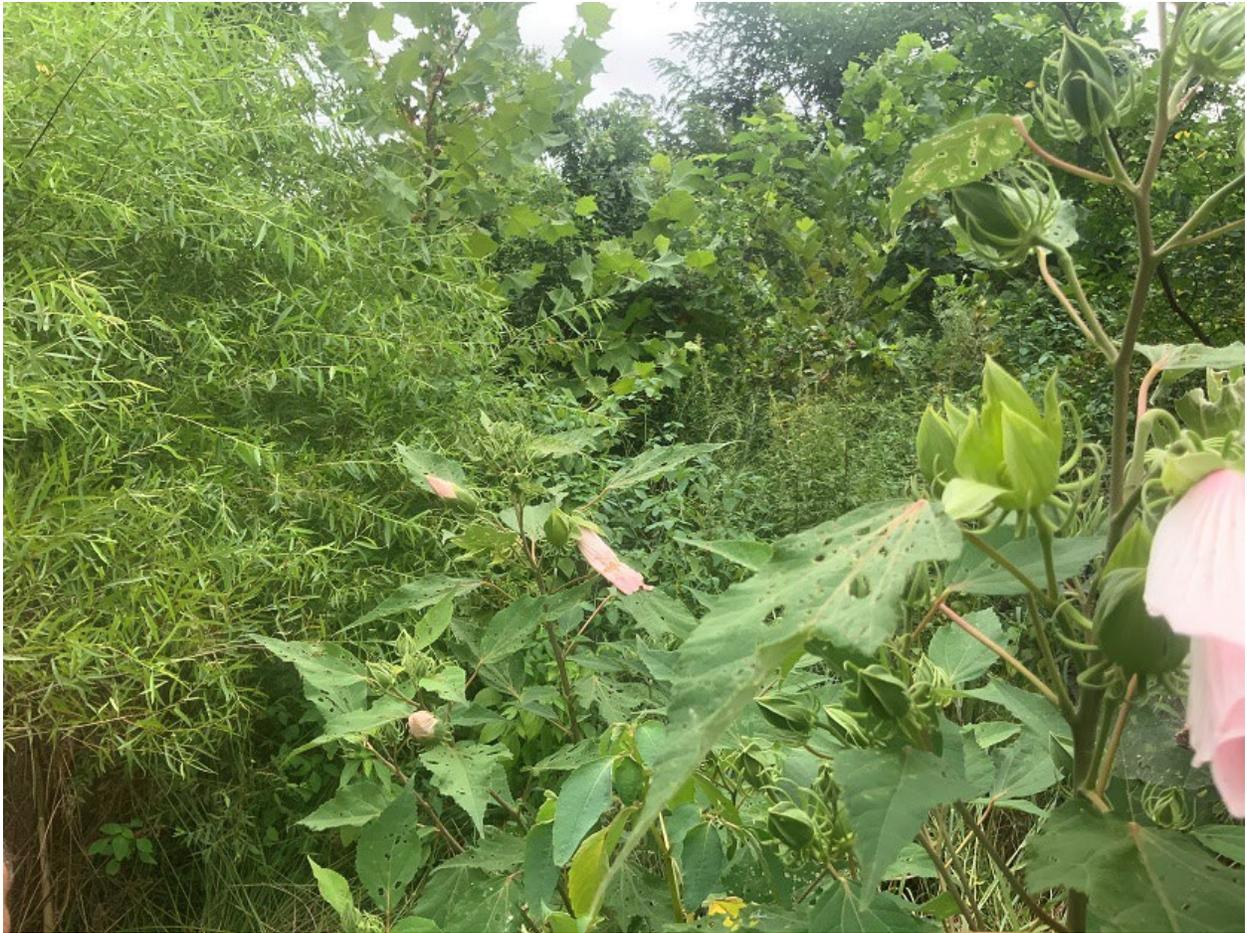
Figure 3-5. Plot 4– View of Forested Wetland Bordering Cow Pen Creek on Lockheed Martin Shoreline Including Willows and Sycamore
(Rose Mallow in Foreground is on Wetter Downslope Edge)

Plot 4: This forested wetland monitoring location (Figures 3-1 and 3-5) is on the Lockheed Martin side of the creek and farther downstream from Plot 3 at slightly lower elevation, and near the scrub-shrub wetland boundary. Ground cover is 100% with no bare spots, and the dominant herbaceous vegetation is soft rush (*Juncus effusus*) at 30% coverage followed by creeping bentgrass (20%) and sedges (10%) and rice cutgrass (*Leersia oryzoides*) (10%). The remaining herbaceous ground cover consists of common boneset, broadleaf cattail, and false nettle. Thirteen plants with woody

stems, including four sycamores, four river birch (*Betula nigra*), two boxelder (*Acer negundo*), one silver maple, one black willow, and one sweet gum. Survival of planted woody material is 100%, as no dead shrubs or trees were observed. Soil in the monitoring location was wet at the surface, saturated at a depth of 14 inches, and is hydric based on colors and features. No invasive plants were observed within the plot.

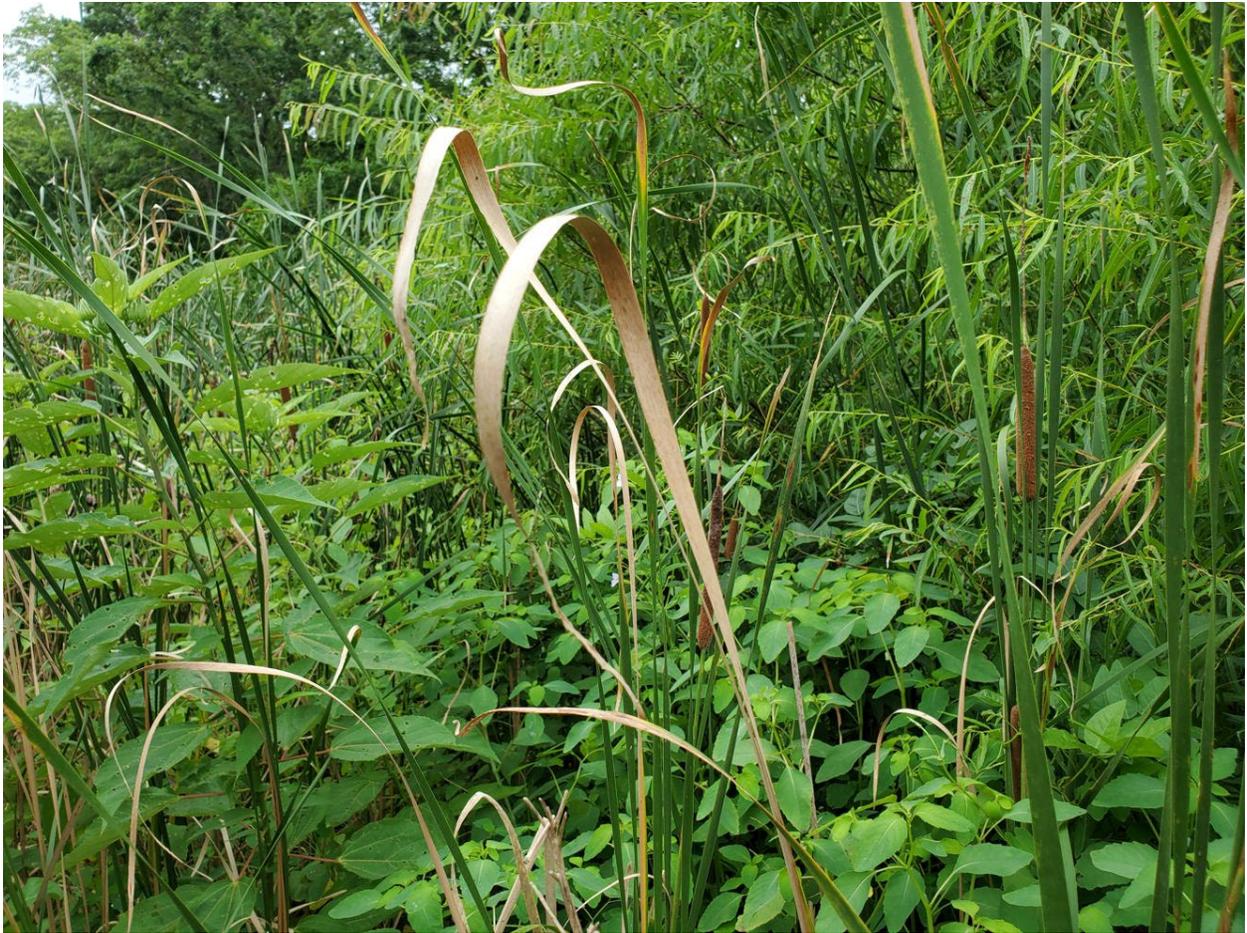
Figure 3-6. Plot 5– Scrub-shrub; Low Area Along the Edge of the Creek with Willow, Cattail, and Jewelweed.

Plot 5: This scrub-shrub wetland sampling location is downstream and downslope of Plot 4 on the Lockheed Martin side of the creek (Figures 3-1 and 3-6). Ground cover is 95% and the dominant herbaceous vegetation is creeping bentgrass with an estimated 75% coverage. Other species included jewelweed, narrow leaf cattails, goldenrod, and sedges. Rose mallow (*Hibiscus moscheutos*) were common, making up about 10% coverage at the 0.5-to-1.5-meter height. No dead shrubs or trees were observed in or adjacent to the plot. Five planted and/or natural recruitment tree and woody shrub species were observed, including two sycamores and three willows. Soil in the monitoring location was saturated at the surface and is hydric based on colors and features.

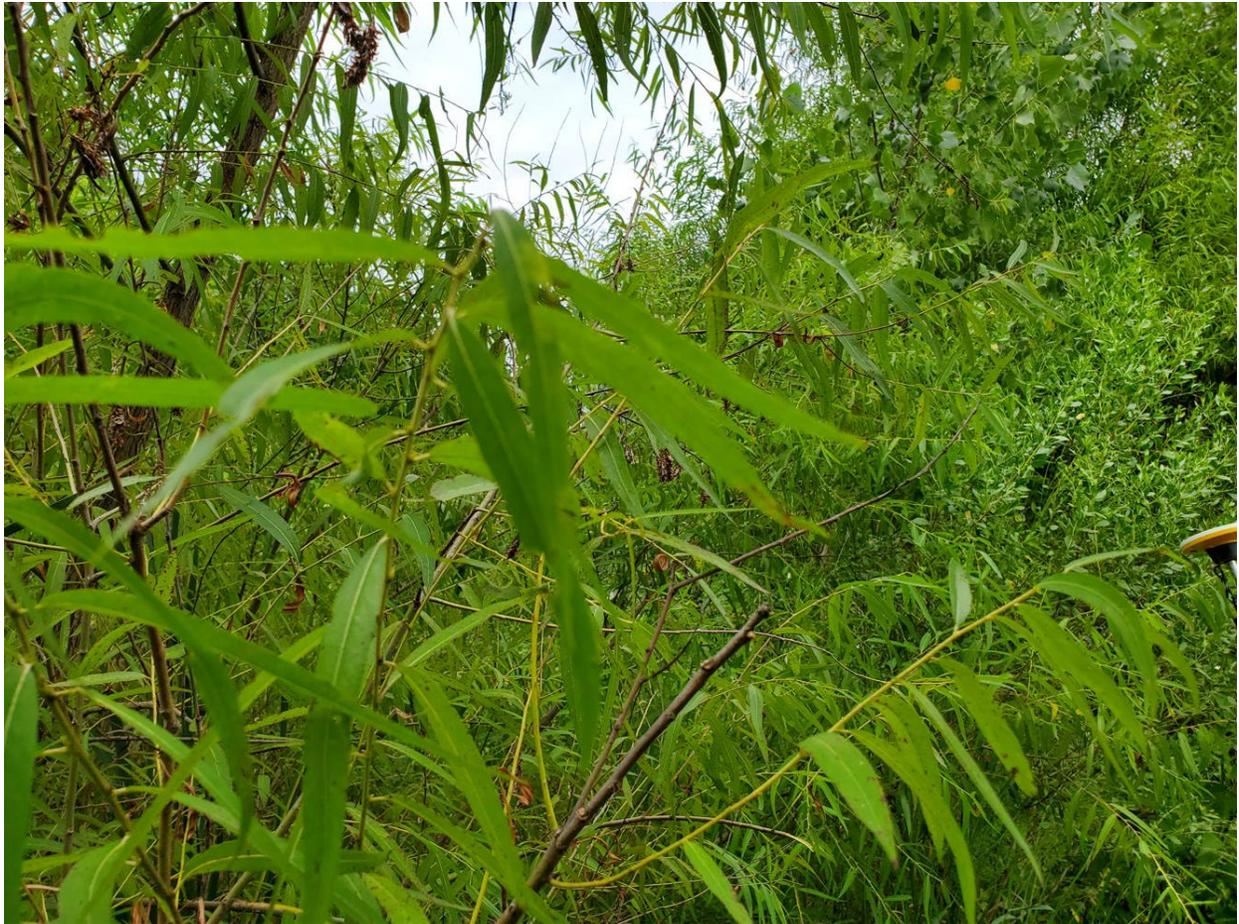
Figure 3-7. Plot 6– Forested Wetland Across from Hawthorne Bar Including Willows and Sycamore.

Plot 6: This forested wetland sampling location is downstream on the Lockheed Martin side of the creek and is close to the transition to emergent wetlands (Figures 3-1 and 3-7). Ground cover is 95%, with creeping bentgrass estimated as 60% cover, jewelweed at 10% and soft rush at 10%, while Pennsylvania smartweed (*Persicaria pensylvanica*), common boneset, sedge, and grass species make up the remaining 15% cover. Ten living woody stems were counted, including seven black willow, two sycamore, and one silver maple. Several hibiscus plants were noted on the downslope edge of the site. No dead shrubs or trees were observed. Soil in the monitoring location was moist at the surface to saturated at 14 inches and is hydric based on colors and features. No invasive plants were observed within the plot.

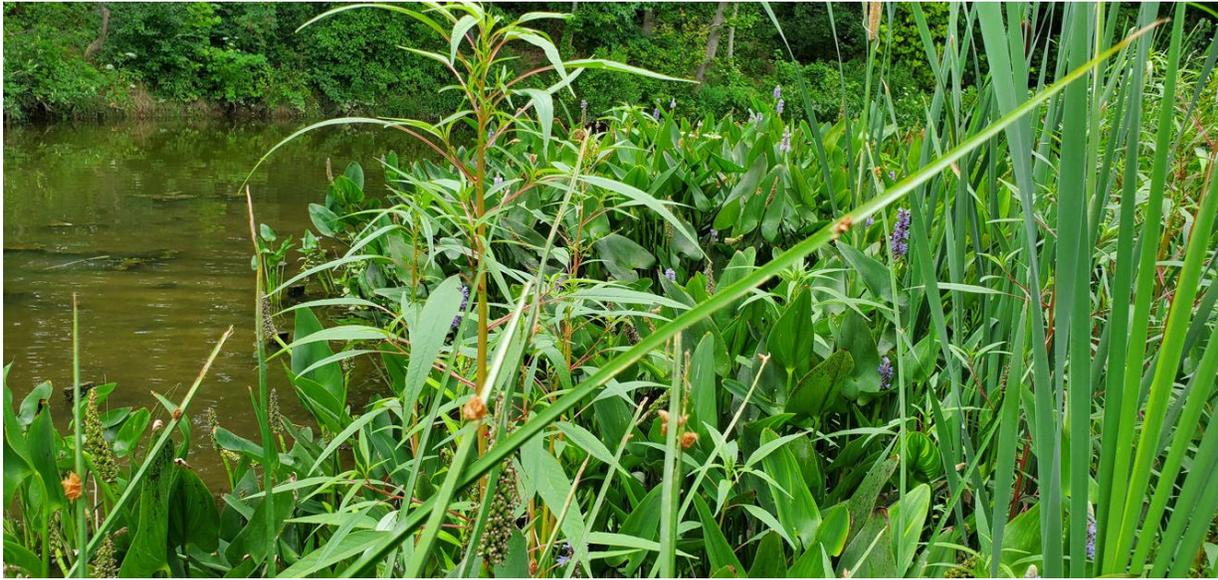
Figure 3-8. Plot 7– Emergent Wetland Across from the Hawthorne Bar
(Dominant Vegetation is Pickerelweed)

Plot 7: This emergent wetland plot is down slope of Plot 6 along the water's edge (Figures 3-1 and 3-8). Herbaceous ground cover is 95% with 50% pickerelweed, 20% broad leaf cattail, 5% hibiscus, and 5% sedges and other herbaceous wetland plants. No woody plants were within the

sampling plot. No invasive plants were observed within the plot. The soil was flooded at the surface due to the level of the tide.

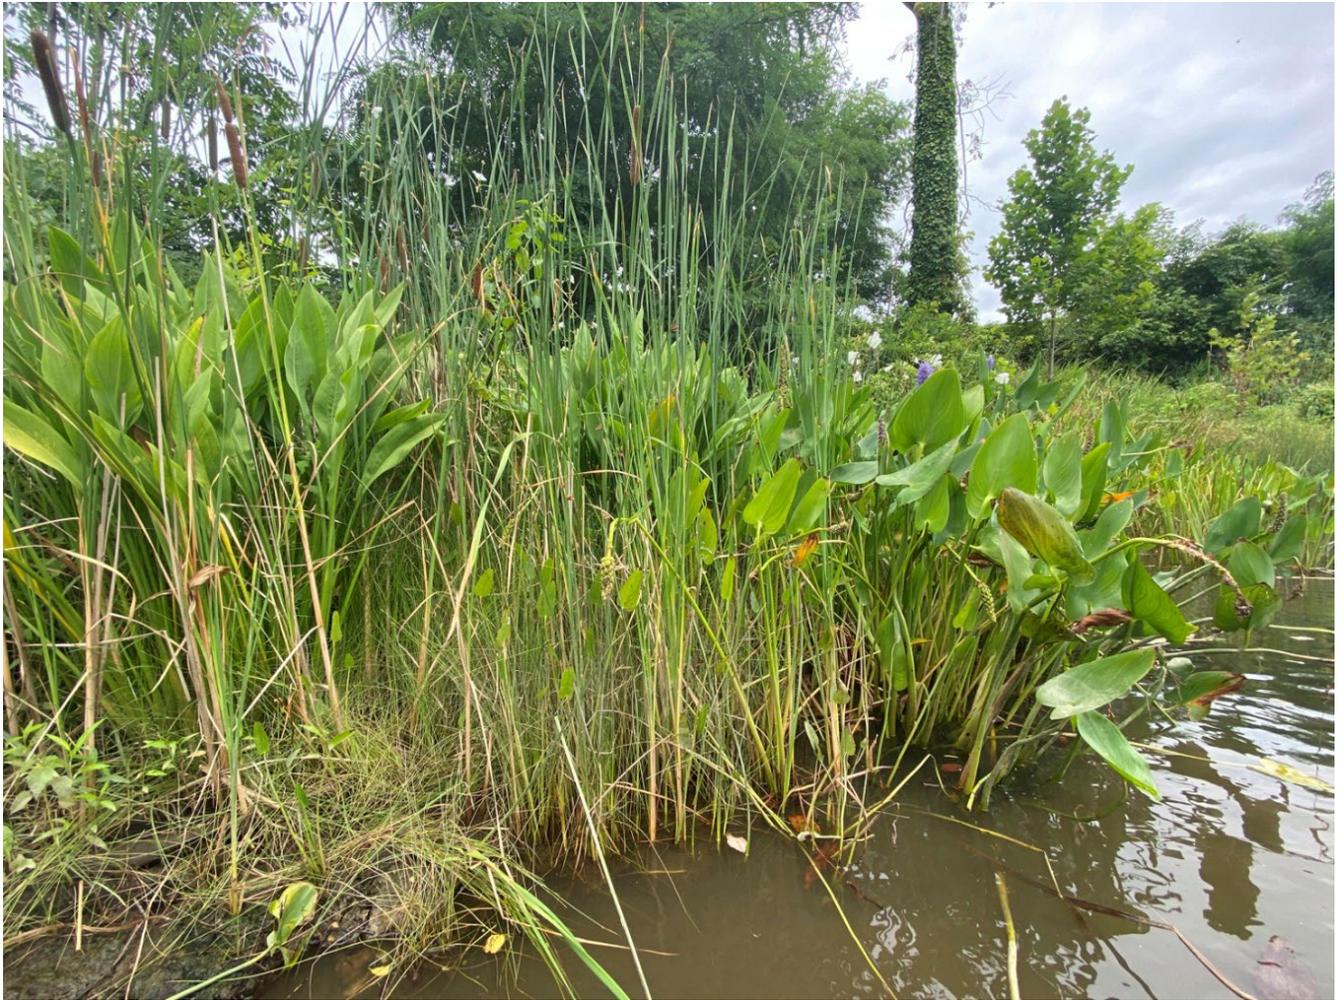
Figure 3-9. Plot 8– Emergent Wetland Farthest Downstream on the Lockheed Martin Side
(Dominant Vegetation Includes Pickerelweed, Duck Potato, and Cattails)

Plot 8: This emergent wetland plot is the farthest downstream on the Lockheed Martin side of the creek where the creek is widening (Figures 3-1 and 3-9). Herbaceous ground cover is 95% with 50% pickerelweed, 20 percent duck potato (*Sagittaria latifolia*), 20% narrow leaf cattail, 5% rose mallow, and 5% grass and sedge species. No woody plants were within the sampling plot. The soil was flooded at the surface due to the level of the tide.

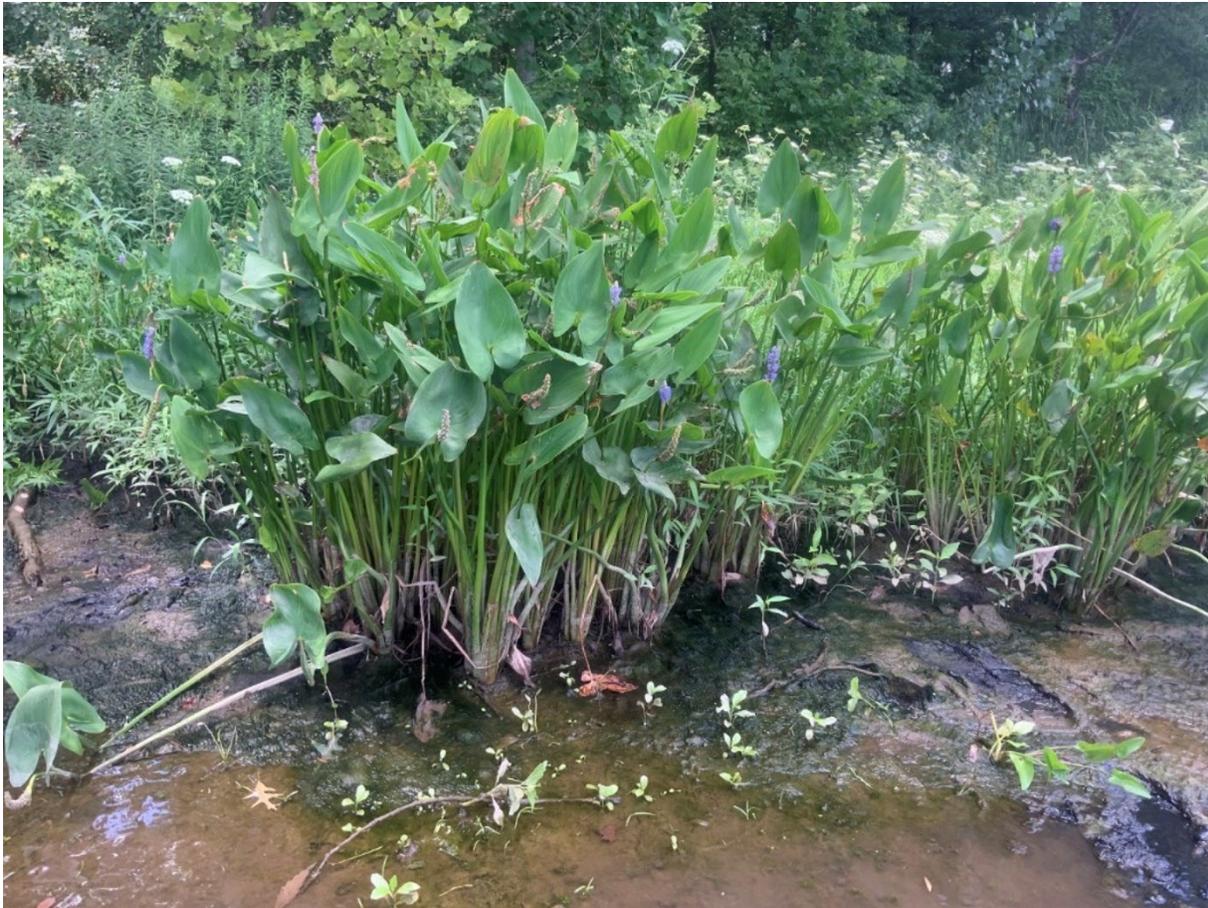
Figure 3-10. Plot 9– Emergent Wetland on Downstream Edge of Hawthorne Bar
(Dominant Vegetation Includes Pickerelweed and Pennsylvania Smartweed)

Plot 9: This emergent wetland plot is on the Hawthorne Elementary School (southern) side of the creek on the silt and sand bar in an area that is frequently flooded at high tide, about halfway down the restored section of the creek (Figures 3-1 and 3-10). Herbaceous groundcover is 95% with rice cutgrass and pickerelweed estimated at 40% each. Pennsylvania smartweed covers another 15%. Broad leaf cattail is present. No woody plants were within the sampling plot. Soil in the monitoring location was saturated at the surface and is hydric based on colors and features. No invasive plants were observed within the plot.

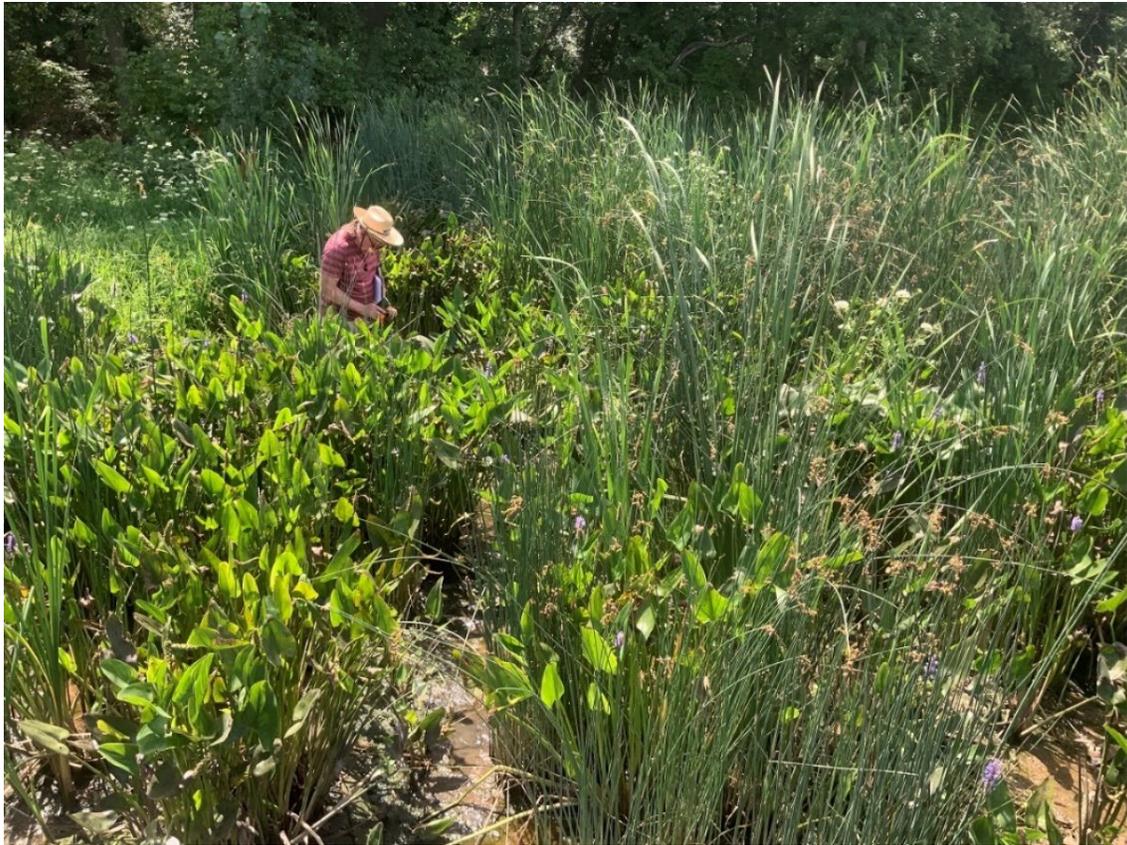
Figure 3-11. Plot 10– Emergent Wetland Near Center of Hawthorne Bar
(Dominant Vegetation Includes Pickerelweed, Rushes, and Cattails)

Plot 10: This emergent wetland plot is on the Hawthorne Elementary School (southern) side of the creek and is closer to the water's edge than Plot 9 (Figures 3-1 and 3-11). Herbaceous coverage is about 85% with bare spots between clumps of pickerelweed and rushes. The bare spots may be due to the higher duration of flooding with the soil only exposed during low tide. The herbaceous cover include pickerelweed at 55%, soft rush at 20%, Pennsylvania smartweed at 5%, marsh fleabane (*Pluchea odorata*) at 5%, and narrow leaf cattail at 5% on the edge of the plot. No woody plants were within the sampling plot. Soil in the monitoring location was saturated at the surface, water filled the soil sampling hole.

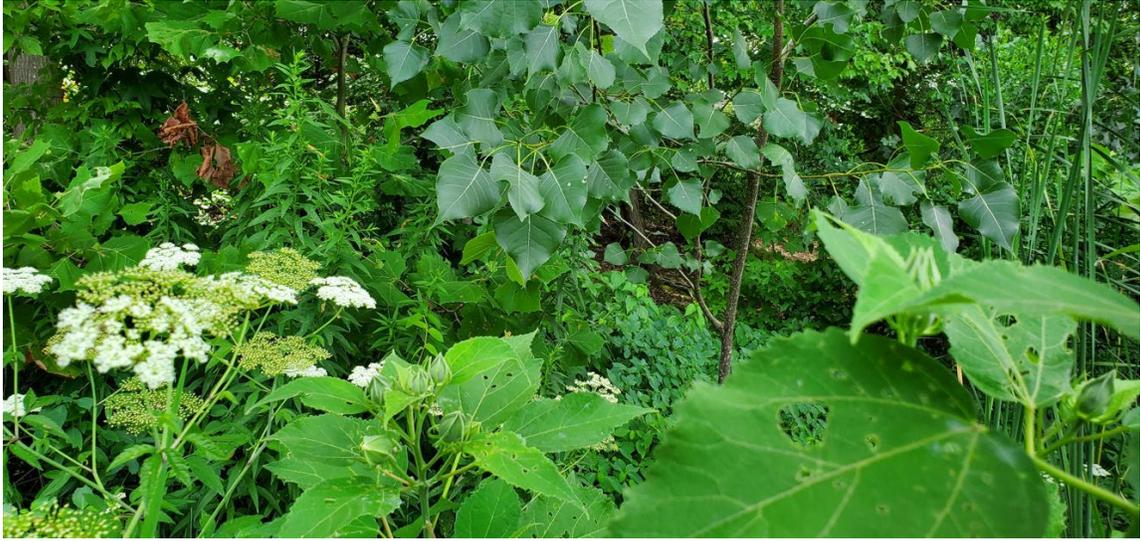
Figure 3-12. Plot 11– Forested Wetland near Center of Hawthorne Bar Close to the Upland Bank (Trees Include Sycamore, Eastern Cottonwood, and Silver Maple)

Plot 11: This forested wetland plot on the Hawthorne Elementary School side is closer to the upland bank than Plots 10 and 11 (Figures 3-1 and 3-12). Ground cover is 95%, with about 50% jewelweed, 40% rice cutgrass, and 5% water hemlock (*Cicuta maculata*). Woody living stems include 10 sycamore, one eastern cottonweed, one sweet gum, and two groundsel bush (*Baccharis halimifolia*) shrubs. No dead shrubs or trees were observed. Soil in the monitoring location was

moist at the surface to saturated at 14 inches and is hydric based on colors and features. No invasive plants were observed within the plot.
