Subject: Transmittal Cow Pen Creek and Dark Head Cove Sav Restoration and Monitoring Report  
Lockheed Martin Corporation – Middle River Complex  
2323 Eastern Boulevard, Middle River, Baltimore County, Maryland

**COW PEN CREEK AND DARK HEAD COVE  
SAV RESTORATION AND MONITORING REPORT  
LOCKHEED MARTIN MIDDLE RIVER COMPLEX  
2323 EASTERN BOULEVARD  
MIDDLE RIVER, MARYLAND**

Prepared by:  
Tetra Tech, Inc.

November 2022

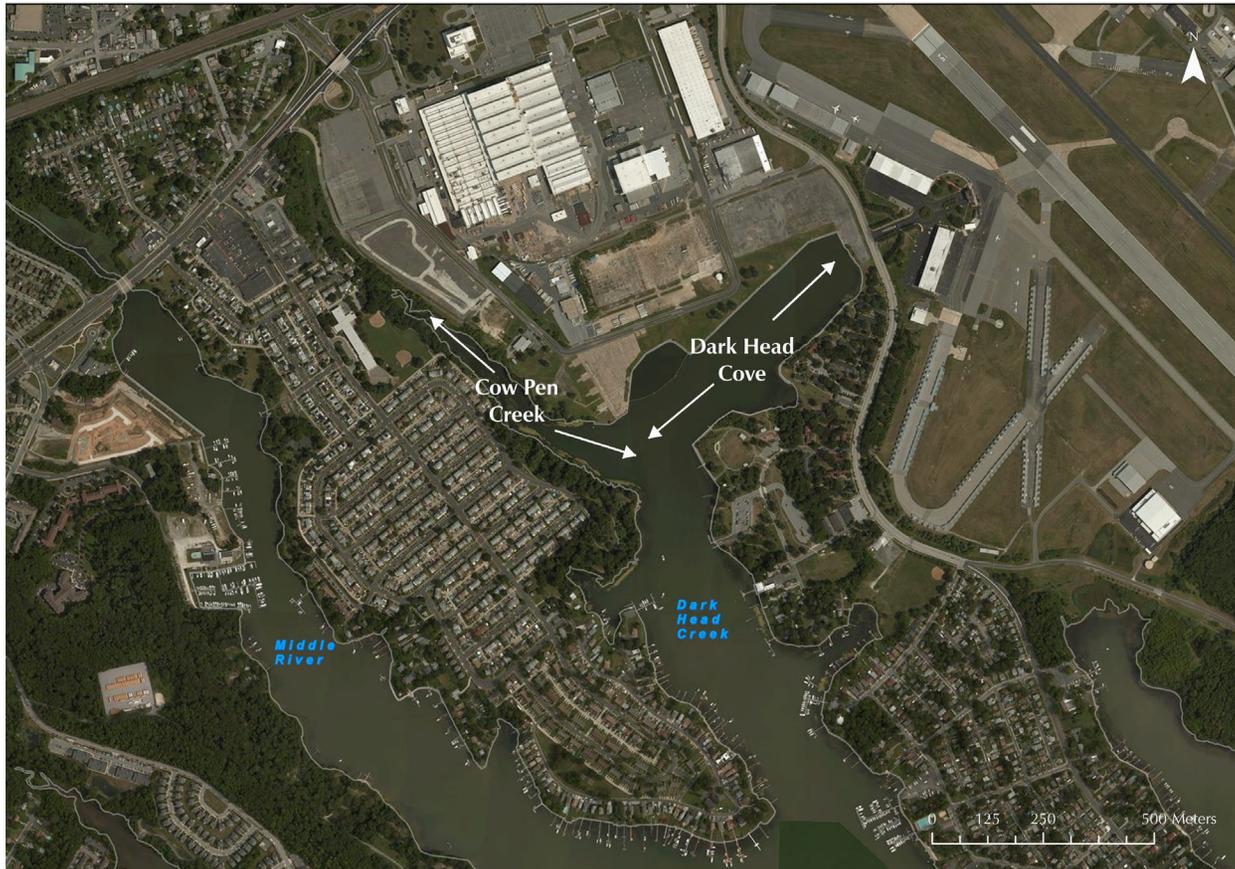
**Figure 1: Middle River Complex Location, Bordered by Cow Pen Creek to the West and Dark Head Cove to the South**

The Lockheed Martin Corporation (Lockheed Martin) Middle River Complex (MRC) is part of the Chesapeake Industrial Park, located at 2323 Eastern Boulevard in Middle River, Maryland, approximately 11.5 miles northeast of downtown Baltimore. The complex consists of approximately 161 acres and twelve main buildings. The property also includes an active industrial area and yard, perimeter parking lots, an athletic field, a concrete-covered vacant lot, a trailer and parts storage lot, and numerous grass-covered green spaces along the facility's perimeter. Locked chain-link fences surround all exterior lots and the main industrial area. The site is bounded by Eastern Boulevard (Route 150) to the north, Dark Head Cove to the south, Cow Pen Creek to the west, and Martin State Airport to the east (Figure 1).

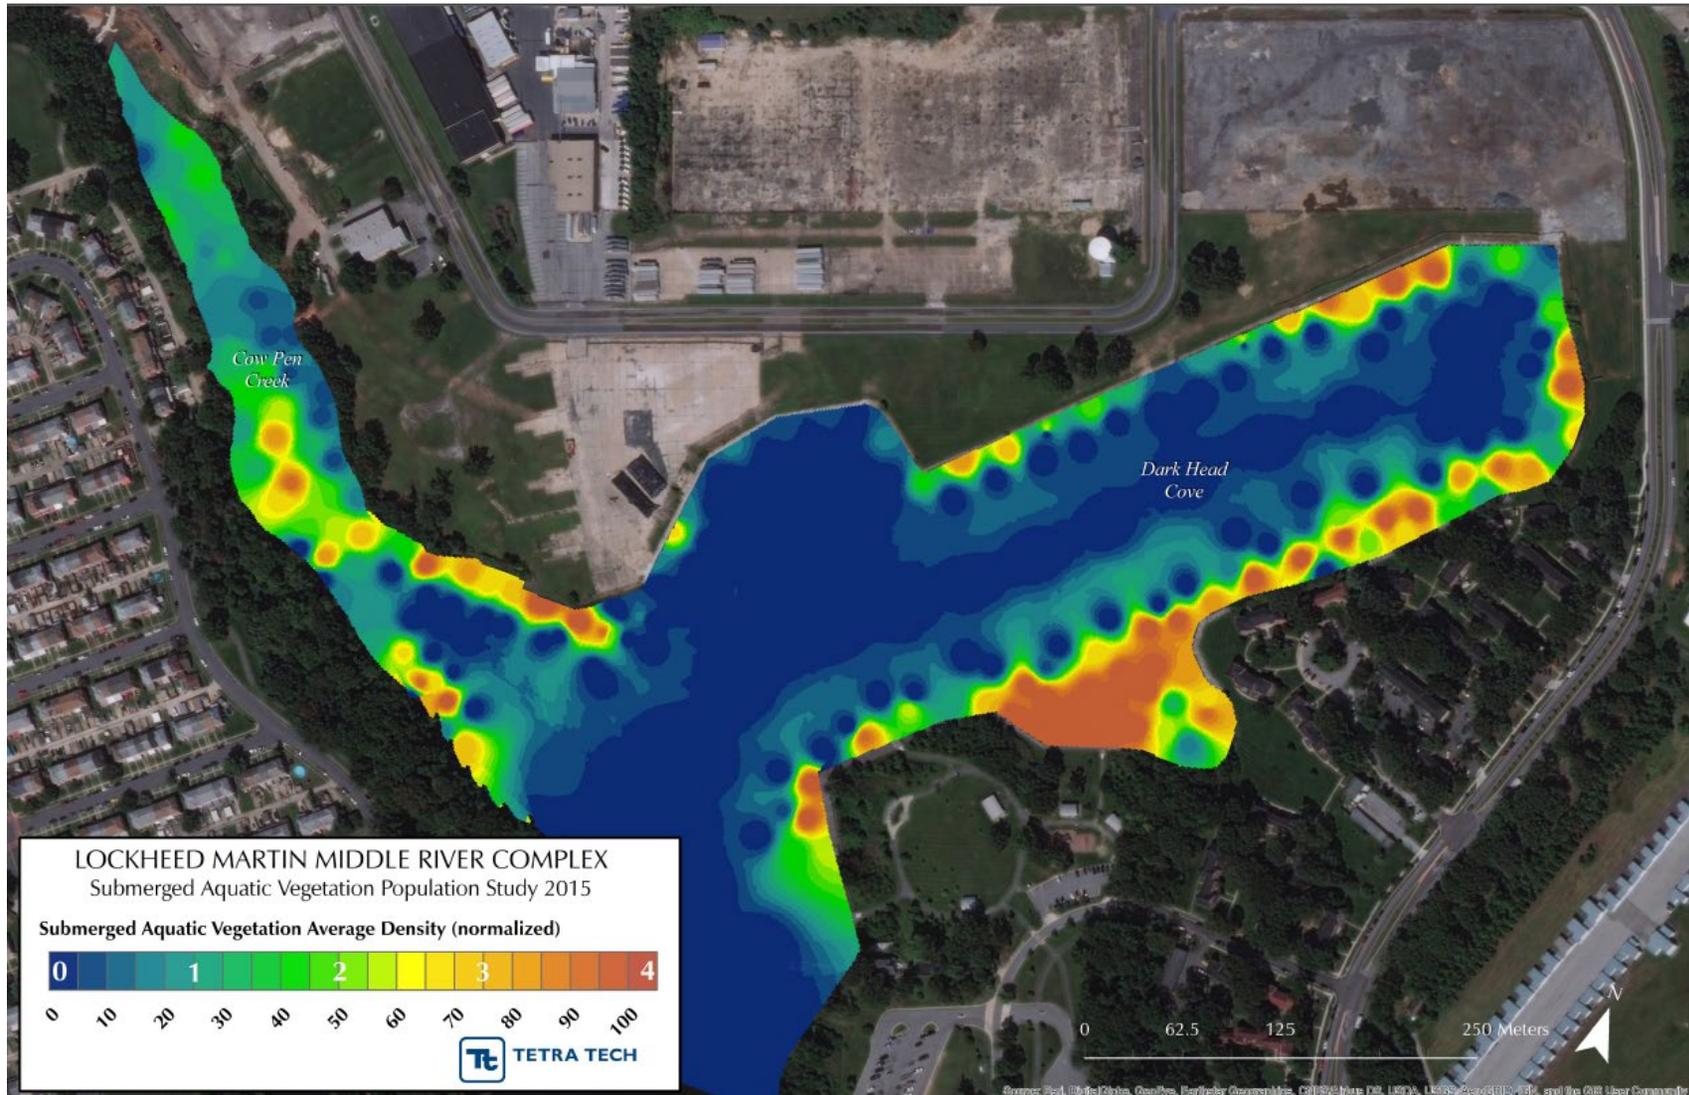
Figure 2: SAV Density (via rake survey) in Dark Head Cove and Cow Pen Creek (2015 survey), Prior to Dredging (Note sparse to non-existent beds off bulkhead where water depths will not support growth)

that the 2015 baseline survey revealed that SAV was not generally present adjacent to the cove bulkhead (Figure 2) because water in that location exceeds suitable depths (2 meters [m]) for SAV growth (Batiuk, *et al.* 2000).

SAV observed in Cow Pen Creek in 2022 is still somewhat sparse (Figure 6) as compared to observed baseline conditions (Figure 2). As previously observed during annual monitoring at Cow Pen Creek and Dark Head Cove, water depths and substrate in Dark Head Cove appear non-conducive to SAV growth and establishment. Figure 7 shows SAV maps for the Middle River area from 2015 through 2021, courtesy of Virginia Institute of Marine Science (VIMS) annual surveys. Regional trends in SAV coverage for the Middle River (and Chesapeake Bay) follow the observations from Dark Head Cove and Cow Pen Creek. The baywide survey noted a decline of more than 30% between 2018 and 2019, the same time period where the project had poor success in the restoration area. Areal coverage has improved, and that has also been noted in the region of study.

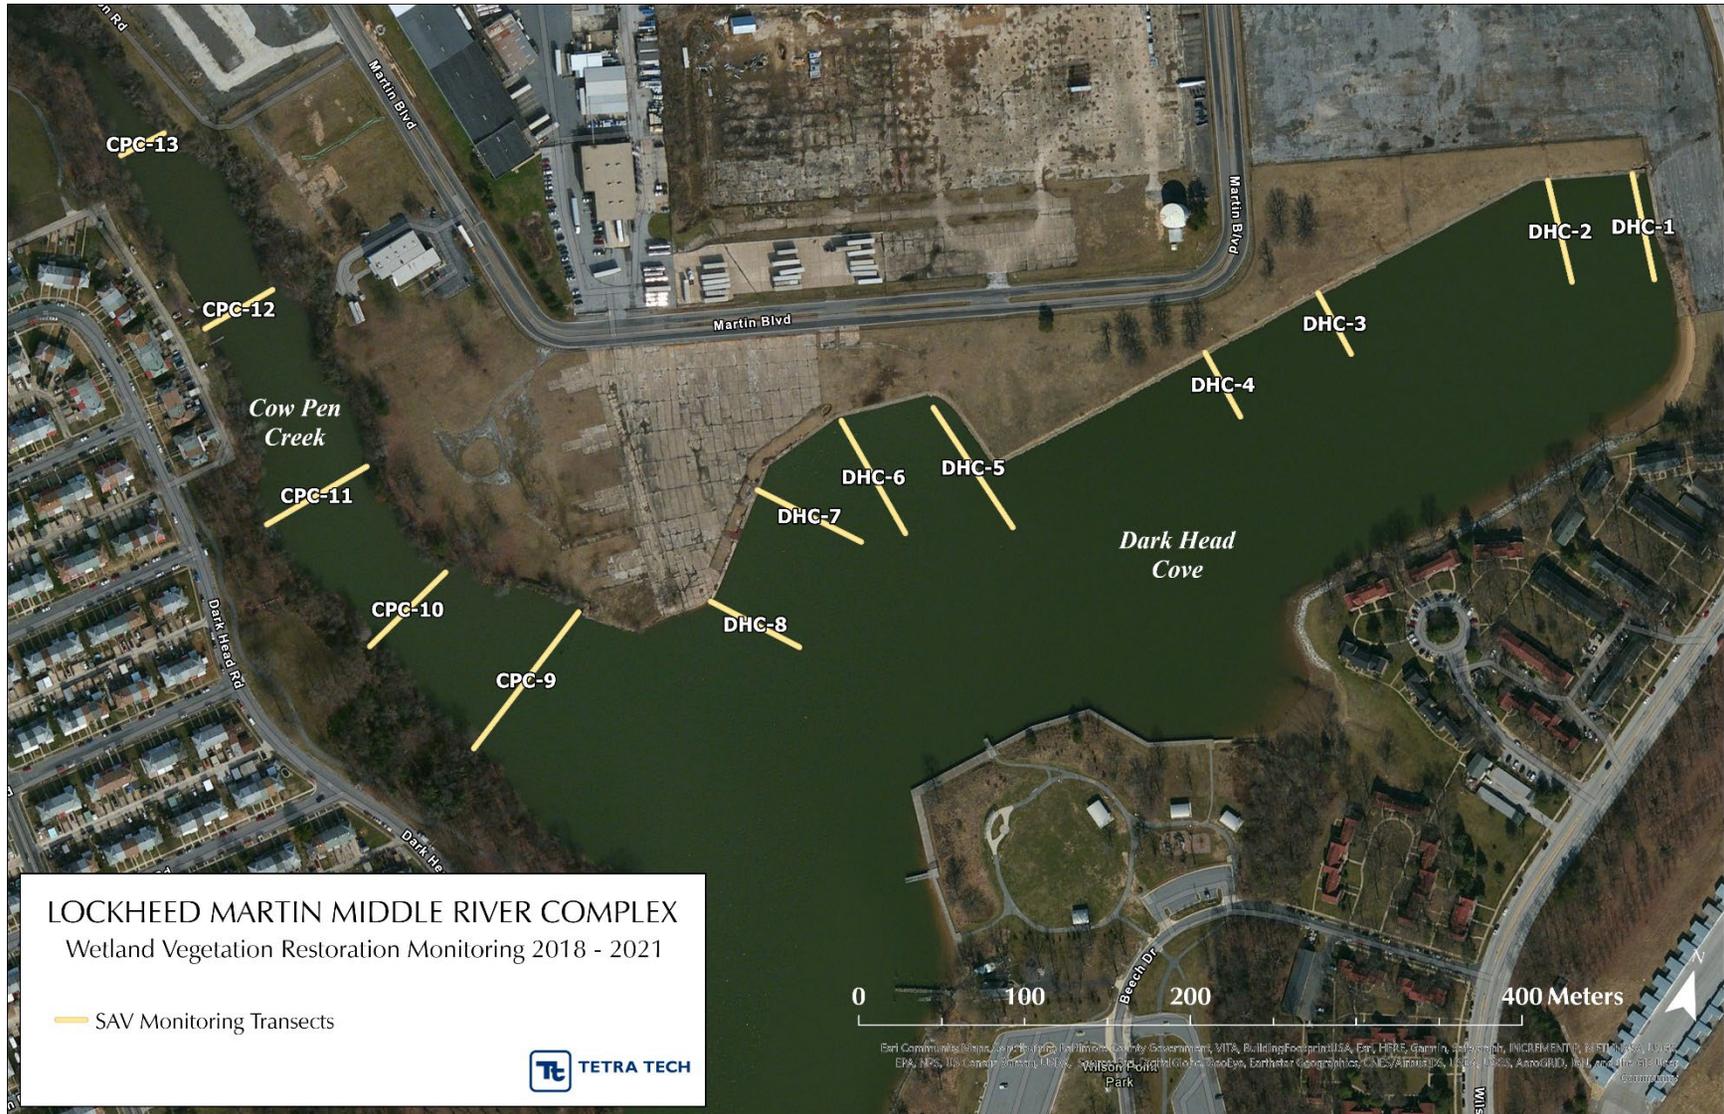
Figure 3: Location of Fixed Monitoring Transects within Cow Pen Creek and Dark Head Cove, 2018–2022

**2021 Monitoring-** Tetra Tech scientific divers conducted the fourth monitoring event on August 5, 2021; SAV was surveyed along each fixed transect in the seed dispersal area (see Figures 3 and 4). Water clarity in both Cow Pen Creek and Dark Head Cove was similar to that observed in 2020, with visibility under 50 cm

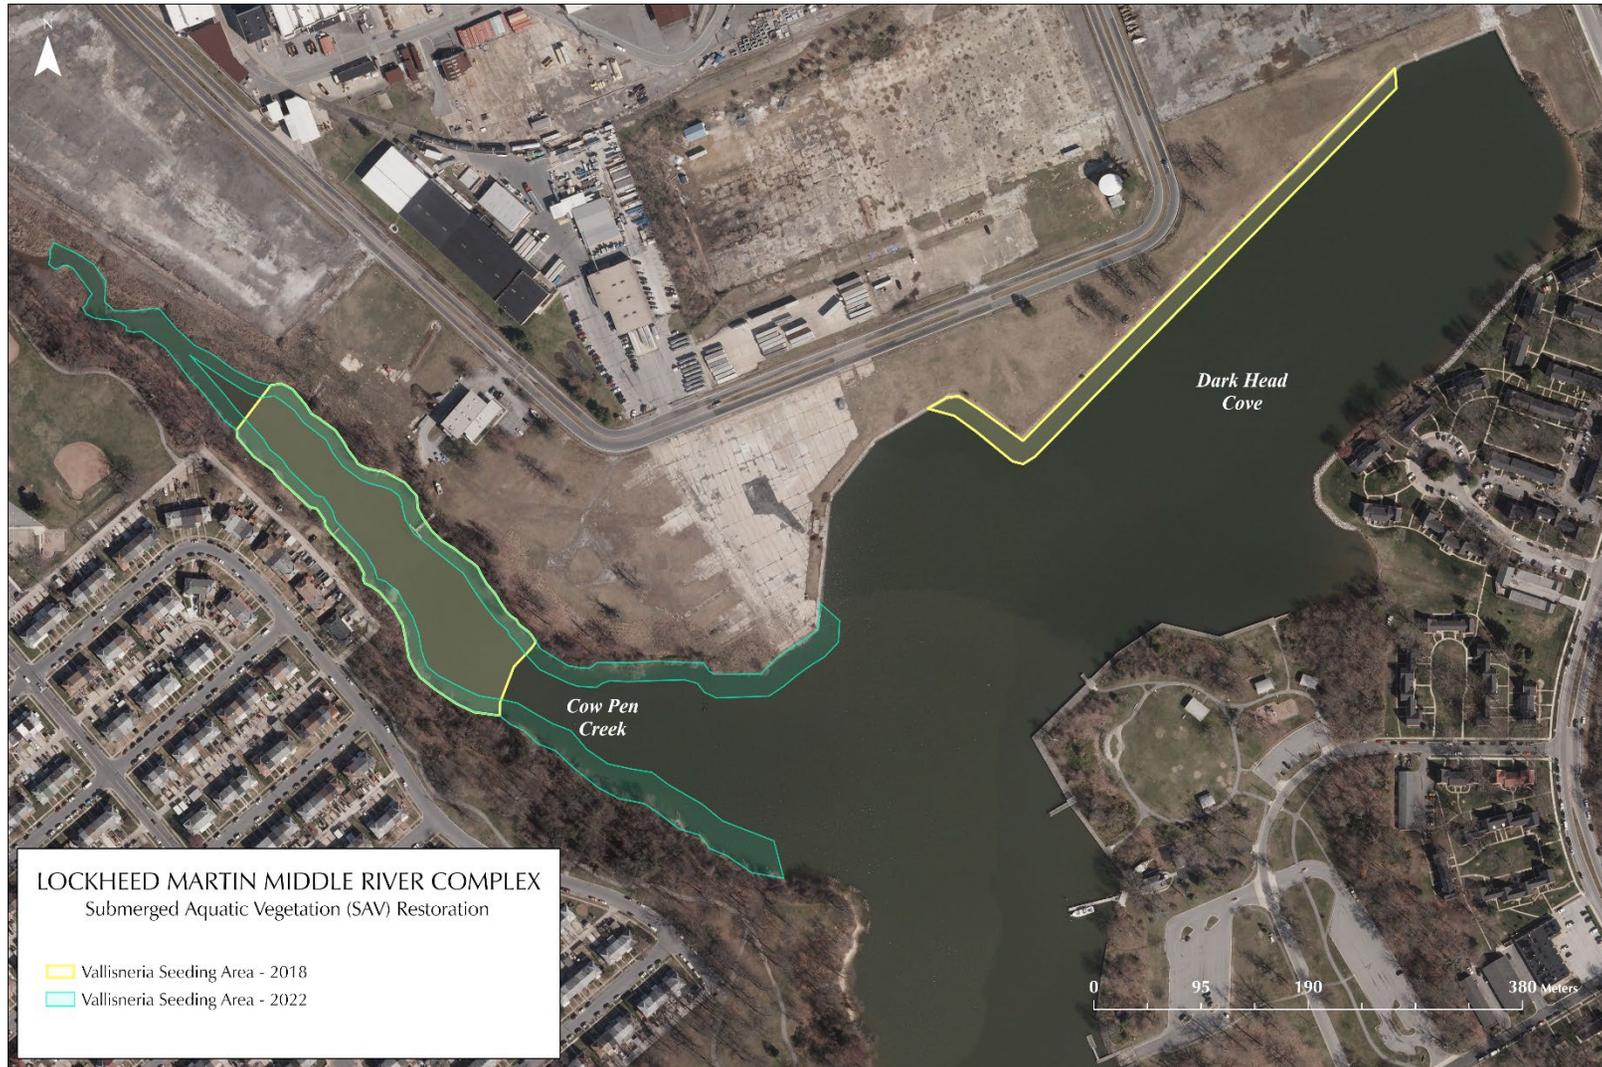
Figure 4: Location of Seed Distribution in April 2018 and May 2022

Tetra Tech scientists hand-seeded Cow Pen Creek and small parts of Dark Head Cove via boat in May 2022 (Figure 4). Areas that were less than 2 meters (m) deep were targeted to provide optimal conditions for seedling establishment. Deeper areas within Dark Head Cove, including the fixed monitoring transects which extend out to depths of 4-5 m, were avoided during seeding. An estimated 250,000 to 275,000 wild celery seeds were dispersed in total, with the vast majority planted in Cow Pen Creek.

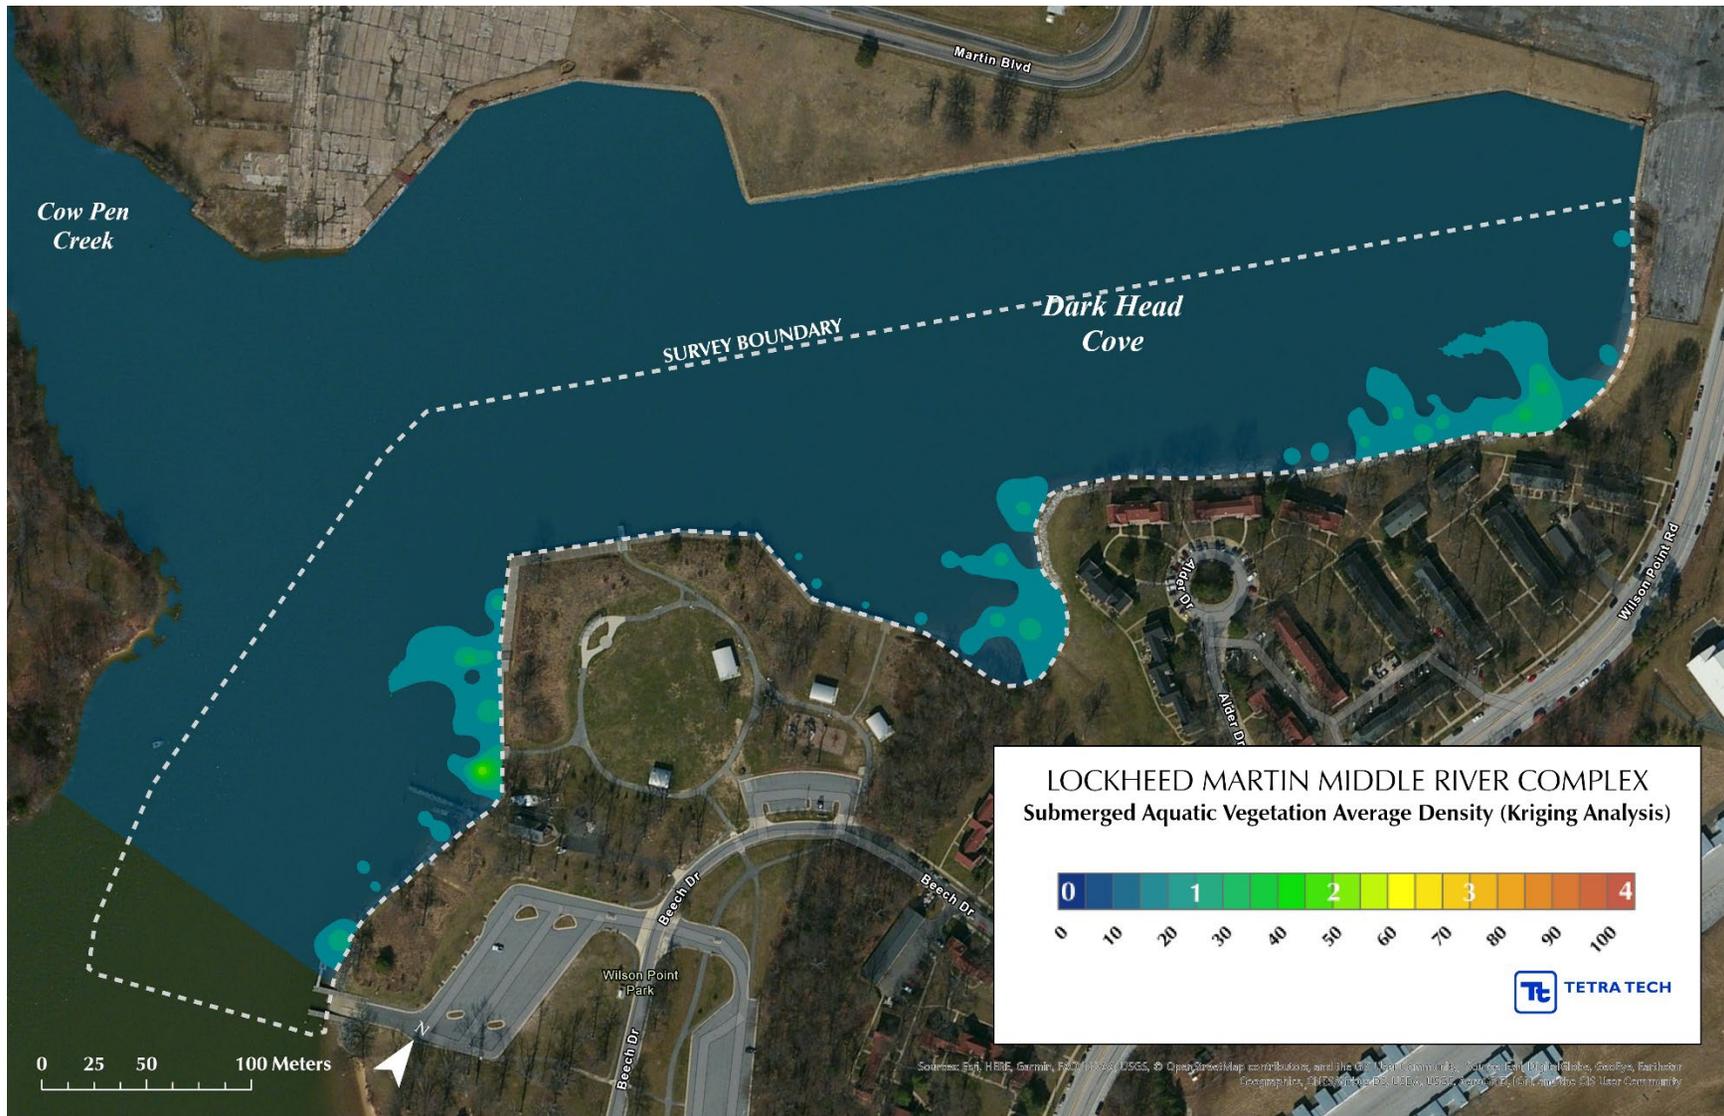
Figure 5: SAV Density in Dark Head Cove (2020 survey)

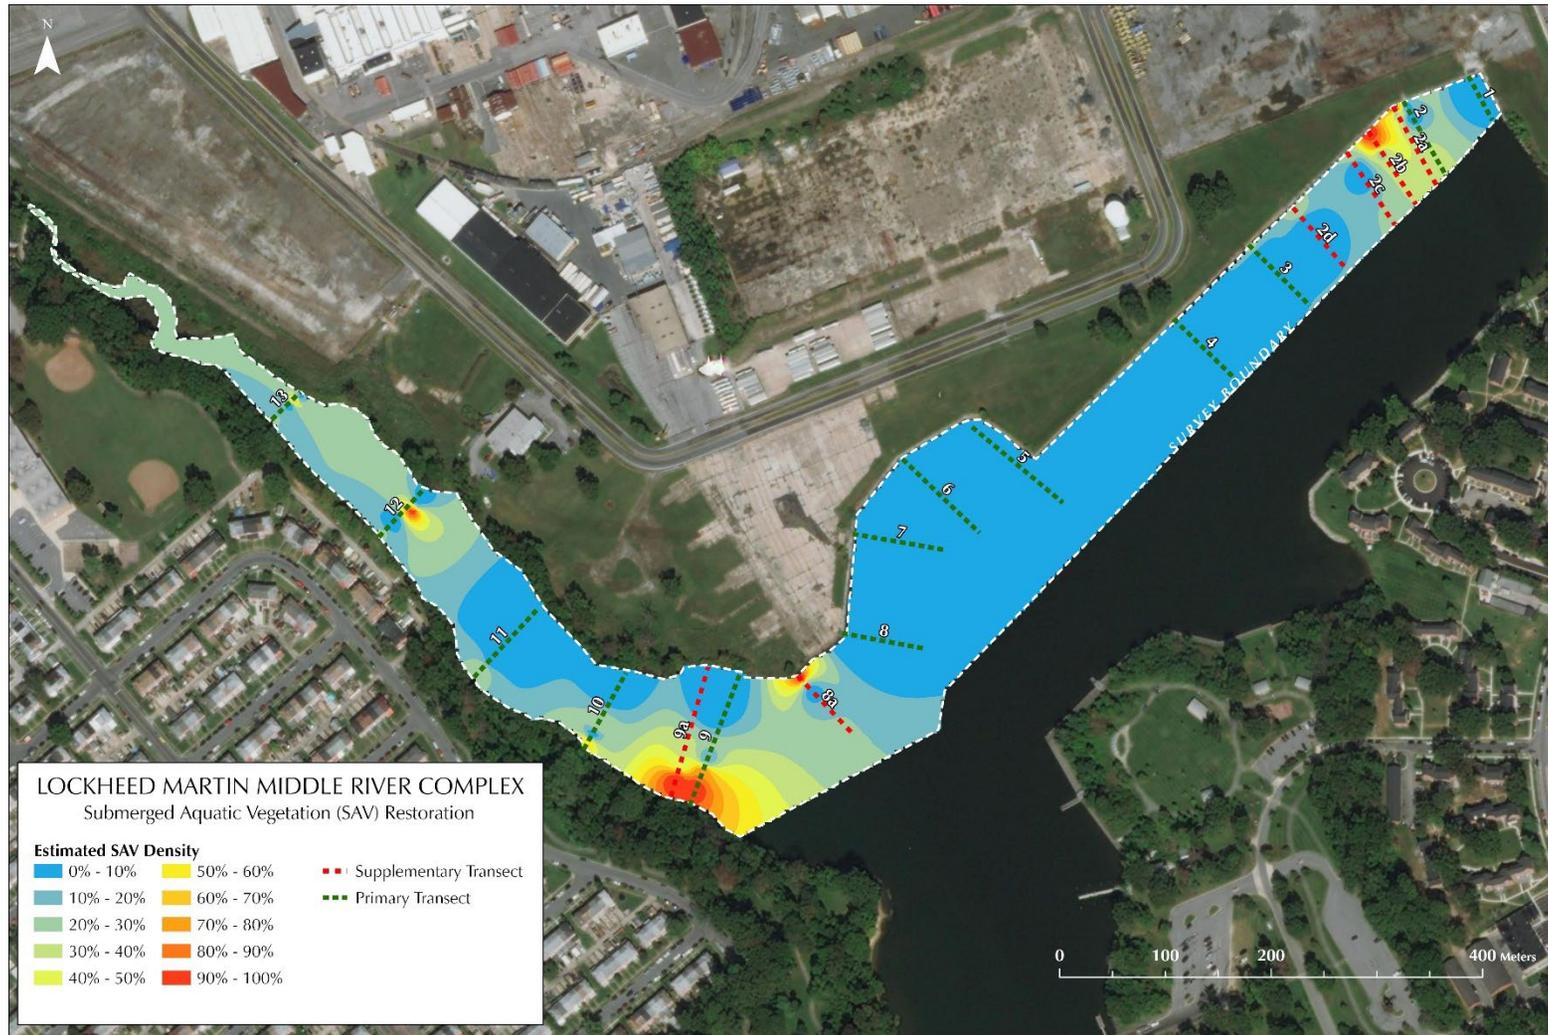
**Figure 6: Results of 2022 Monitoring**  
 (Note the additional transects added [in red])

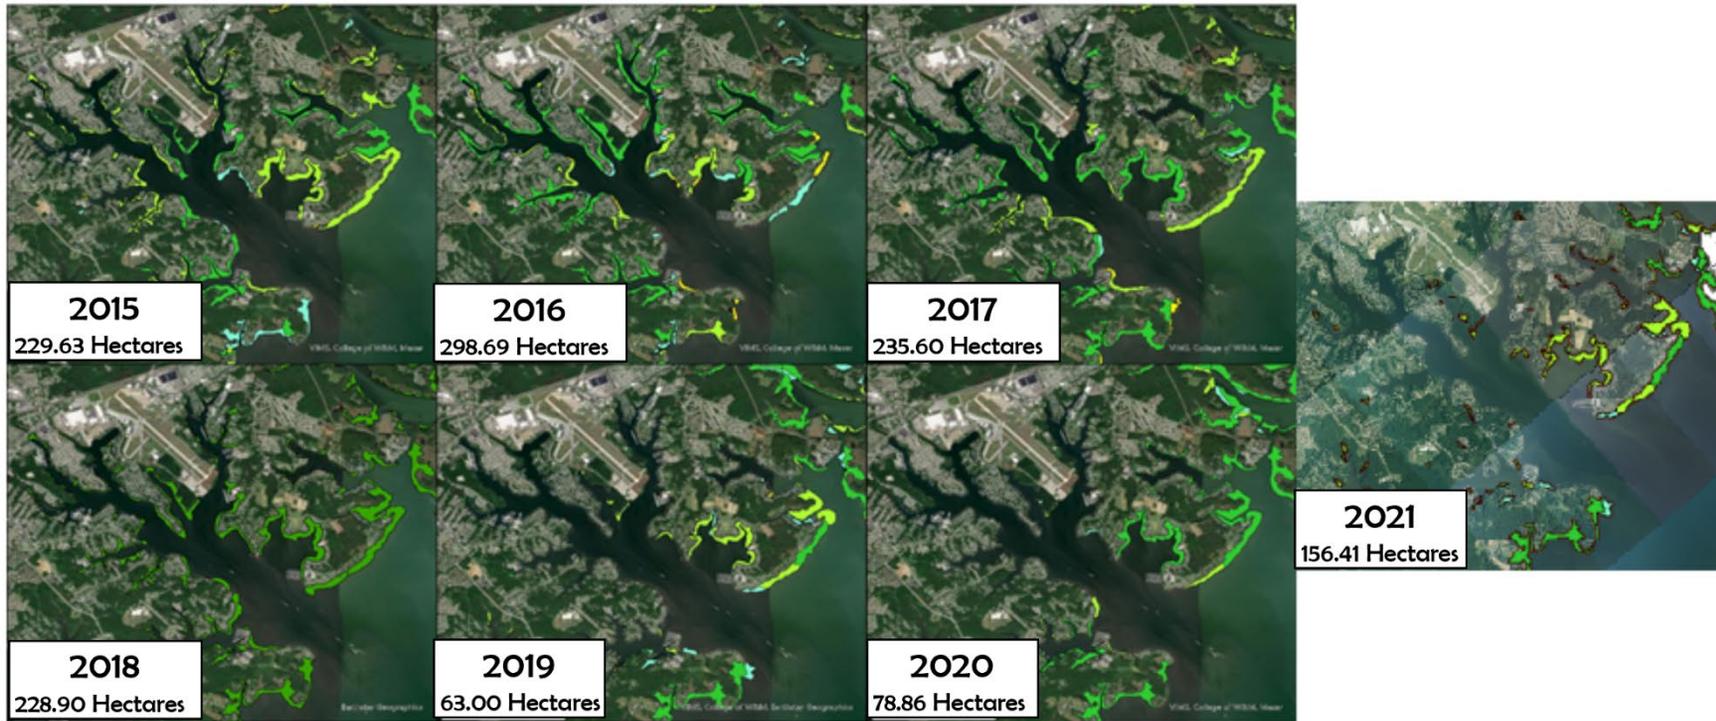
Figure 7: SAV Coverage Maps for Middle River, Courtesy of VIMS Annual Survey (2015-2021)

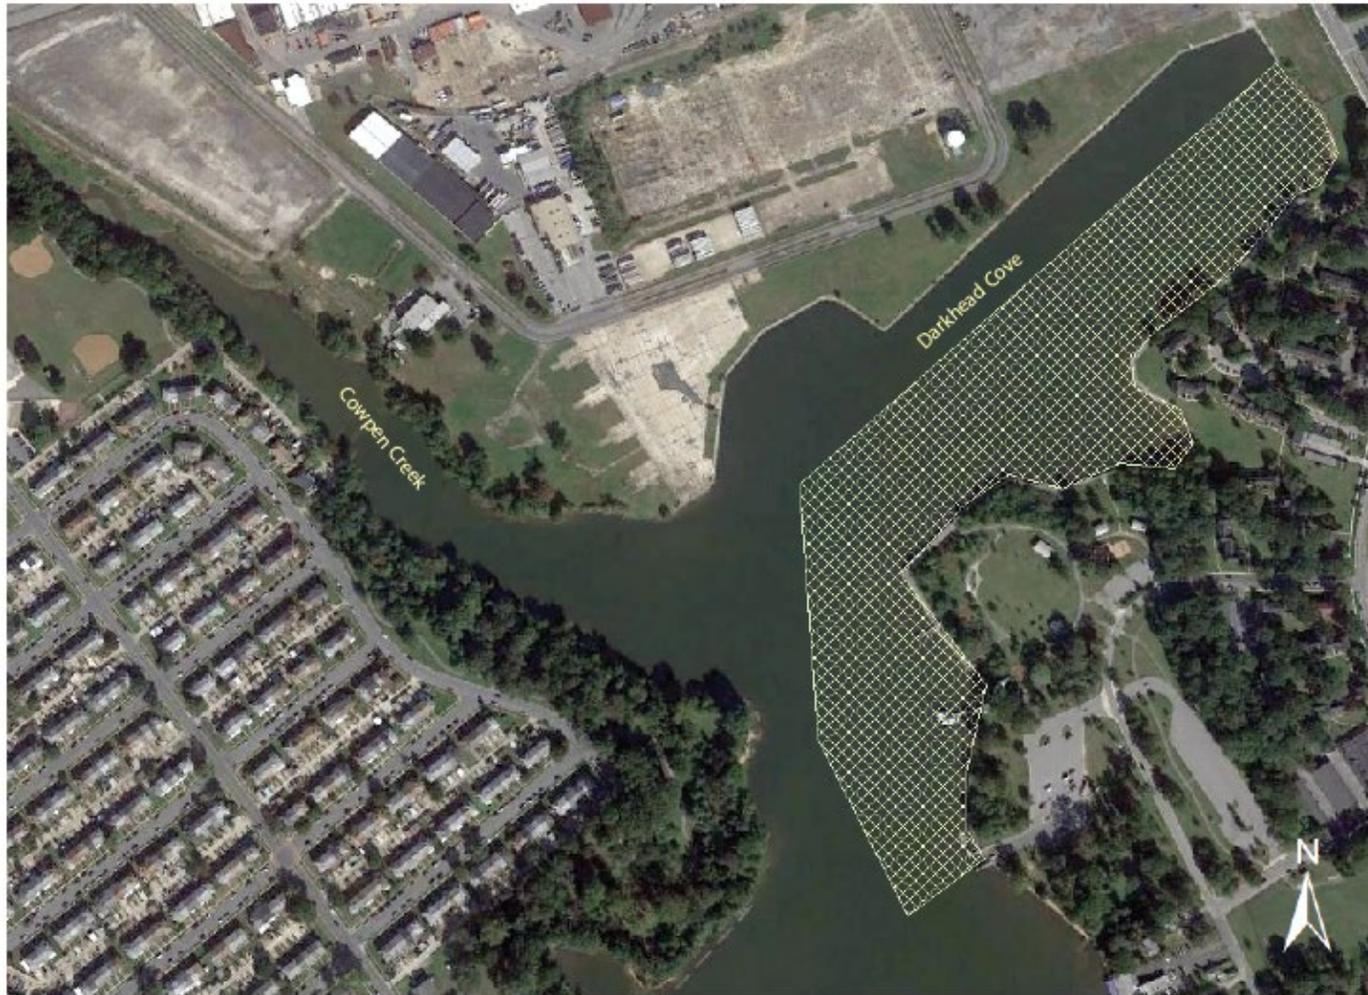
*Figure 1: SAV survey area denoted by green hashed area*

SAV samples, collected via boat operated by Tetra Tech staff, will be collected to evaluate the density and species composition of the bed(s). Sampling locations will be pre-programmed into a global positioning system (GPS) unit (Trimble or equivalent). Samples will be collected along the southern shore of Dark Head Cove out to the 10-foot bathymetric contour interval. SAV generally does not grow at depths greater than two meters in the Chesapeake Bay region ([Batiuk et al., 2000](#)), so sampling beyond this depth is not warranted. Sampling locations will be spaced at five-meter intervals in each direction, in the area shown on Figure 1.

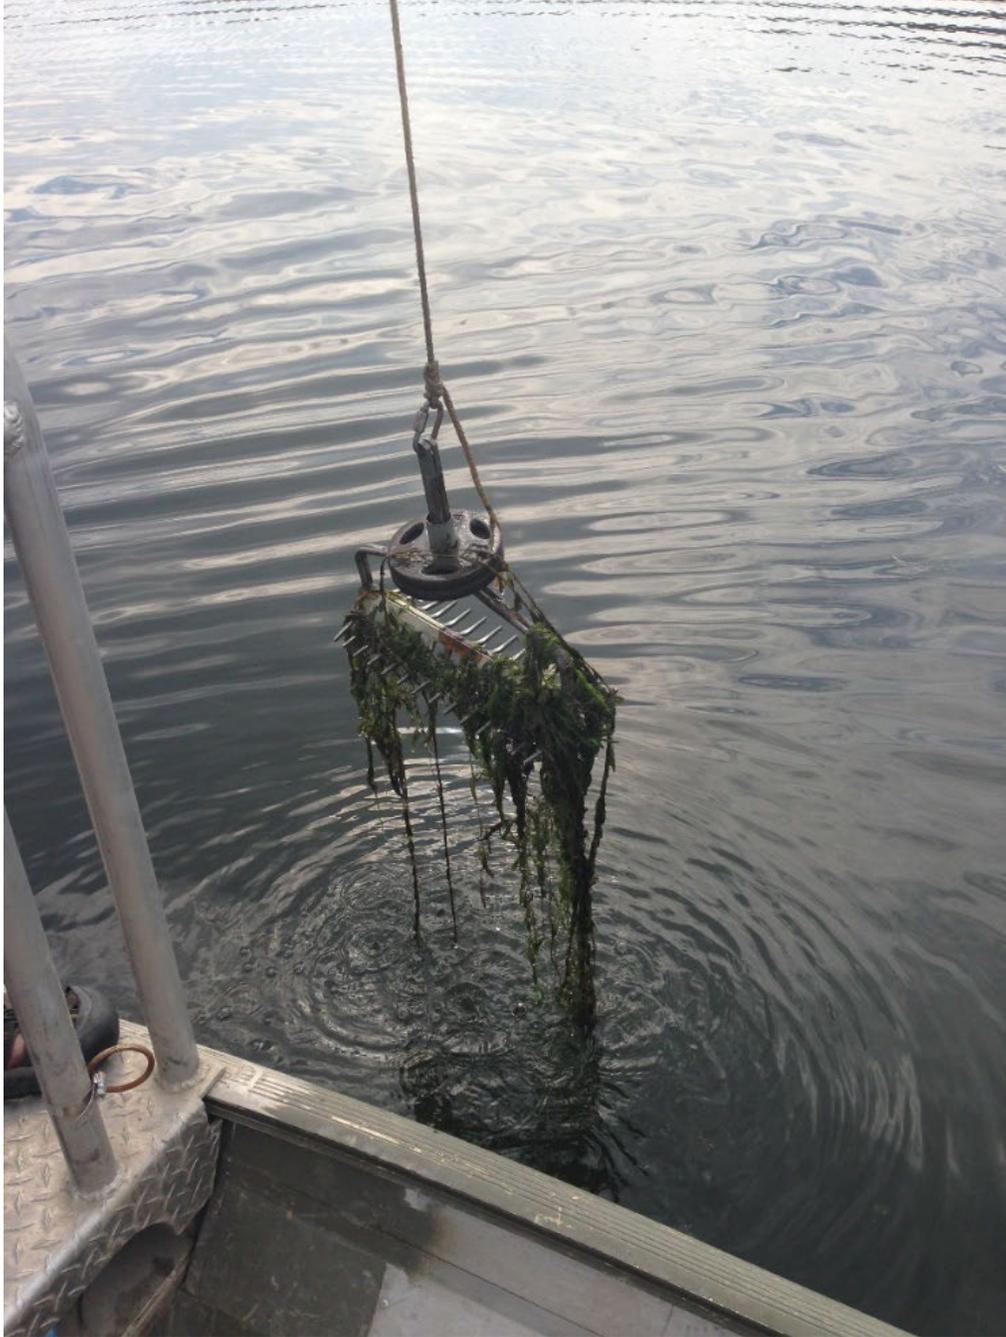
*Figure 2. Modified rake used for conducting SAV surveys.*

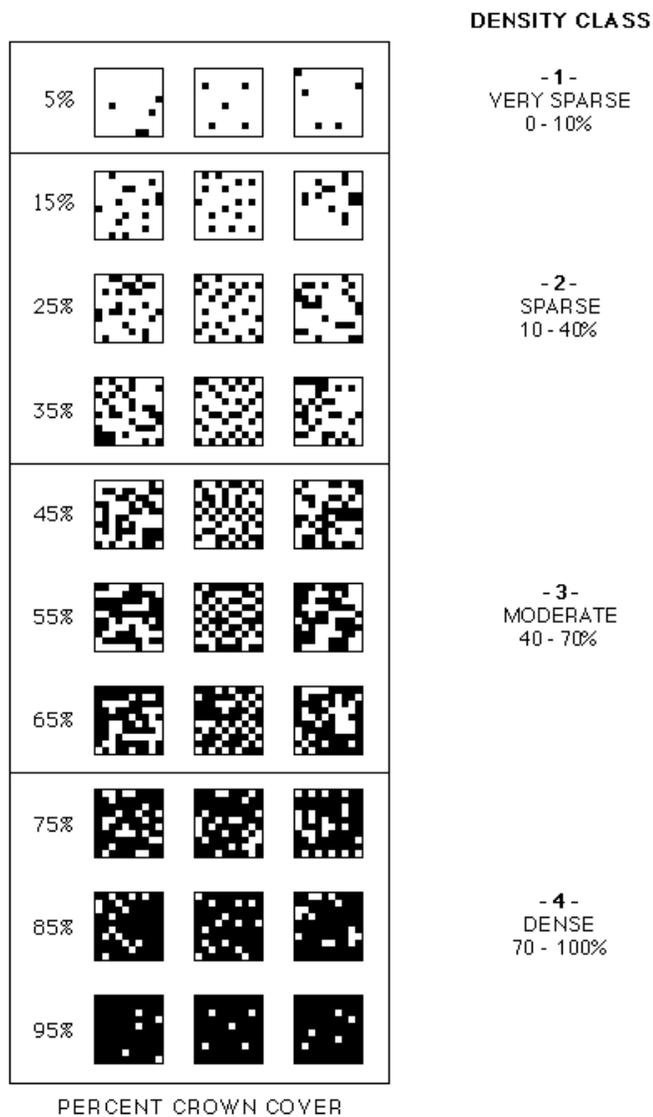
*Figure 3. Scale used to measure the density of SAV rake survey grabs. The scale is based on a modified Braun-Blanquet (1932) scale with values ranging from 0 (no plants present) to 4 (70-100% cover).*

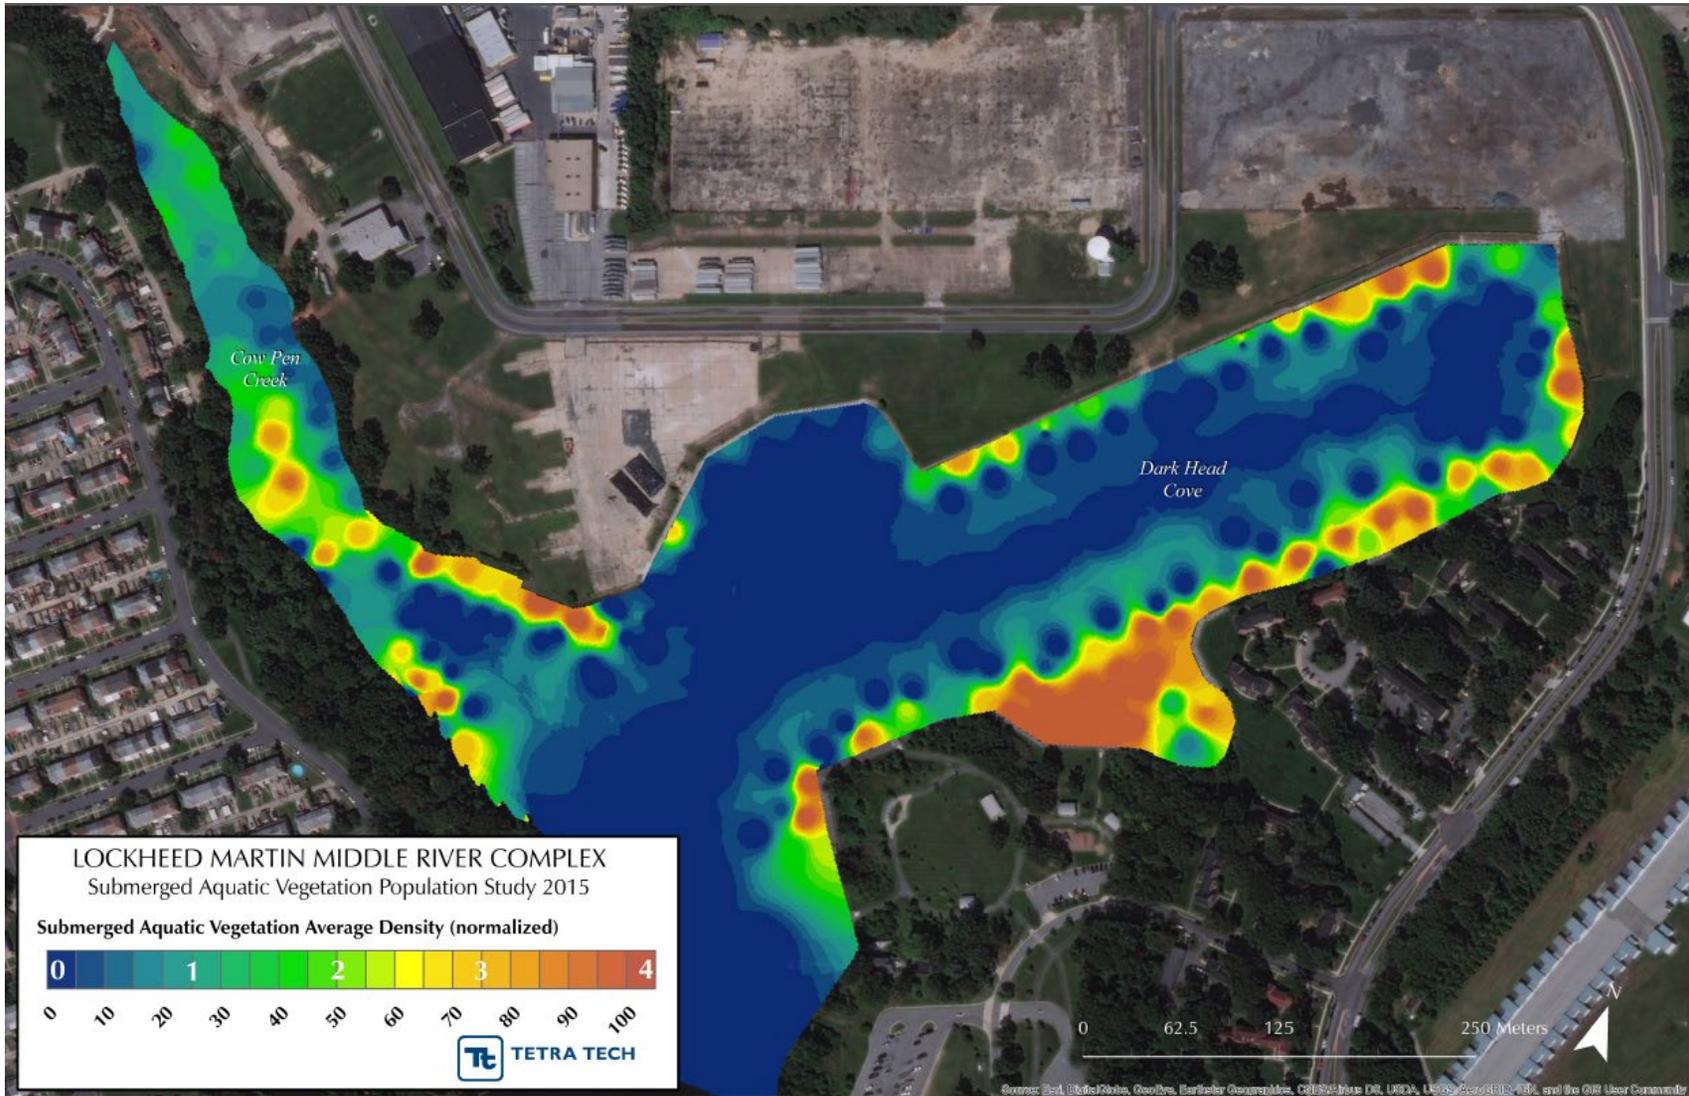
Figure 4. Map of SAV density developed from 2015 baseline survey data.

The density values will be incorporated into an ArcGIS kriging program; this software will analyze the data and generate a map that represents the spatial extent and relative density of the SAV beds. Figure 4 is the ArcGIS map produced for the 2015 baseline survey as an example. In addition, the species data obtained during the survey will be used to determine the observed species frequency of occurrence. These results, including all maps produced by ArcGIS software and the summary data used to produce the maps, will be provided for review via a technical memorandum and be included in the 2020 annual monitoring report.
