Subject: Transmittal of the Cow Pen Creek Bank Stabilization and Floodplain Reconstruction Monitoring:
2021 Report
Lockheed Martin Corporation – Middle River Complex
2323 Eastern Boulevard, Middle River, Baltimore County, Maryland

**COW PEN CREEK
BANK STABILIZATION AND FLOODPLAIN
RECONSTRUCTION MONITORING: 2021 REPORT
LOCKHEED MARTIN MIDDLE RIVER COMPLEX
2323 EASTERN BOULEVARD
MIDDLE RIVER, MARYLAND**

Prepared by:
Tetra Tech, Inc.

January 2022

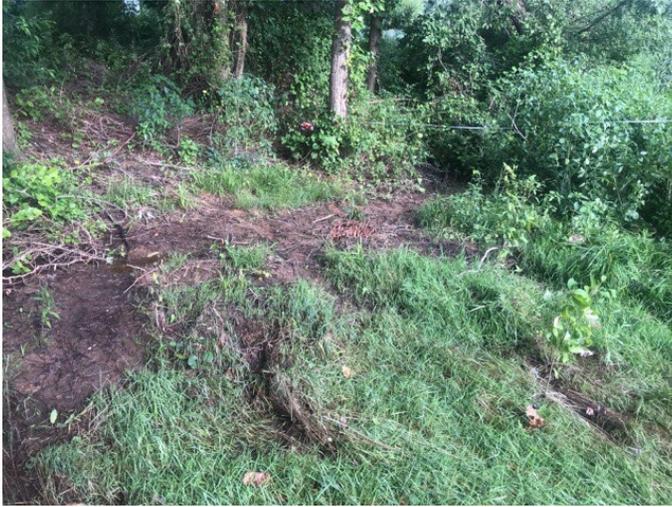
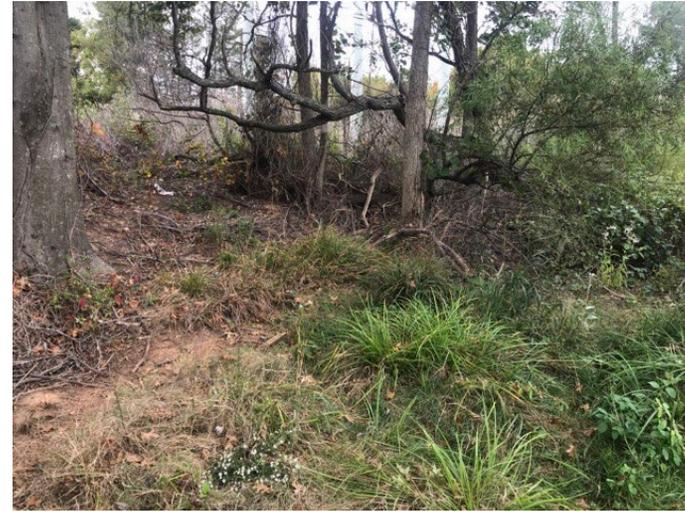
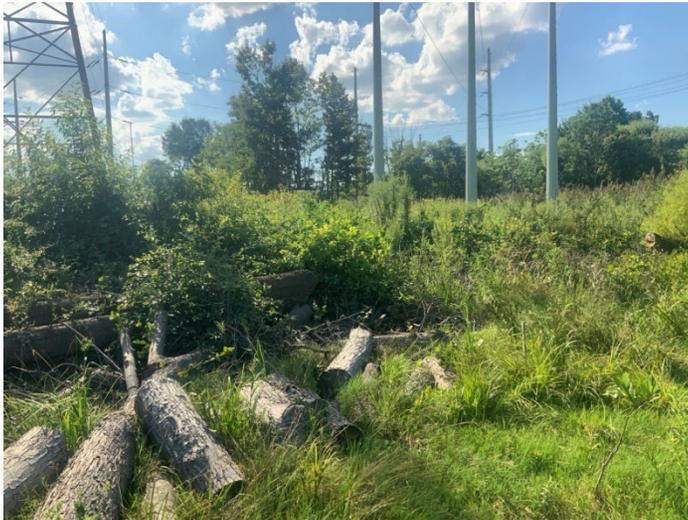
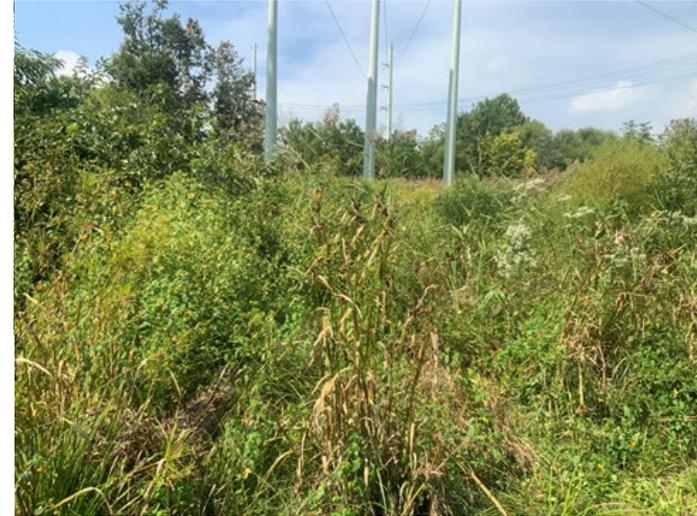
Photo A-76. Bare spot from 2018, which has become more vegetated, on the right streambank at station 00+05, 2018 (A), 2019 (B), 2020 (C), and 2021 (D).

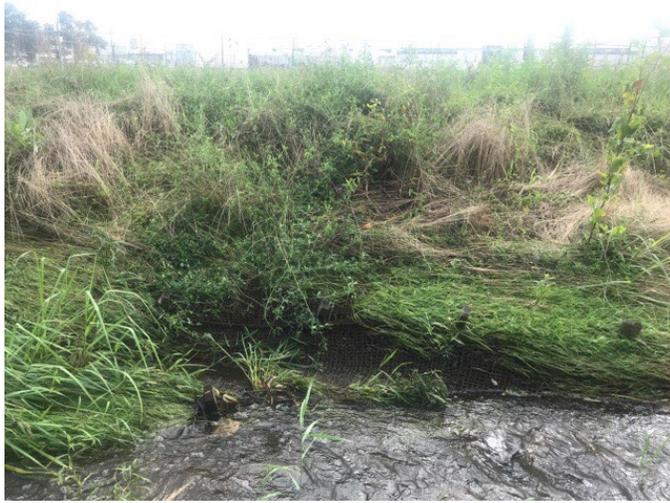
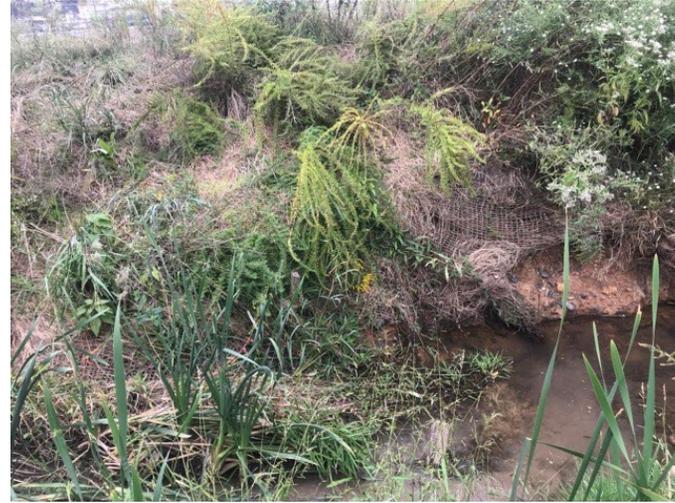
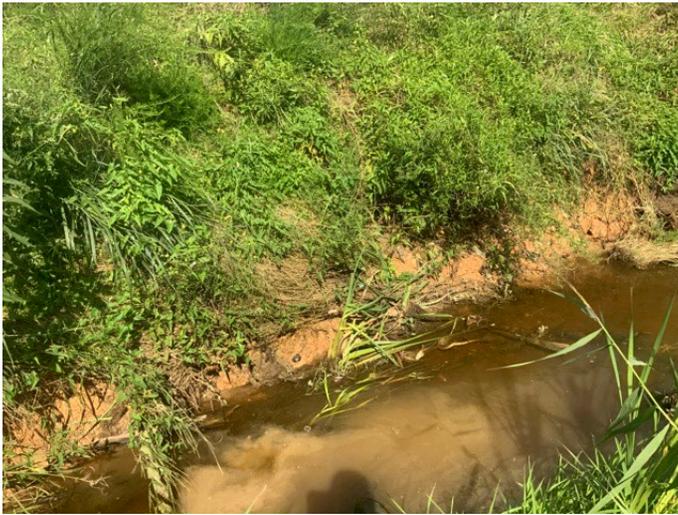
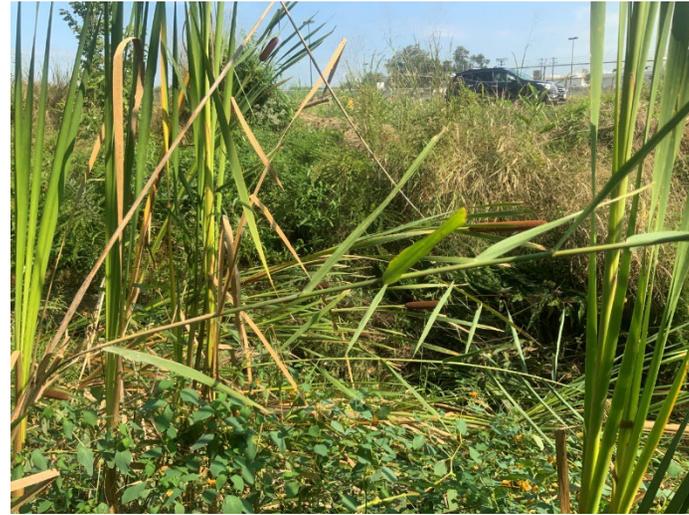
Photo A-79. Soil eroding from under the matting on the lower left bank at station 01+55, 2018 (A), 2019 (B), 2020 (C), and 2021 (D).

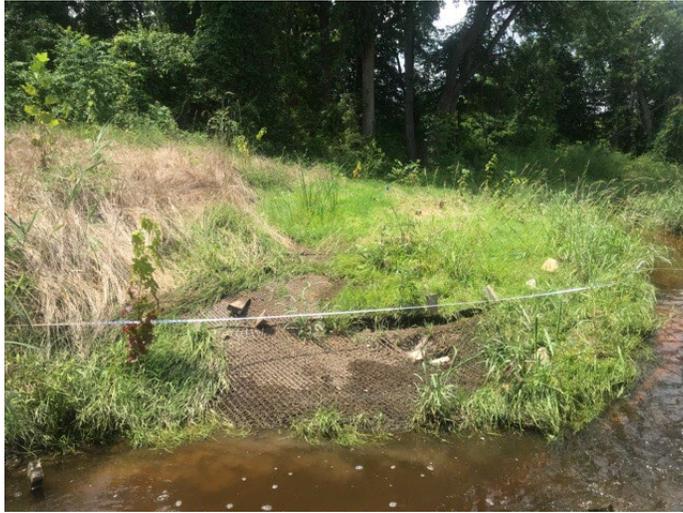
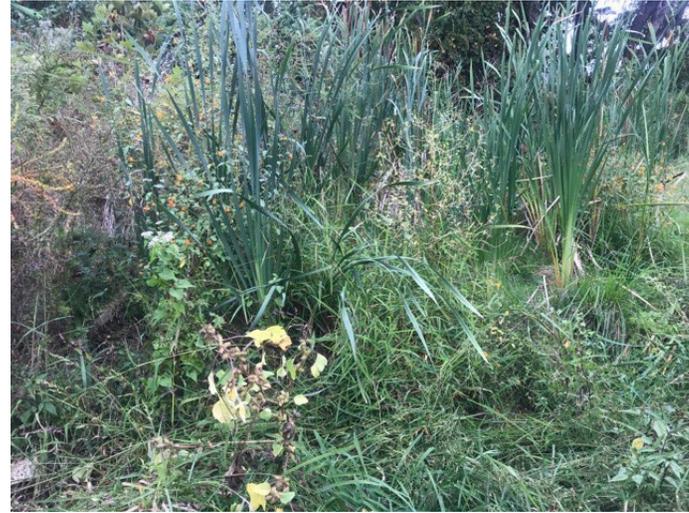
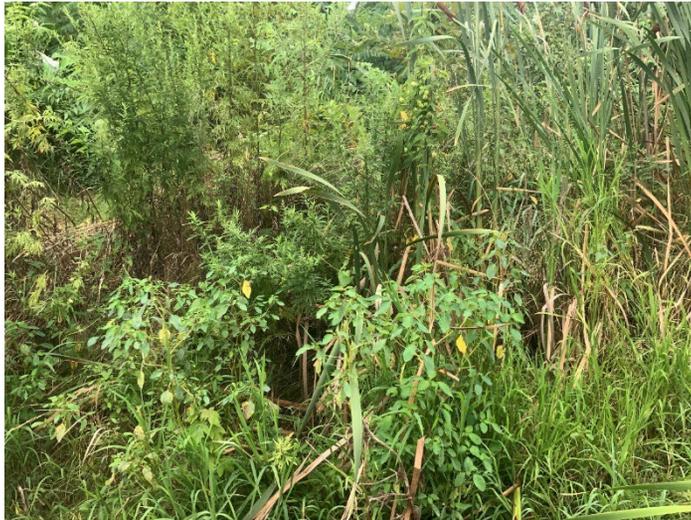
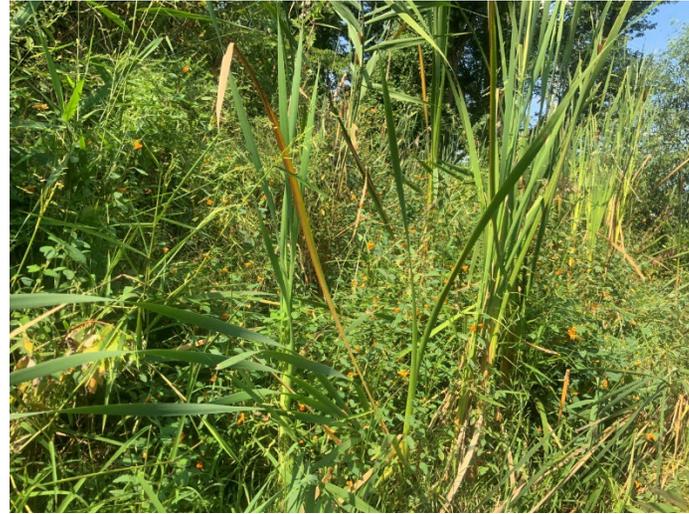
Photo A-80. Soil eroding from under the matting in 2018, which is now vegetated, on the right bank at station 01+67, 2018 (A), 2019 (B), 2020 (C), and 2021 (D).

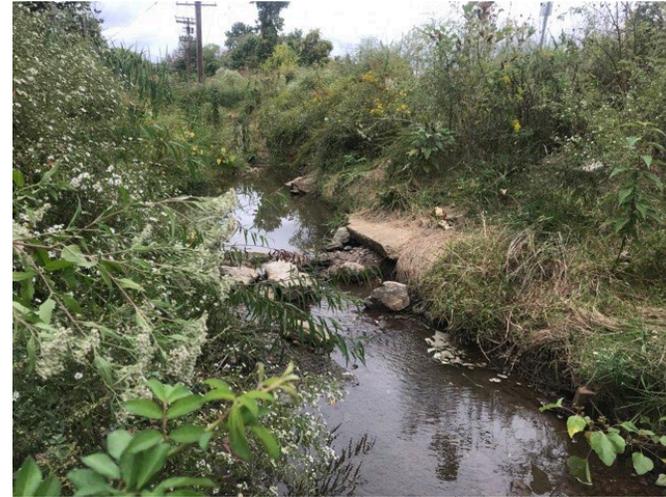
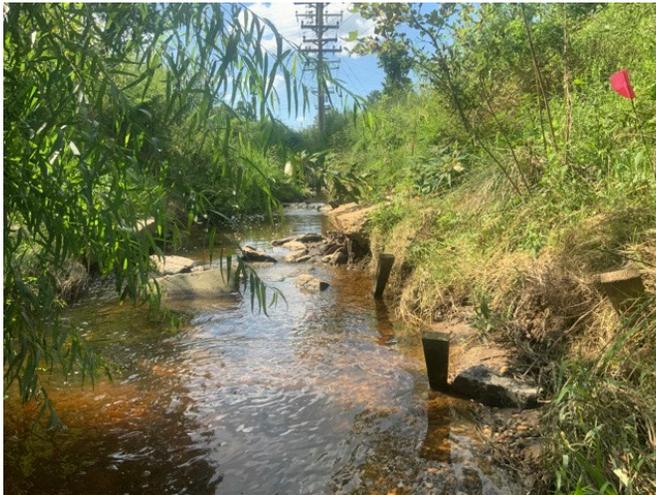
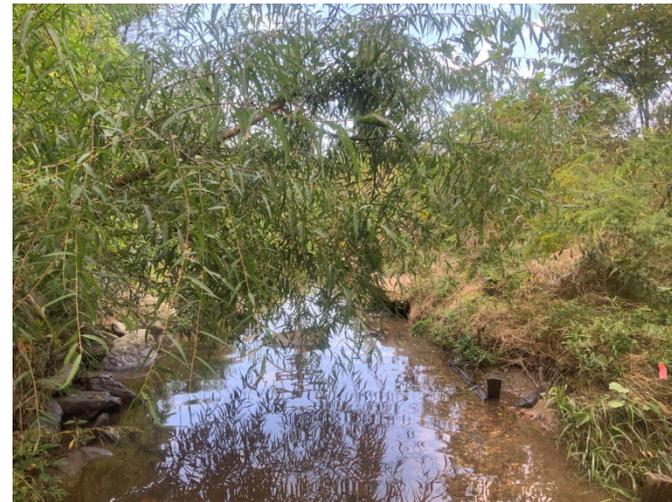
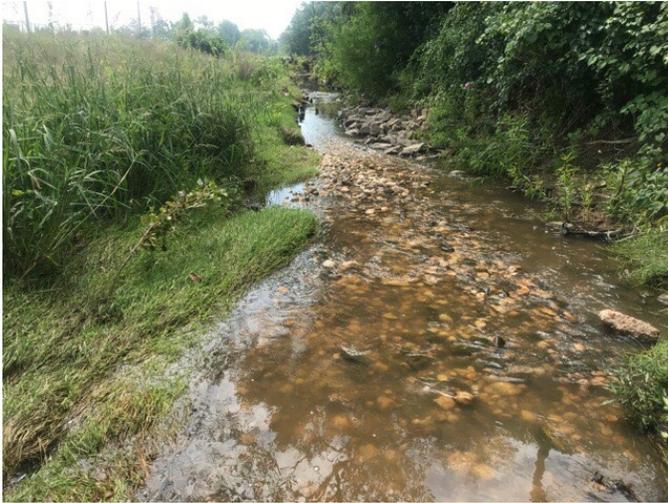
Photo A-84. Upstream view of both streambanks showing some erosion of lower left bank at station 02+01, 2018 (A), 2019 (B), 2020 (C), and 2021 (D).

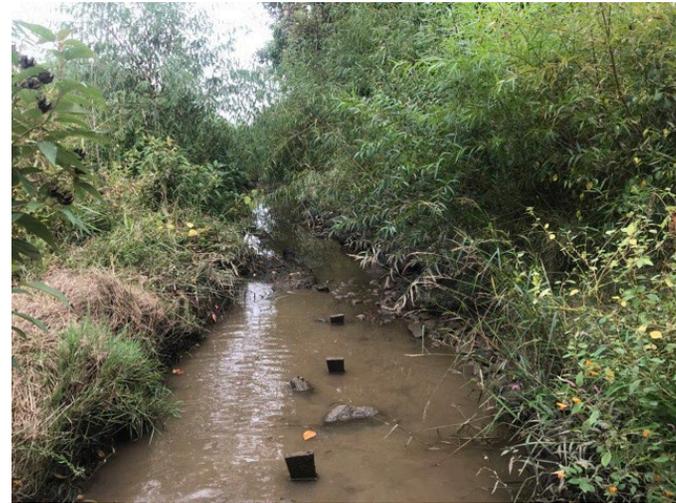
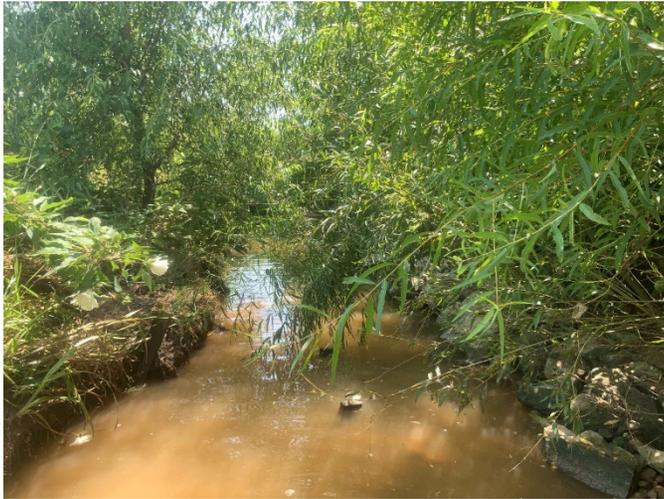
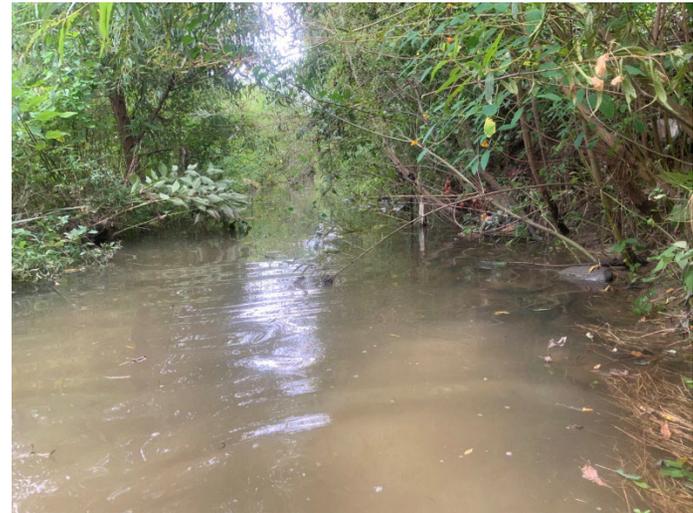
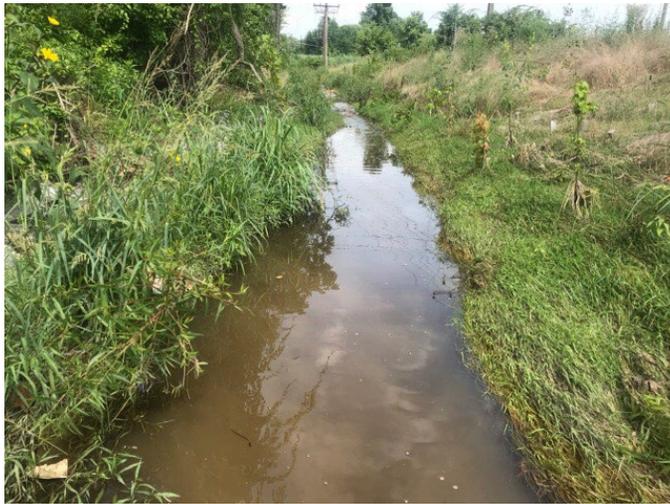
Photo A-85. Downstream view from thalweg at station 03+00, 2018 (A), 2019 (B), 2020 (C), and 2021 (D).

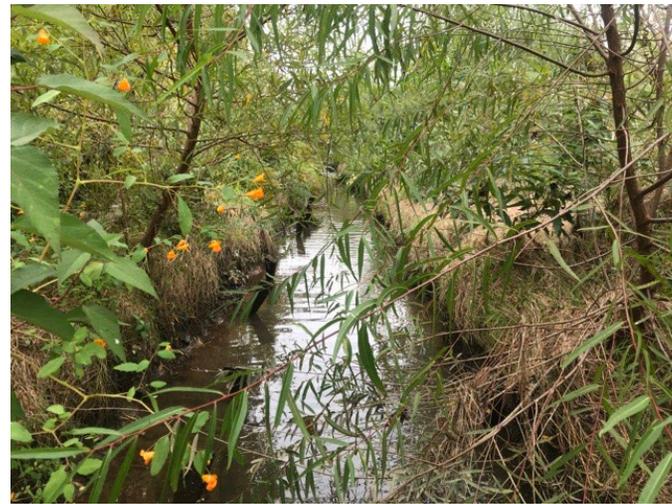
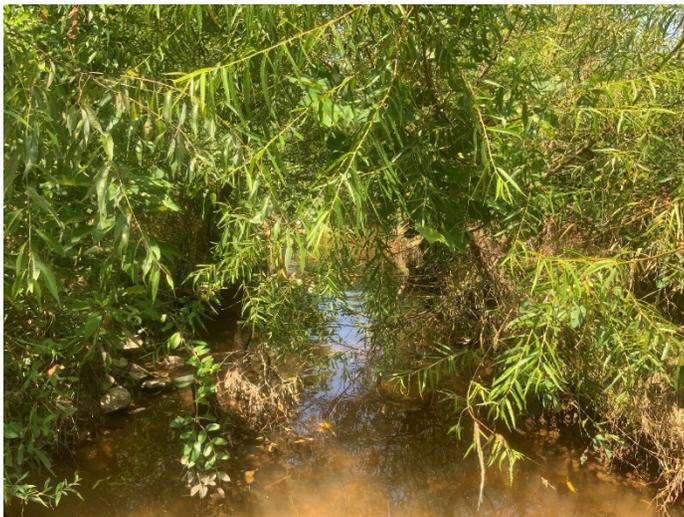
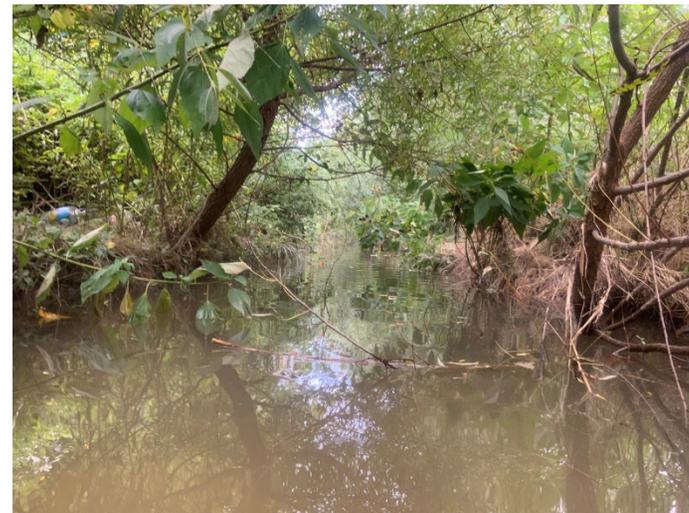
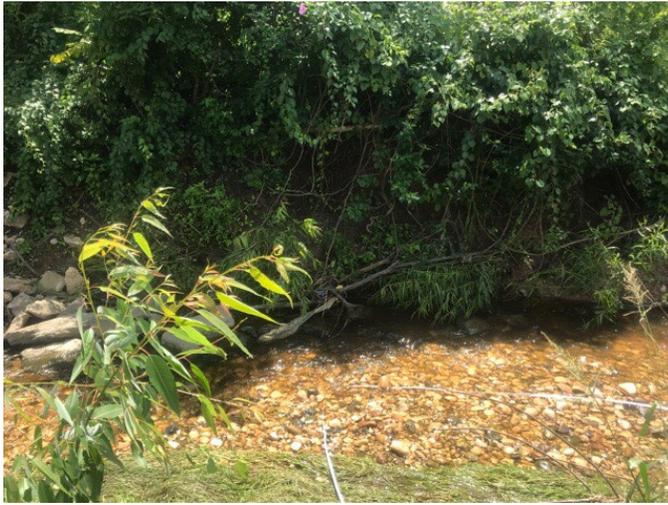
Photo A-86. Upstream view from thalweg at station 03+00, 2018 (A), 2019 (B), 2020 (C), and 2021 (D).

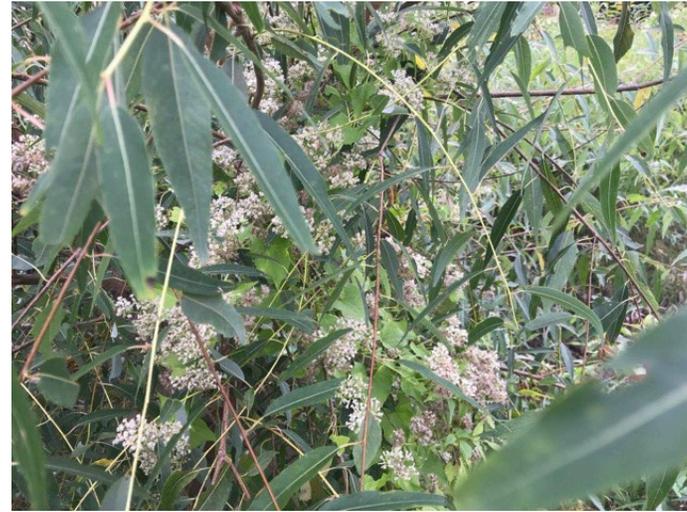
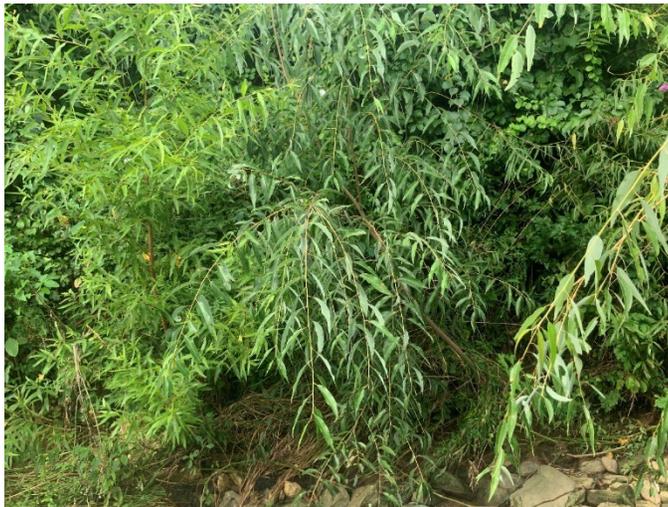
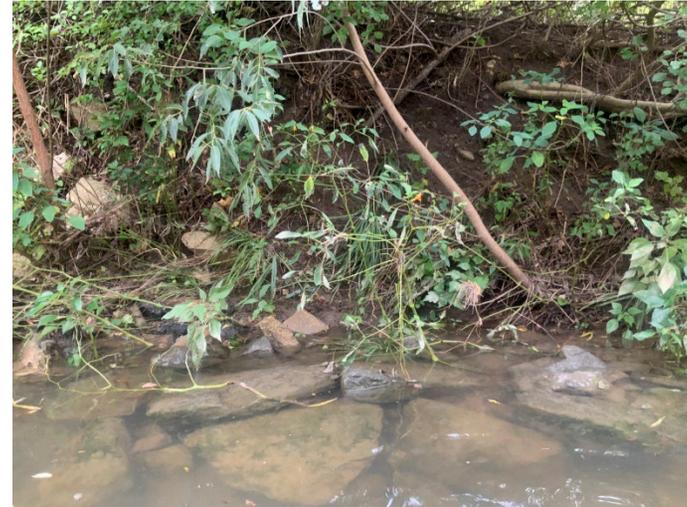
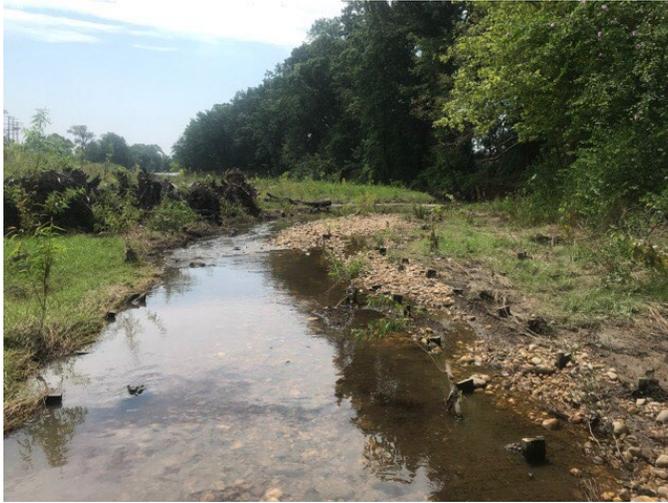
Photo A-87. Right streambank at station 03+20, 2018 (A), 2019 (B), 2020 (C), 2021 (D).

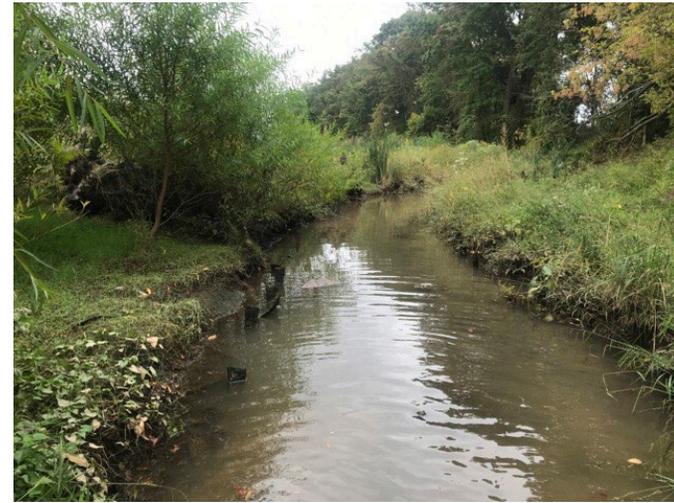
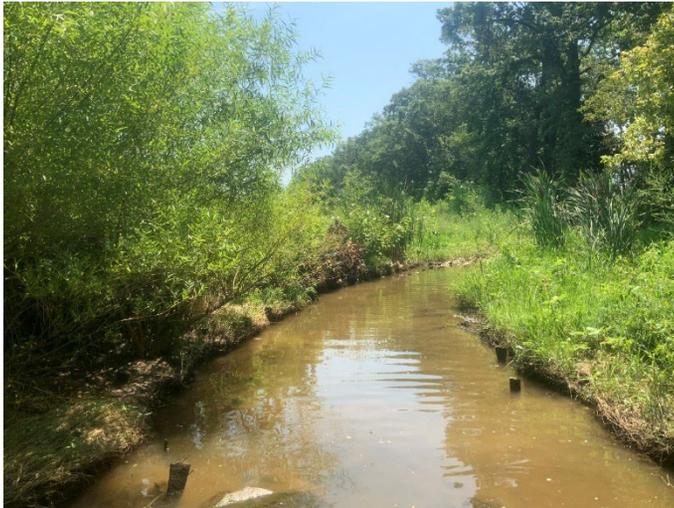
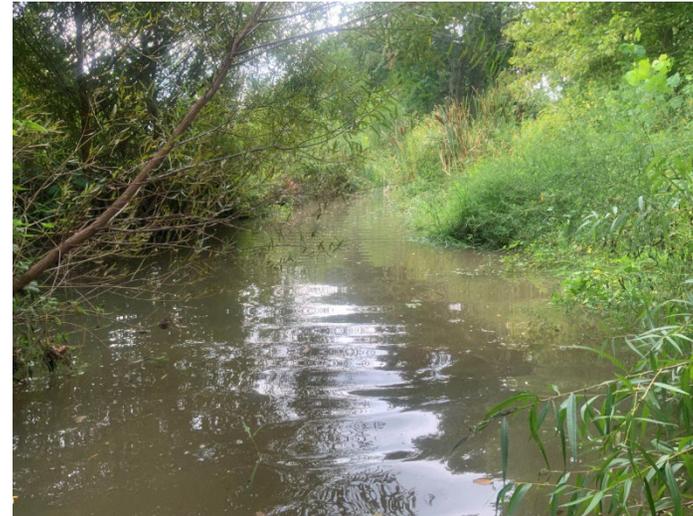
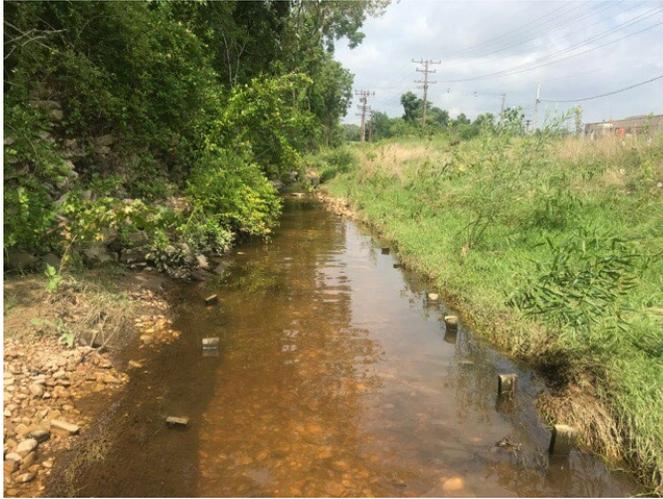
Photo A-88. Downstream view from thalweg at station 04+33, 2018 (A), 2019 (B), 2020 (C), and 2021 (D).

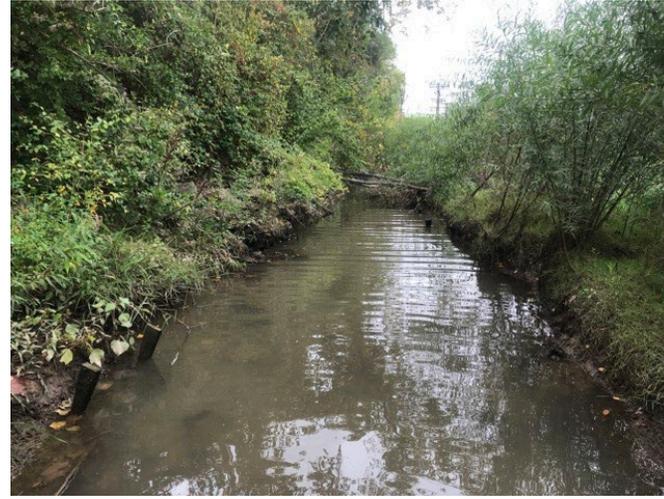
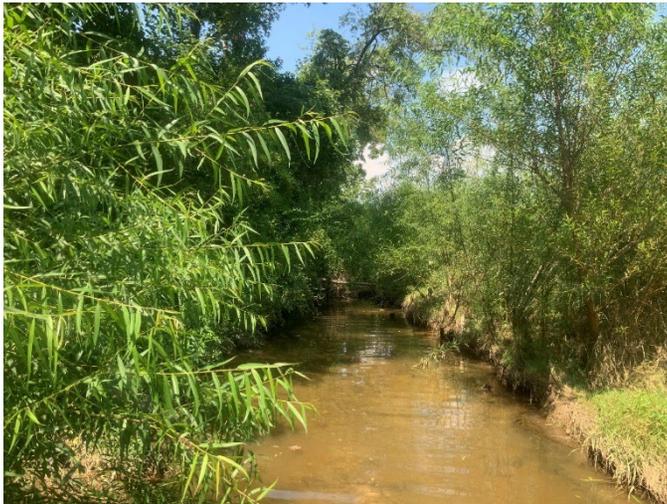
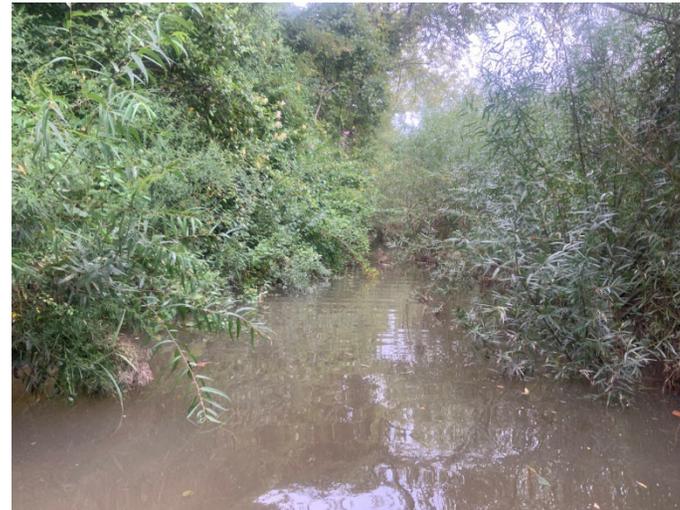
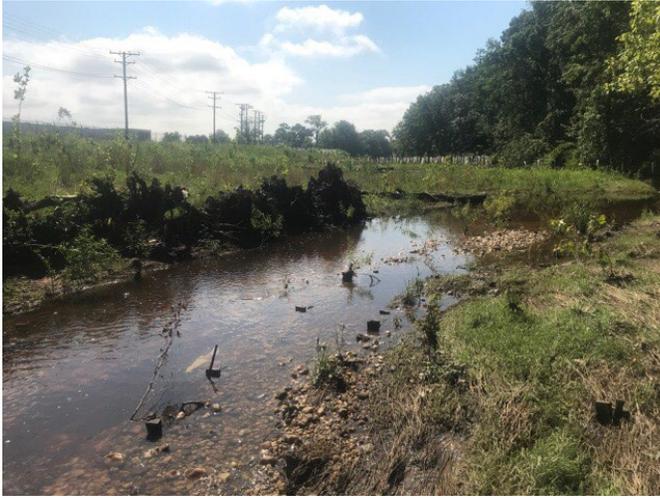
Photo A-89. Upstream view from the thalweg at station 04+33, 2018 (A), 2019 (B), 2020 (C), and 2021 (D).

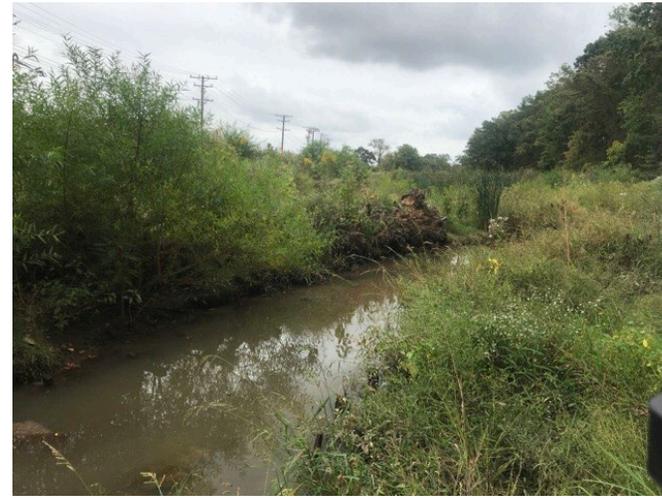
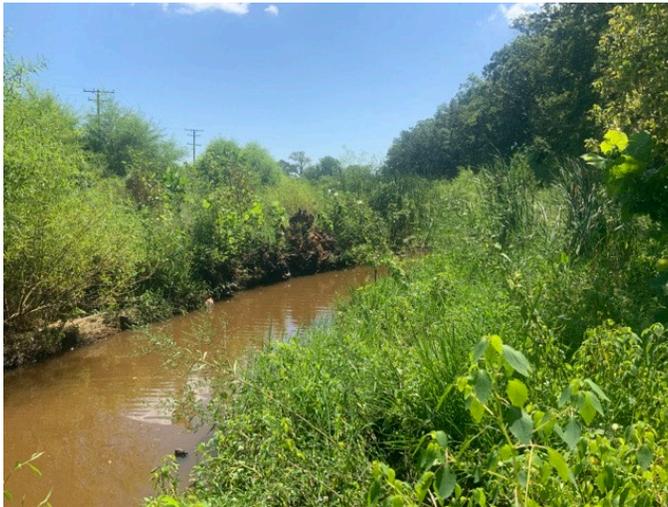
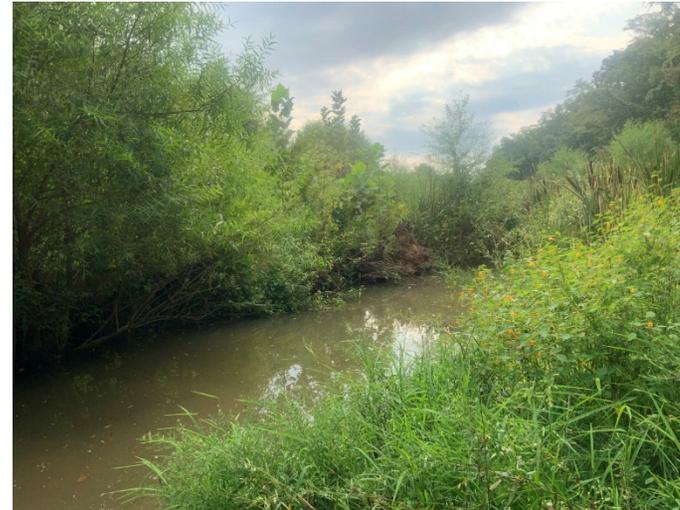
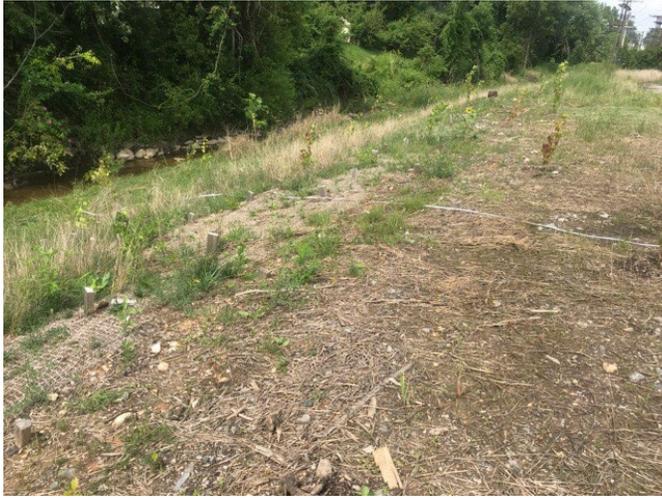
Photo A-90. View of root wad and left bank from station 04+50, 2018 (A), 2019 (B), 2020 (C), 2021 (D).

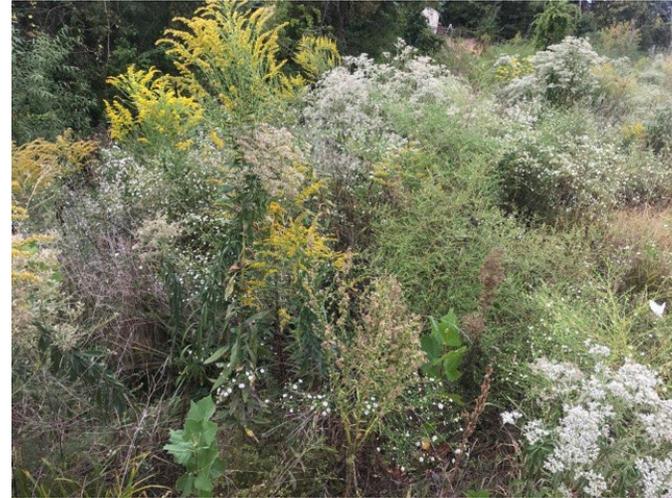
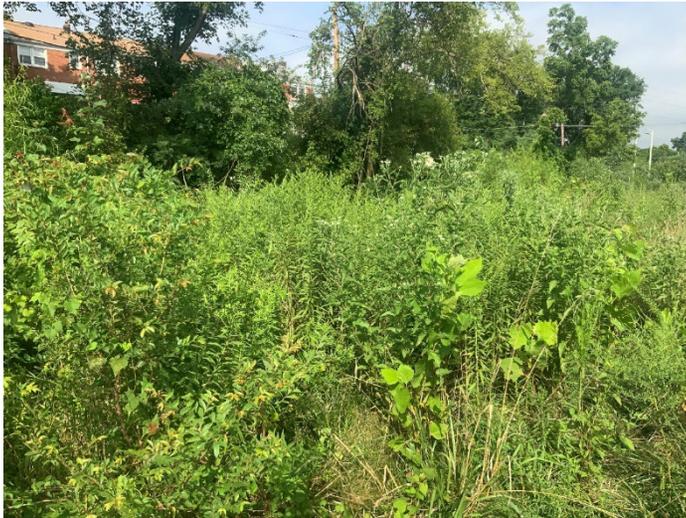
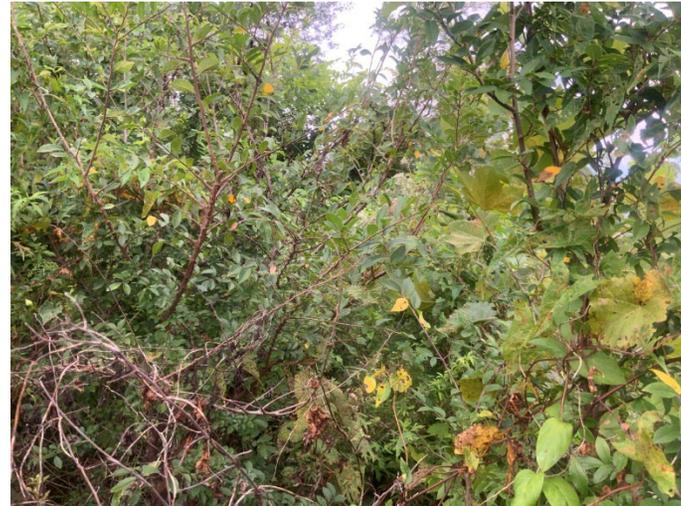
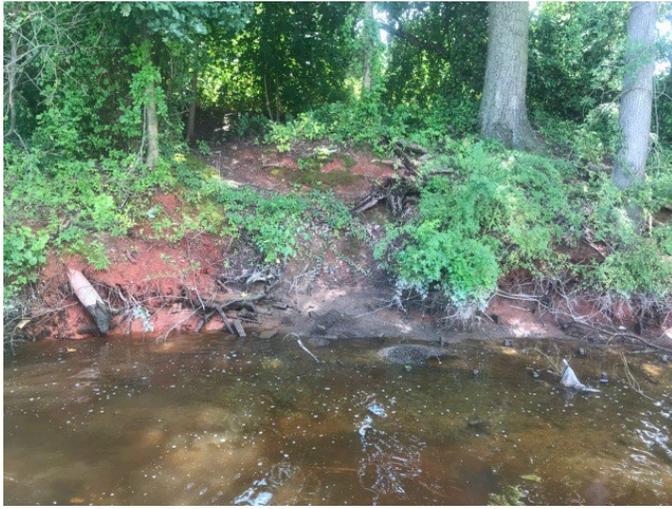
Photo A-91. Barren floodplain area from 2018, which has become more vegetated, on the left streambank at station 04+15, 2018 (A), 2019 (B), 2020 (C), and 2021 (D).

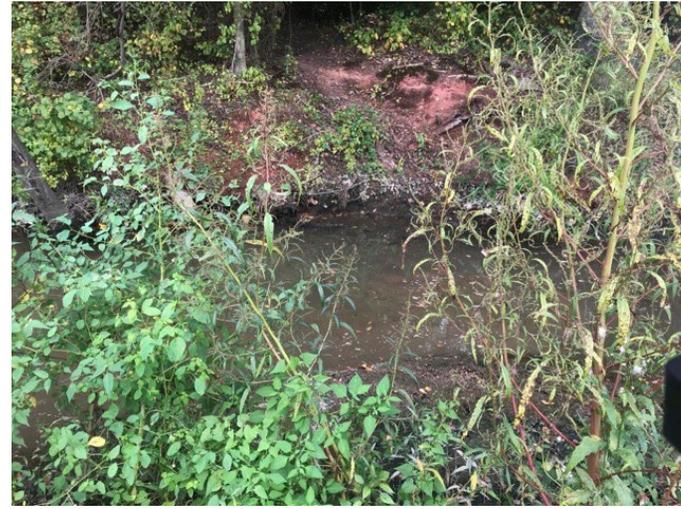
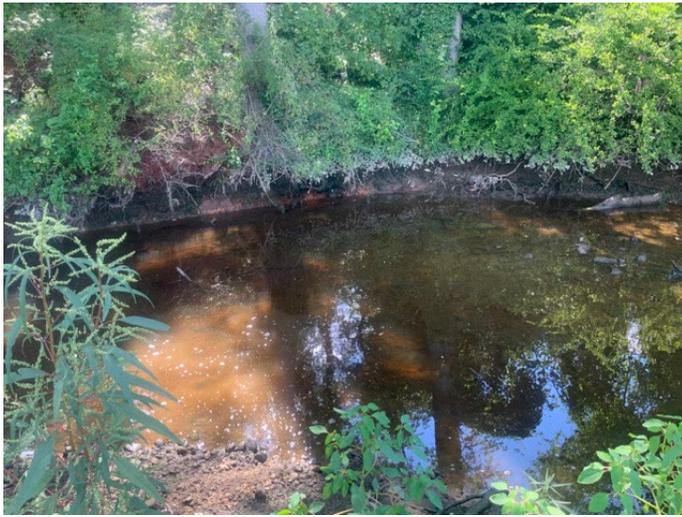
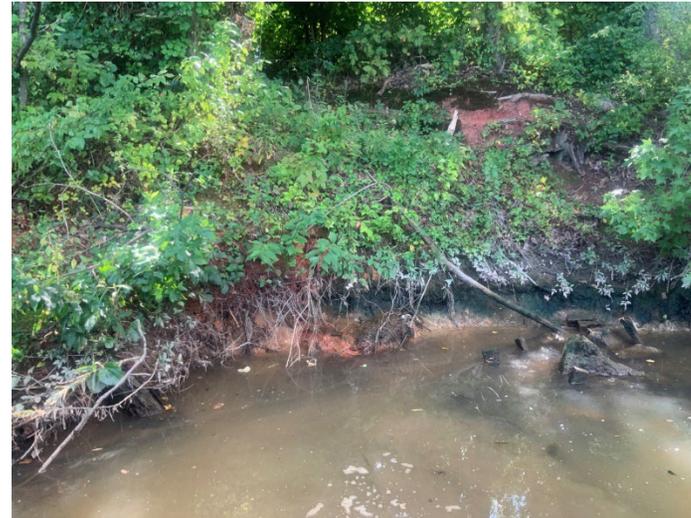
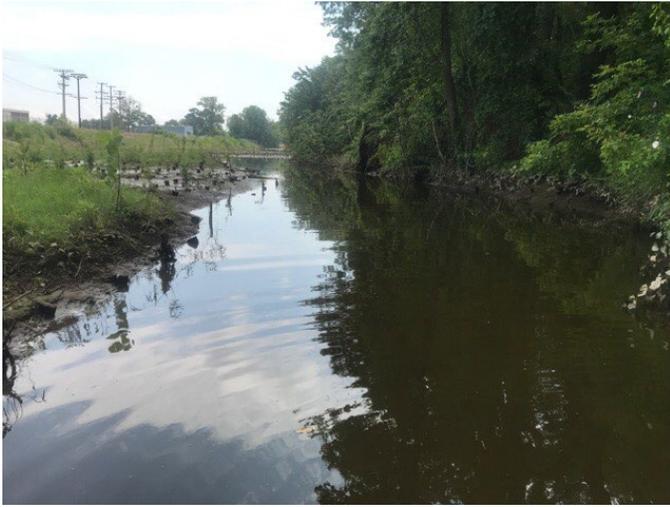
Photo A-92. Barren area on the right streambank at station 05+25, 2018 (A), 2019 (B), 2020 (C), and 2021 (D).

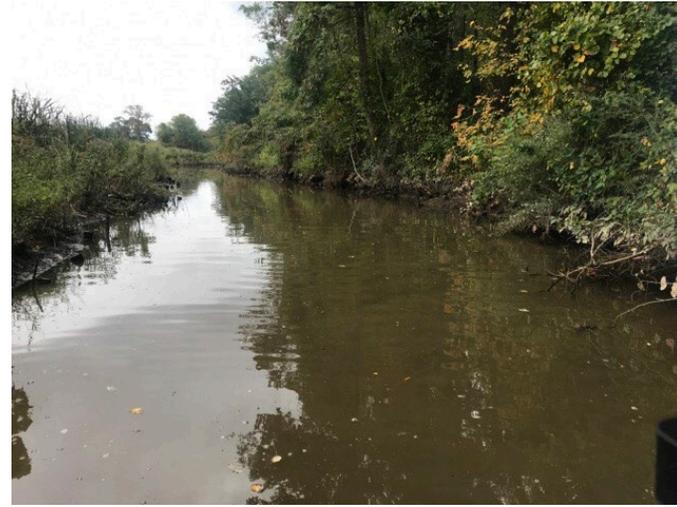
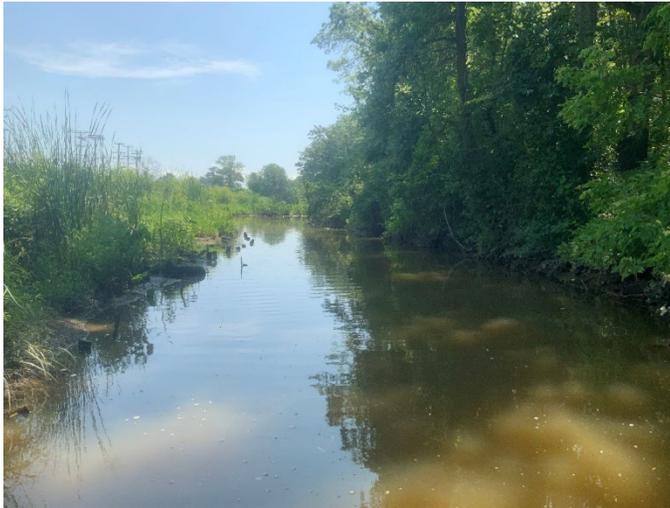
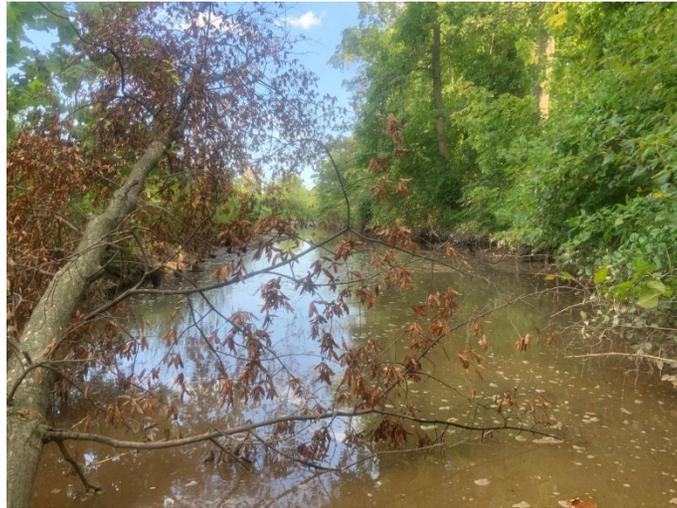
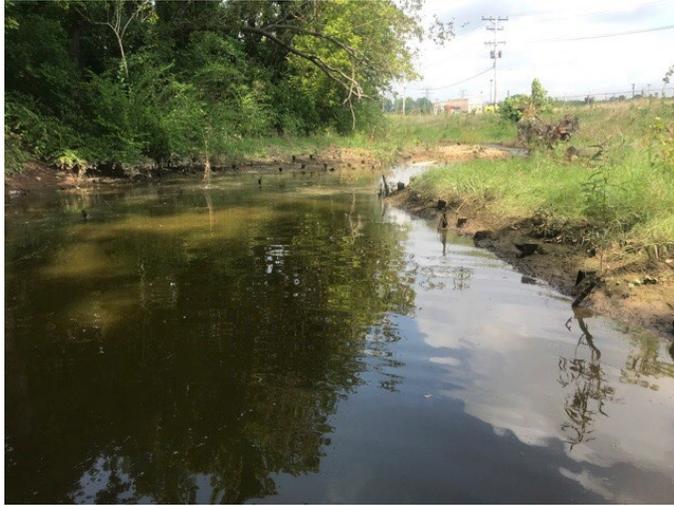
Photo A-93. Downstream view from thalweg at station 05+67, 2018 (A), 2019 (B), 2020 (C), and 2021 (D).

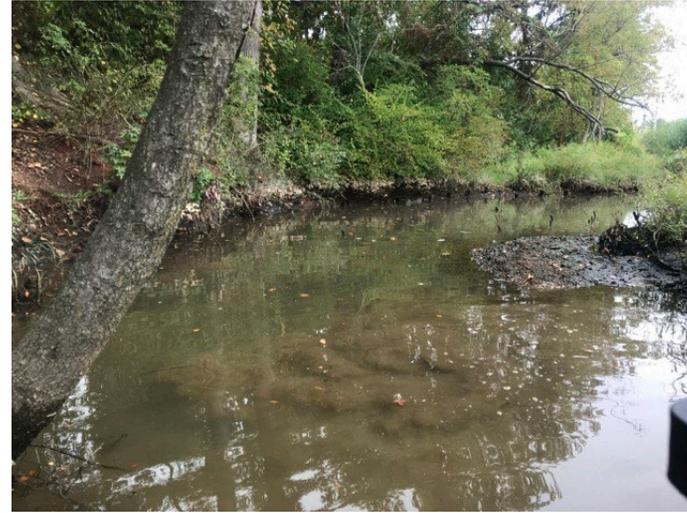
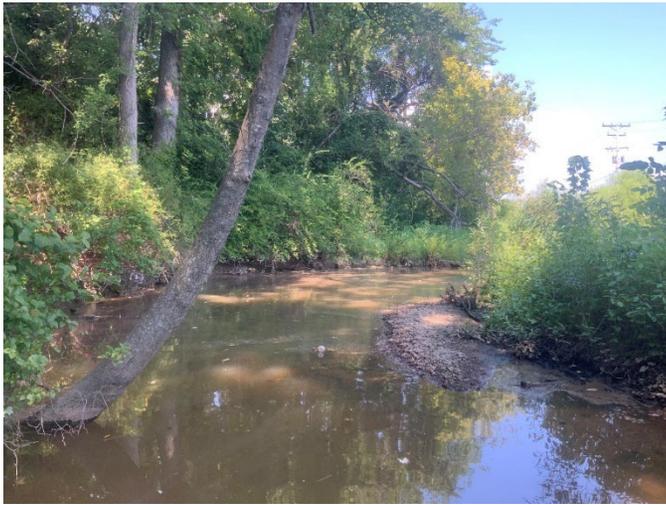
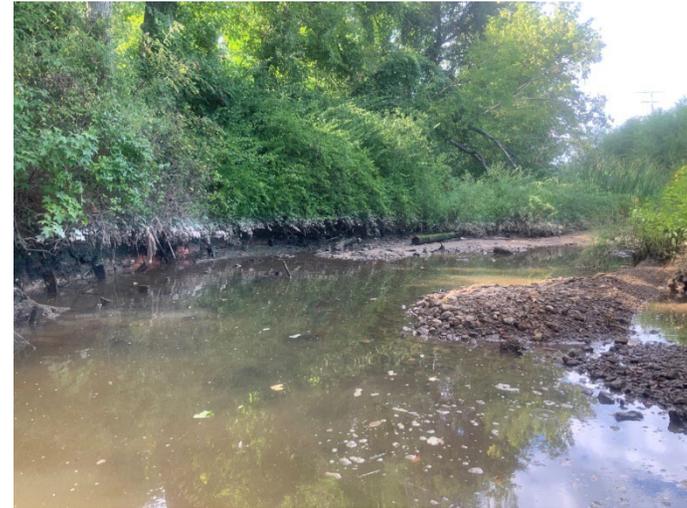
Photo A-94. Upstream view from thalweg at station 05+67, 2018 (A), 2019 (B), 2020 (C), and 2021 (D).

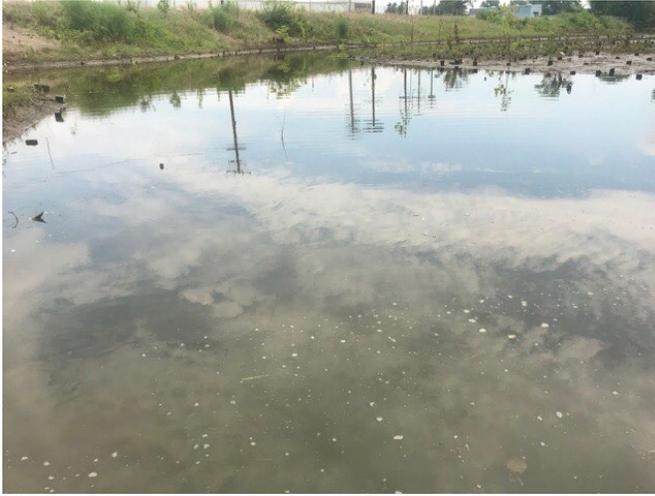
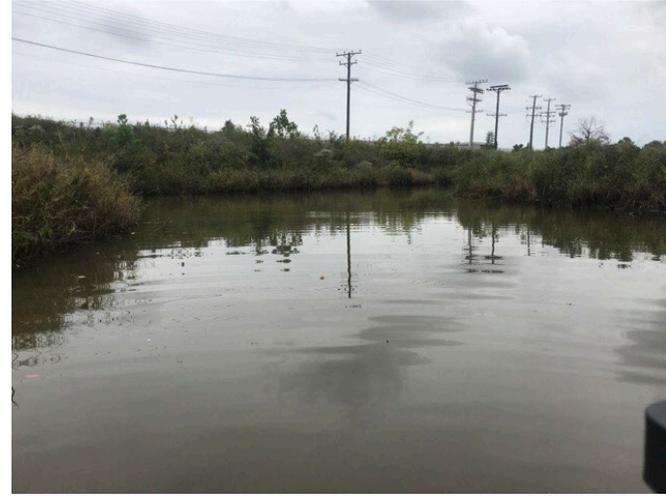
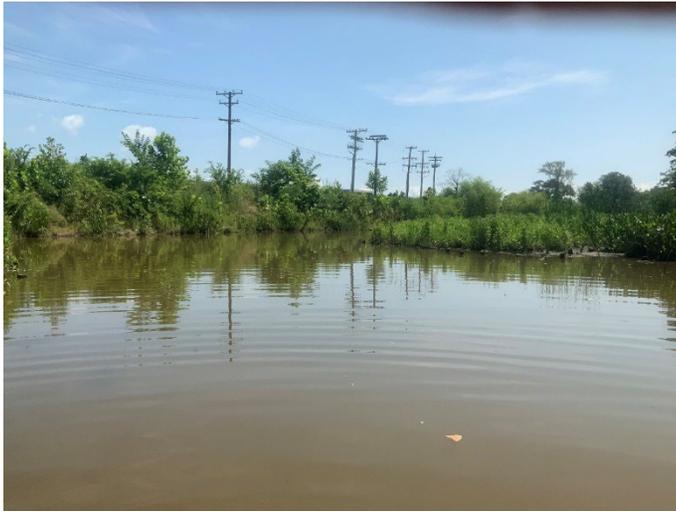
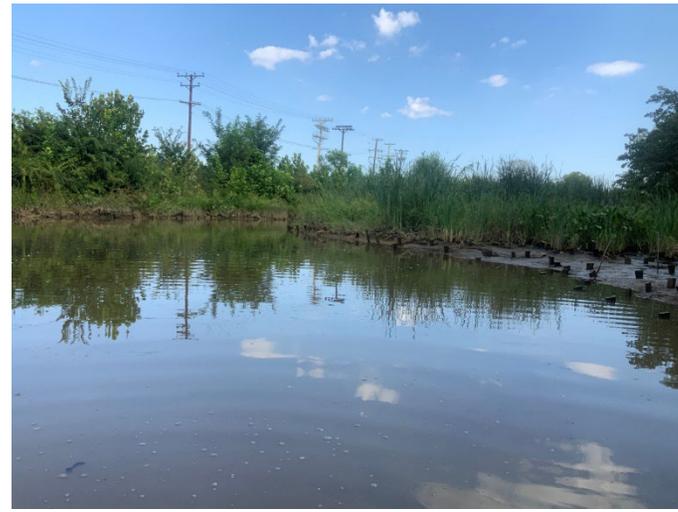
Photo A-95. Downstream view from thalweg at station 07+00, 2018 (A), 2019 (B), 2020 (C), and 2021 (D).

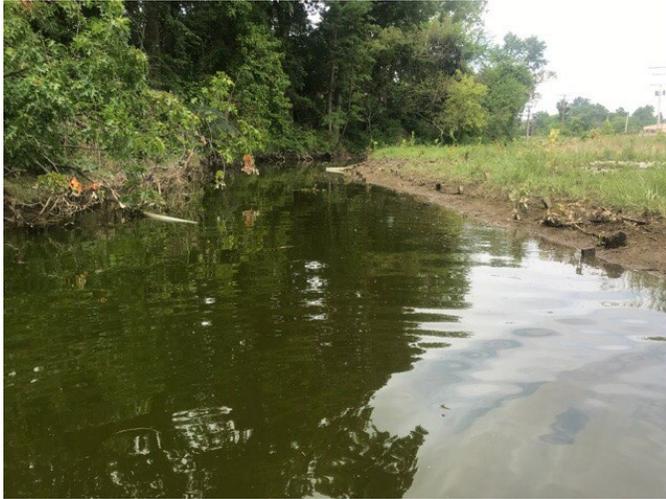
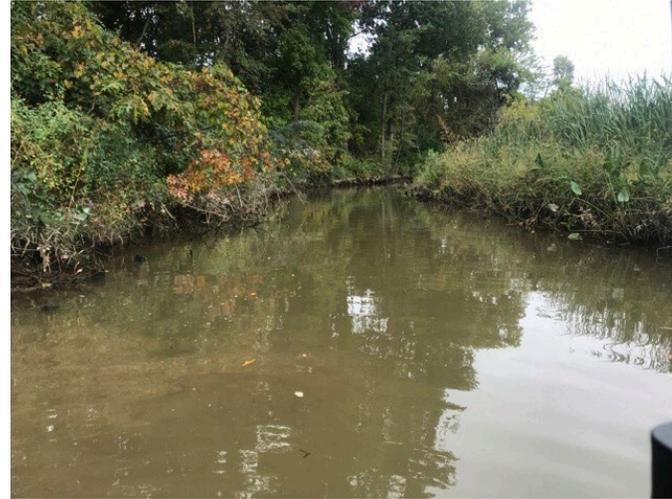
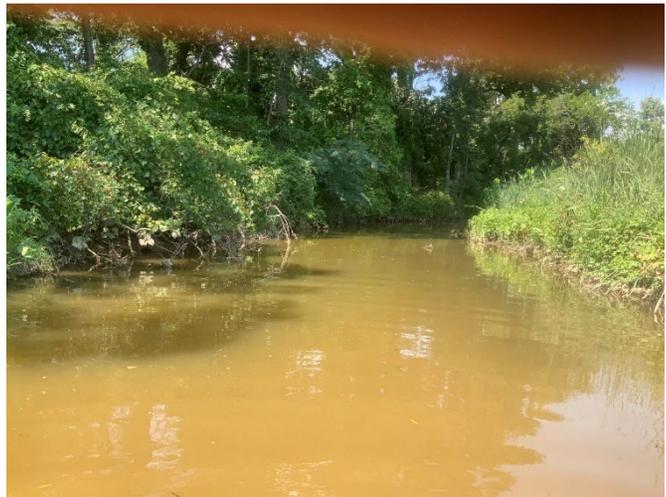
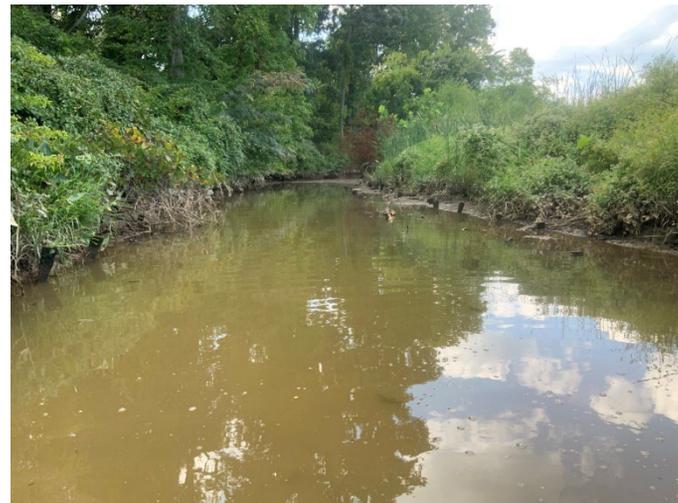
Photo A-96. Upstream view from thalweg at station 07+00, 2018 (A), 2019 (B), 2020 (C), and 2021 (D).
