Subject: Transmittal of the Cow Pen Creek Bank Stabilization and Floodplain Reconstruction Monitoring:
2021 Report
Lockheed Martin Corporation – Middle River Complex
2323 Eastern Boulevard, Middle River, Baltimore County, Maryland

**COW PEN CREEK
BANK STABILIZATION AND FLOODPLAIN
RECONSTRUCTION MONITORING: 2021 REPORT
LOCKHEED MARTIN MIDDLE RIVER COMPLEX
2323 EASTERN BOULEVARD
MIDDLE RIVER, MARYLAND**

Prepared by:
Tetra Tech, Inc.

January 2022

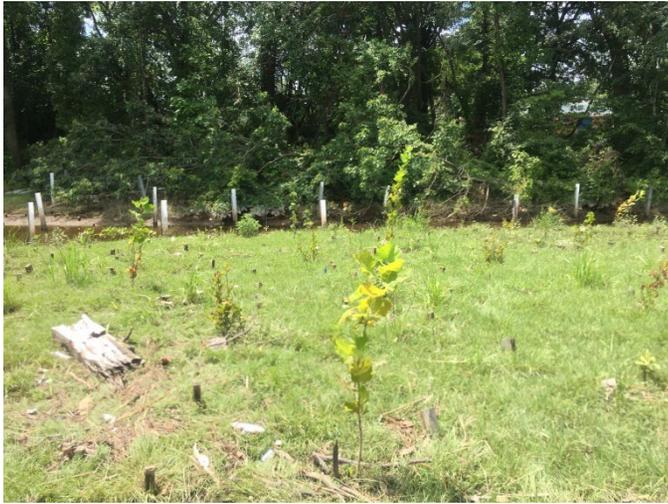
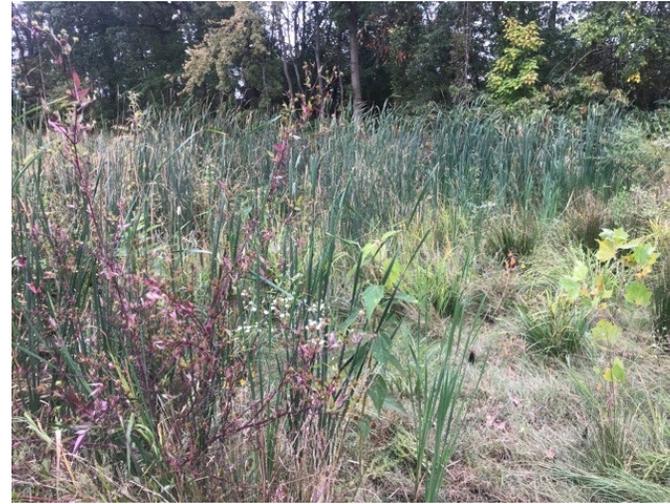
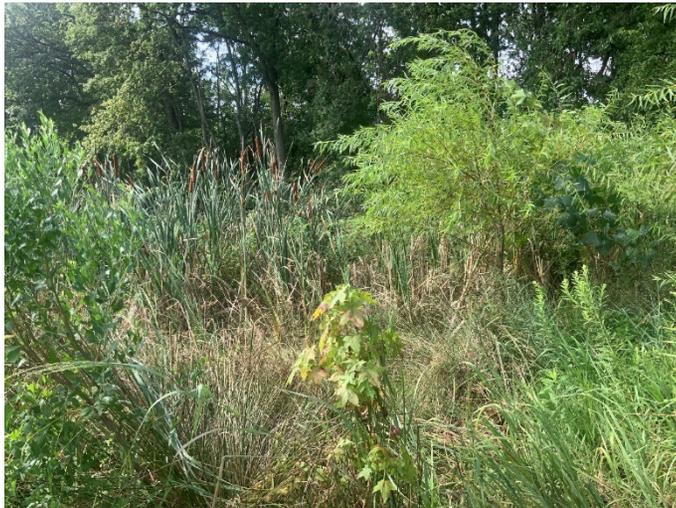
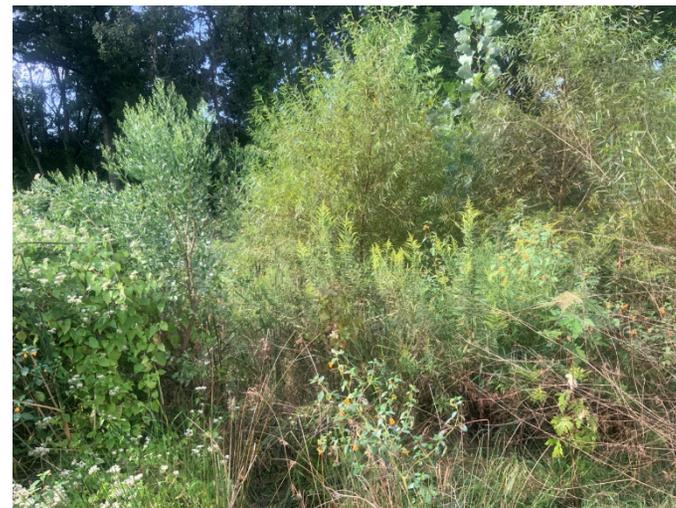
Photo A-97. Tree tubes from 2018 and new vegetation on left bank at station 07+03, 2018 (A), 2019 (B), 2020 (C), and 2021 (D).

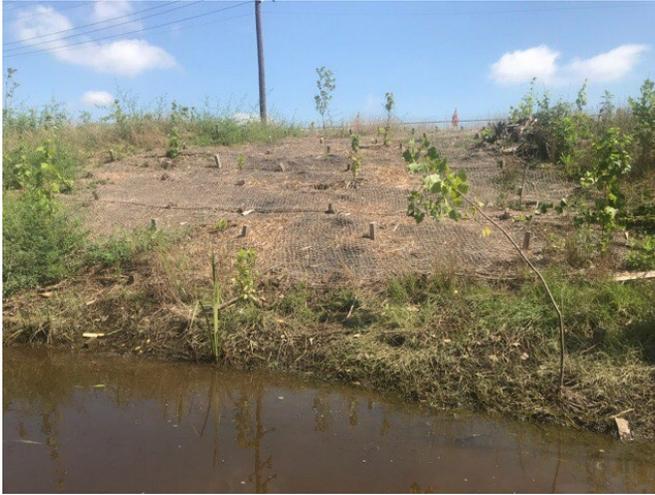
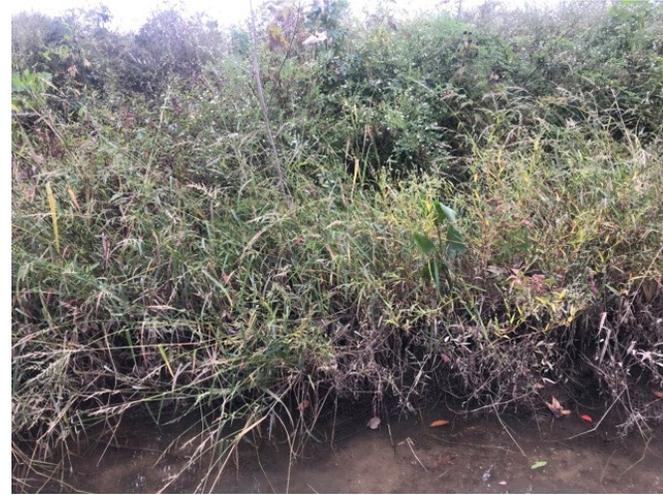
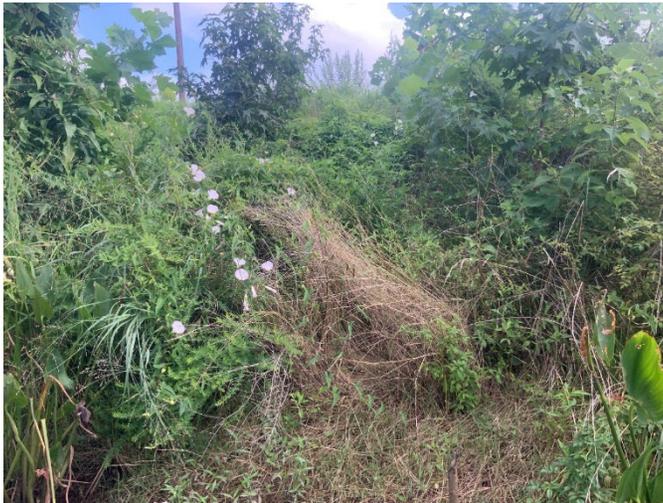
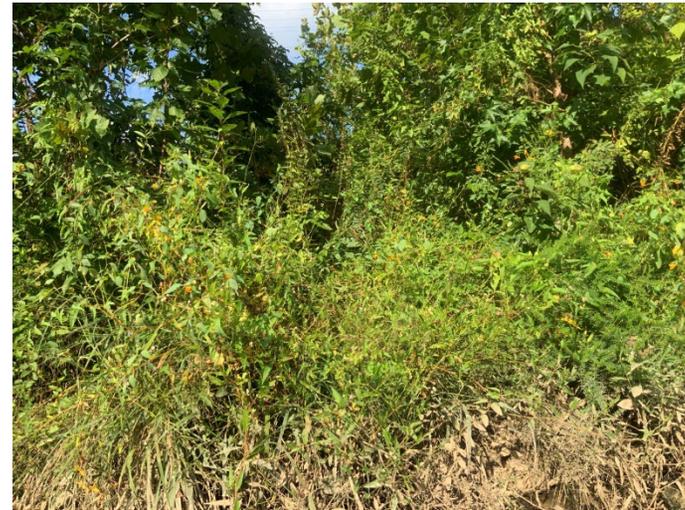
Photo A-98. Barren floodplain area from 2018 and new vegetation on the left streambank at station 07+71, 2018 (A), 2019 (B), 2020 (C), and 2021 (D).

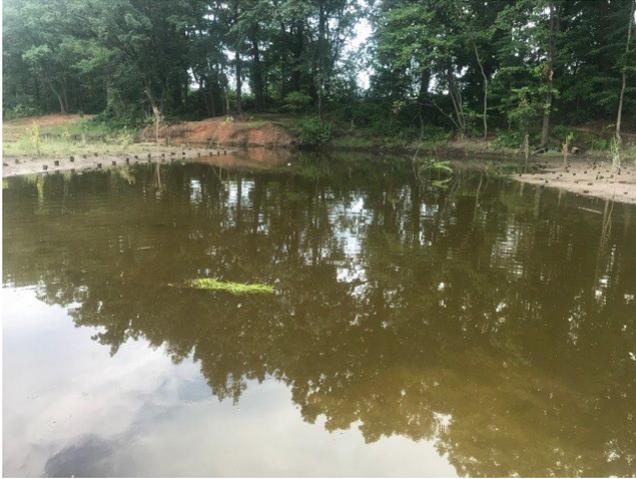
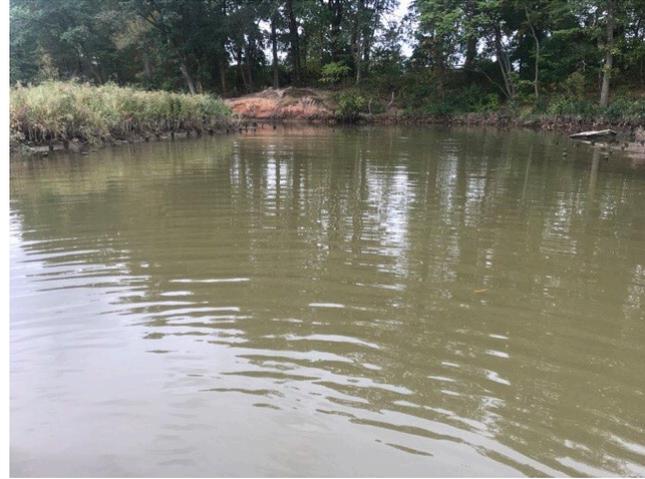
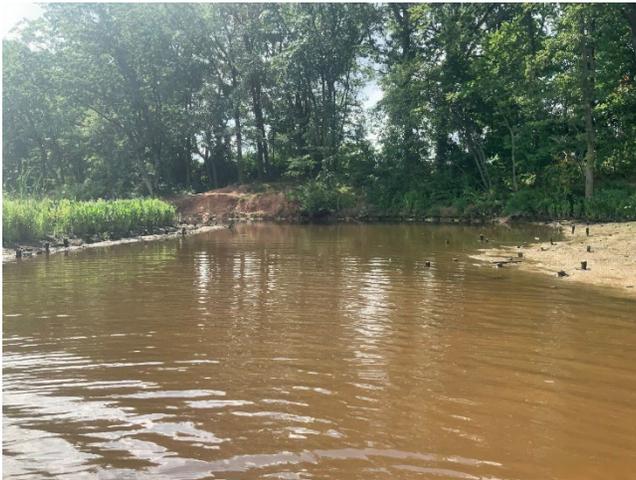
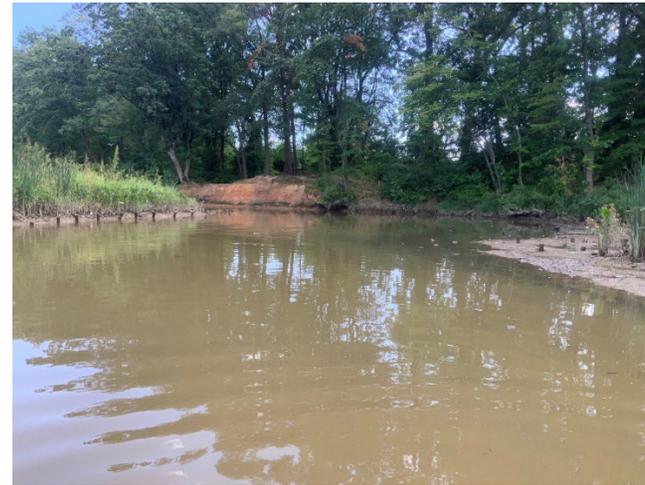
Photo A-99. Downstream view from thalweg at station 08+33, 2018 (A), 2019 (B), 2020 (C), and 2021 (D).

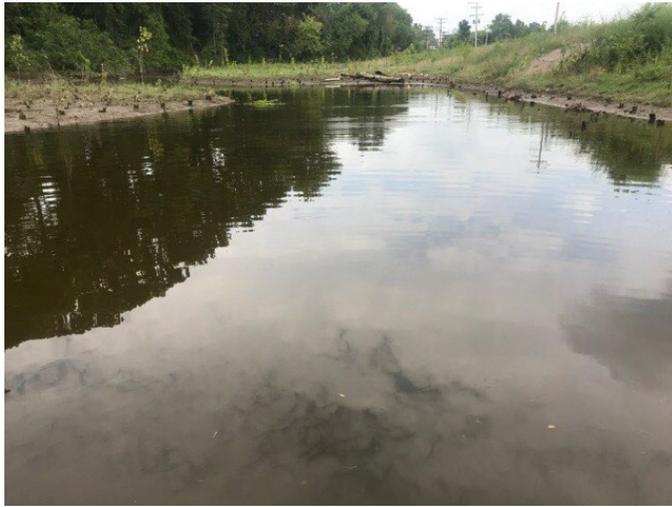
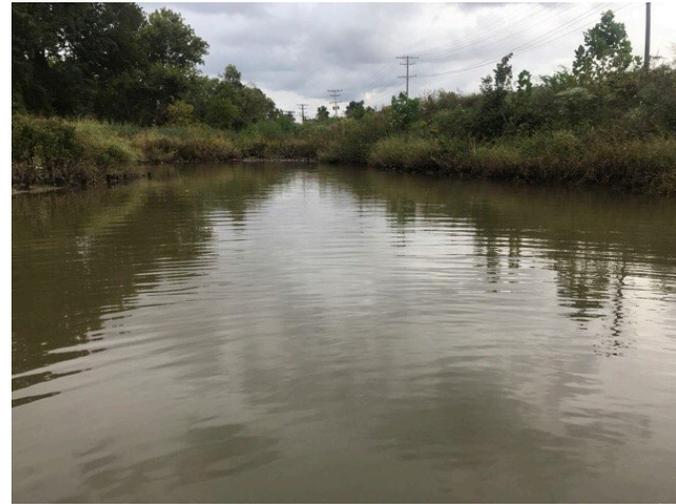
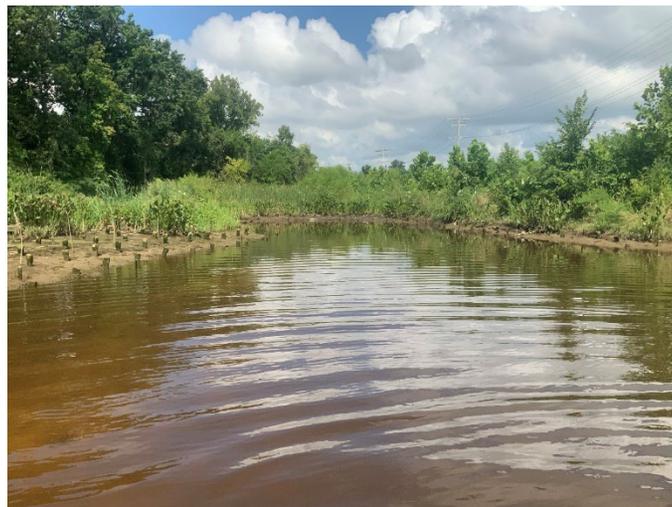
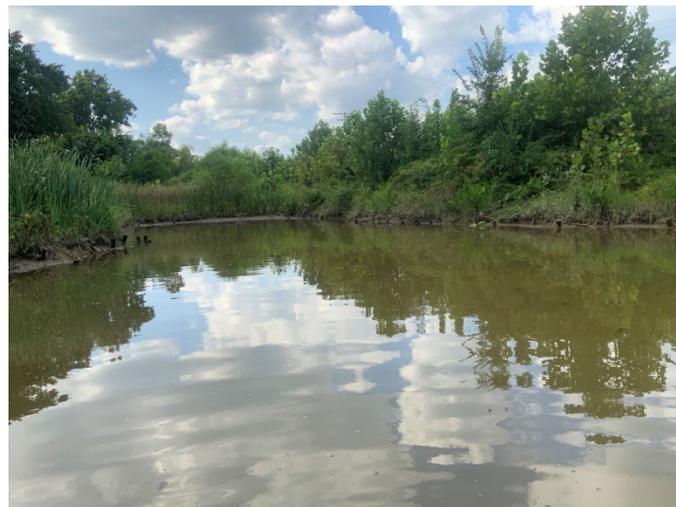
Photo A-100. Upstream view from thalweg at station 08+33, 2018 (A), 2019 (B), 2020 (C), and 2021 (D).

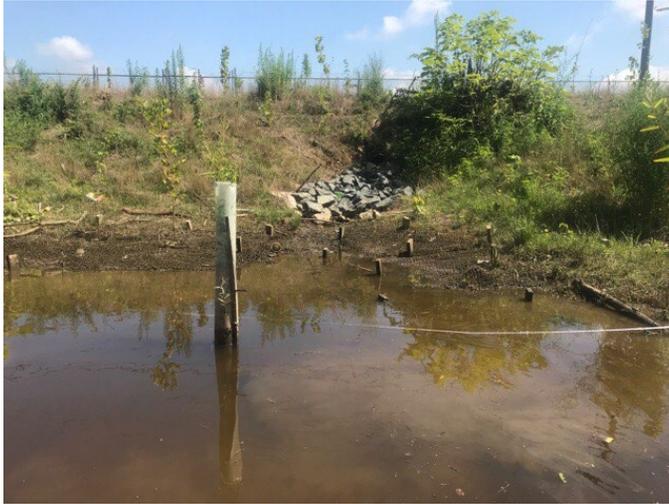
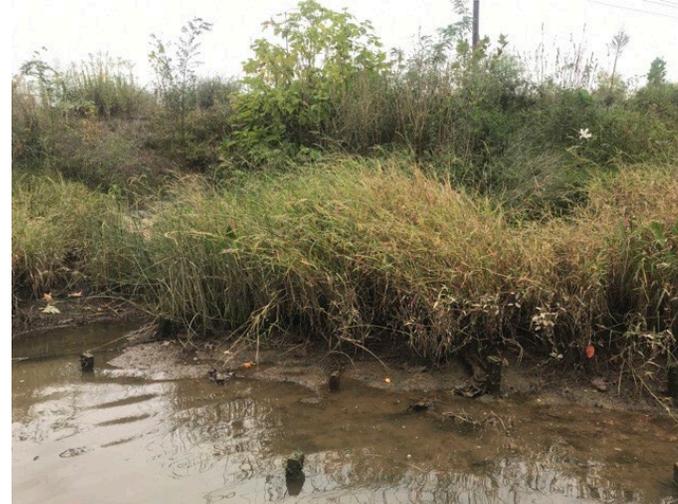
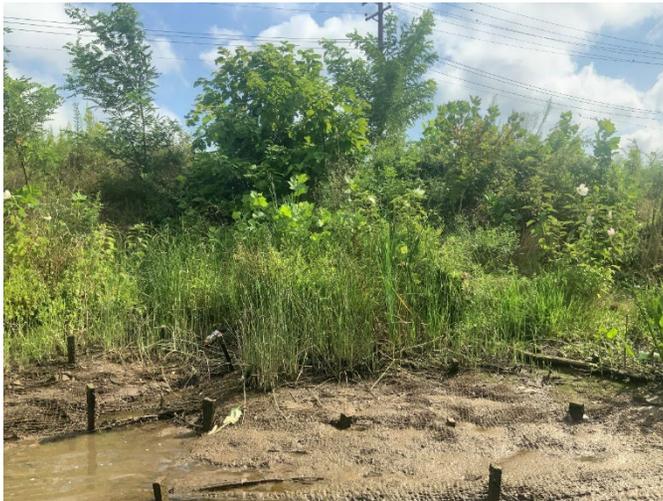
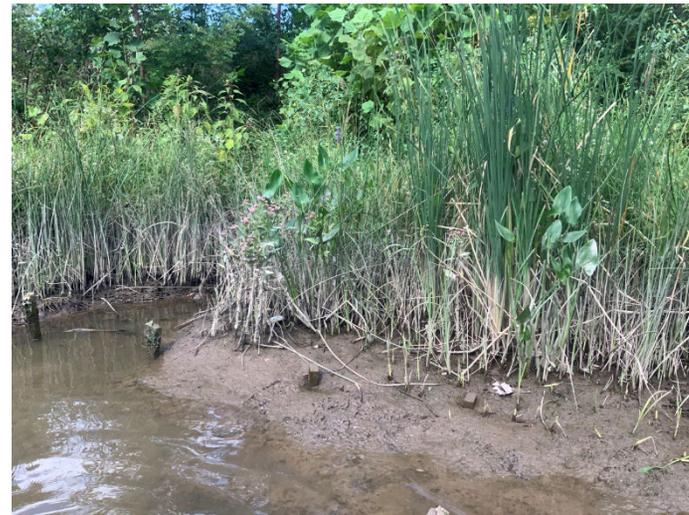
Photo A-101. Outfall / barren area and new vegetation on left streambank at station 08+32, 2018 (A), 2019 (B), 2020 (C), and 2021 (D).

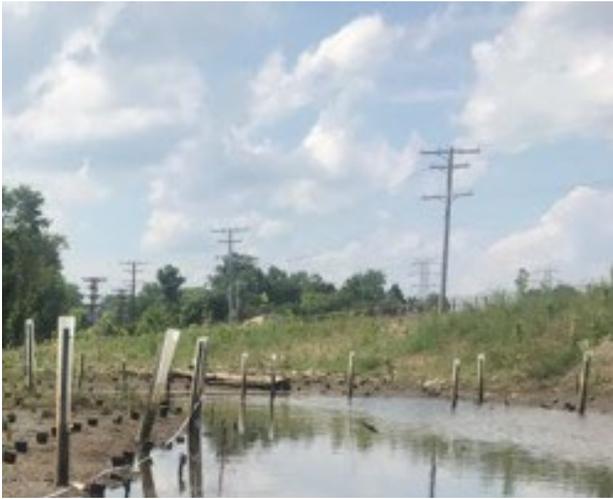
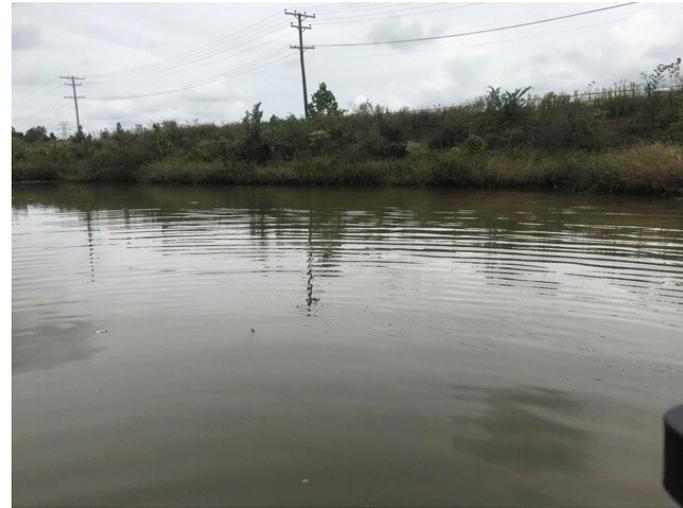
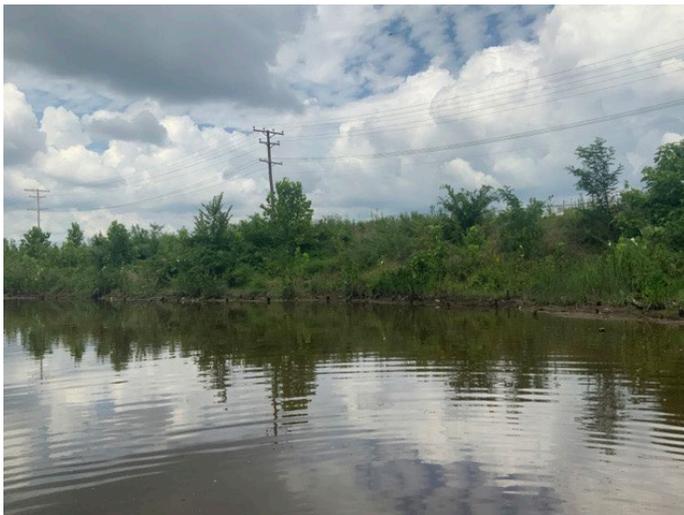
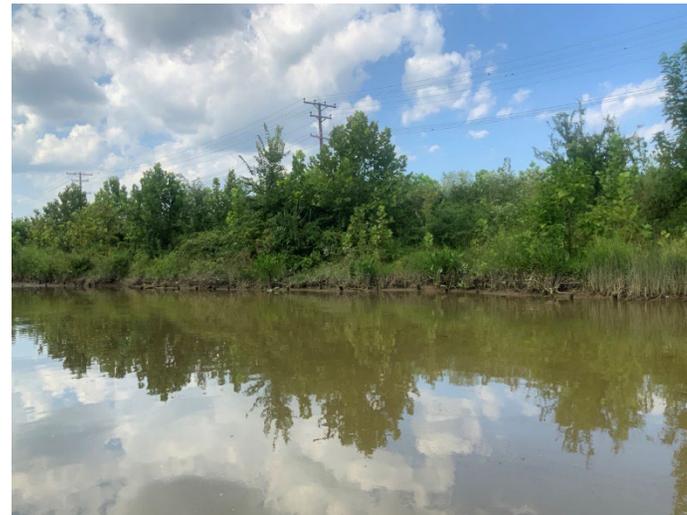
Photo A-102. Barren wetland area (2018) and new vegetation on the left streambank at station 08+41, 2018 (A), 2019 (B), 2020 (C), and 2021 (D).

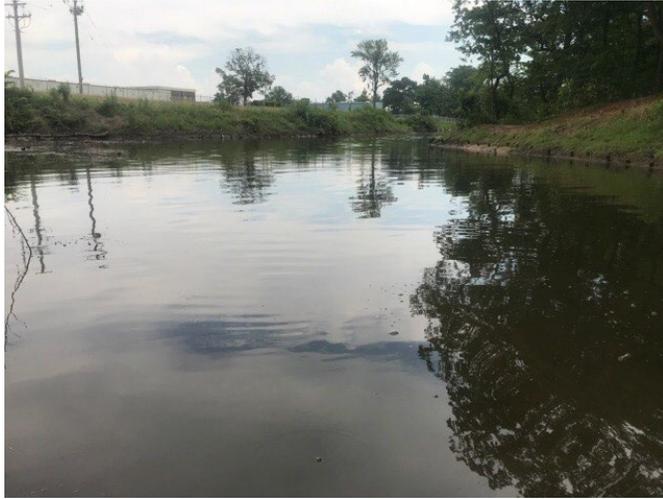
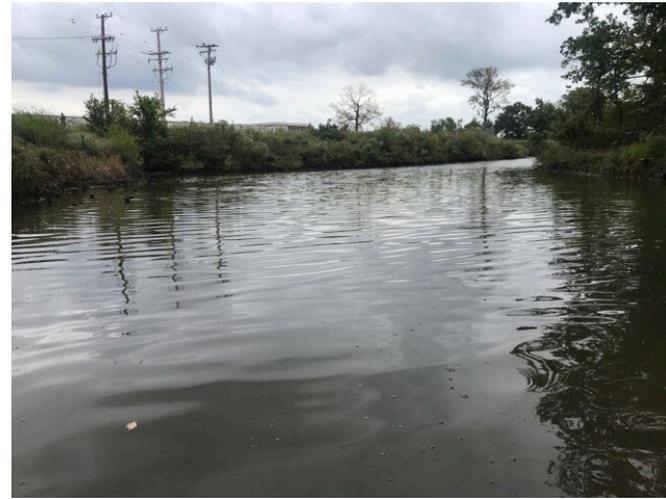
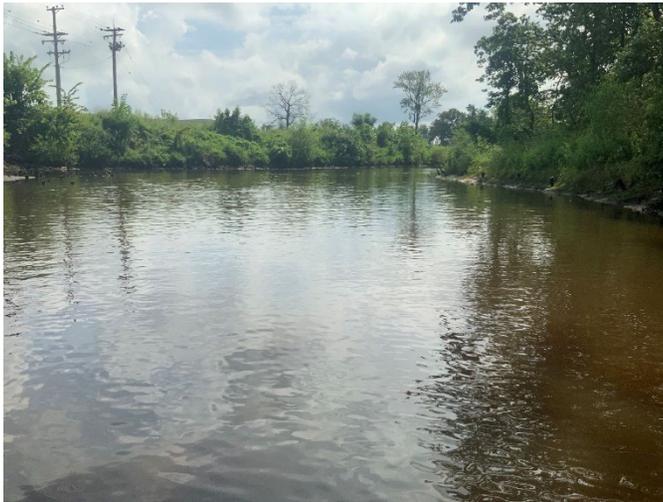
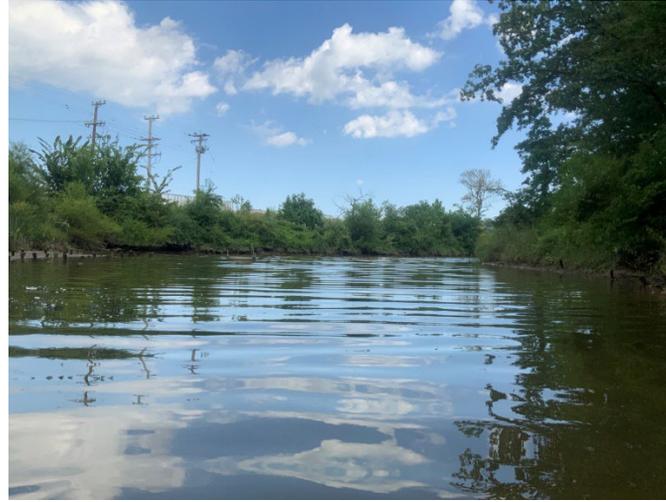
Photo A-103. Downstream view from thalweg at station 09+67, 2018 (A), 2019 (B), 2020 (C), and 2021 (D).

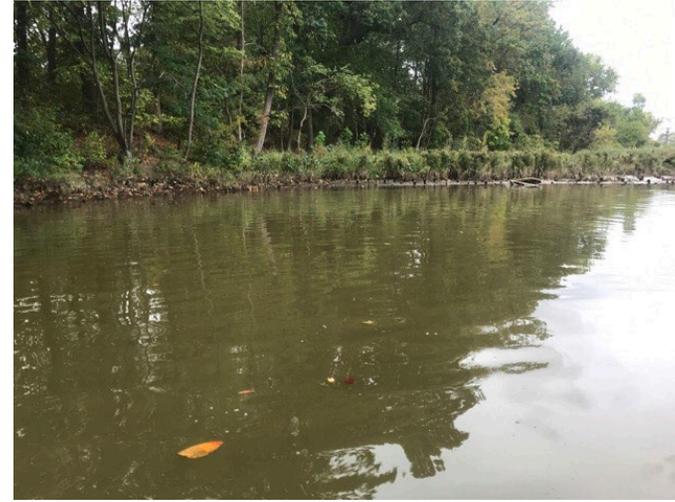
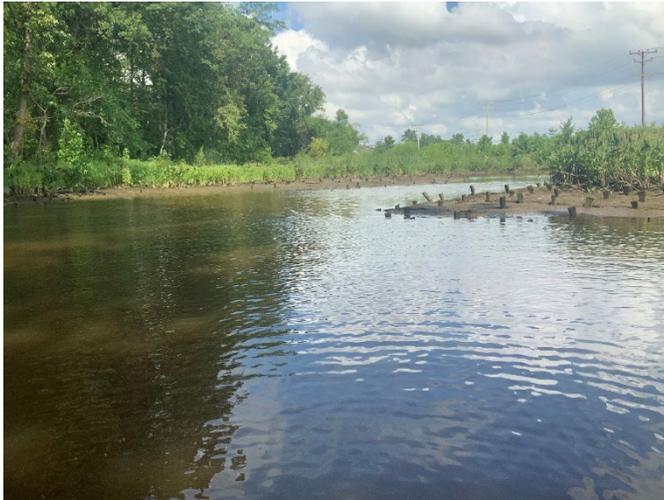
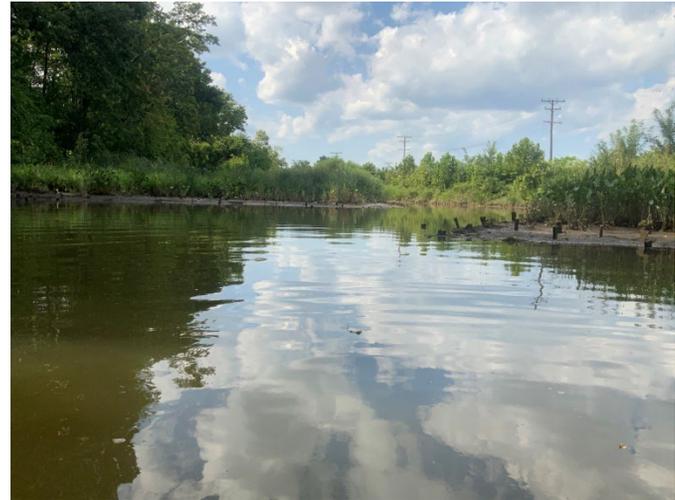
Photo A-104. Upstream view from thalweg at station 09+67, 2018 (A), 2019 (B), 2020 (C), and 2021 (D).

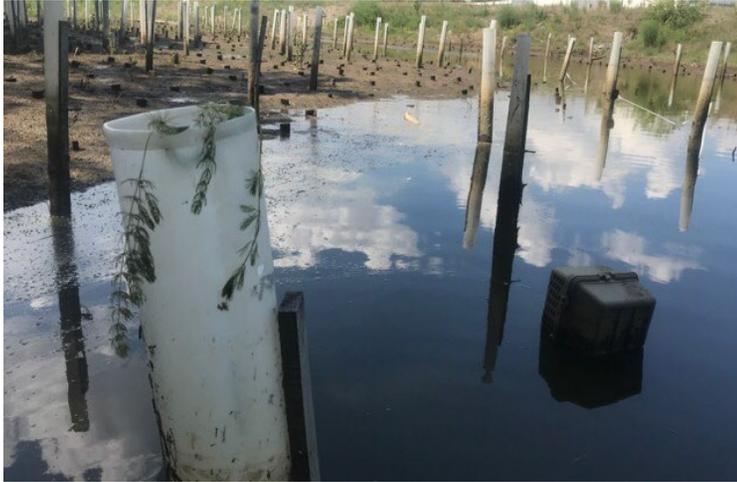
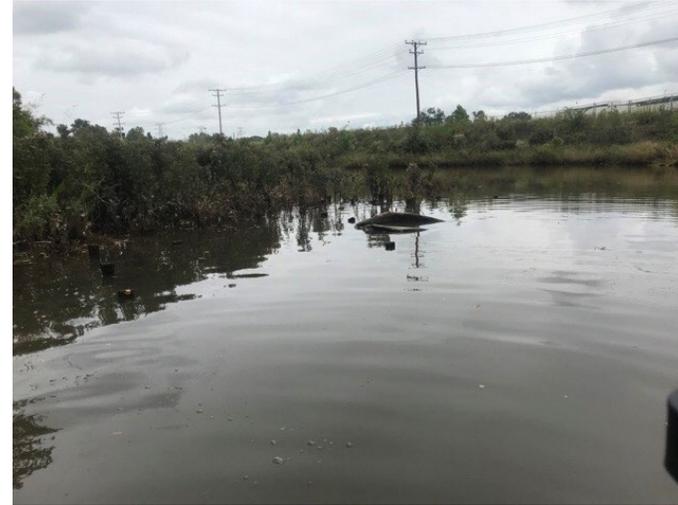
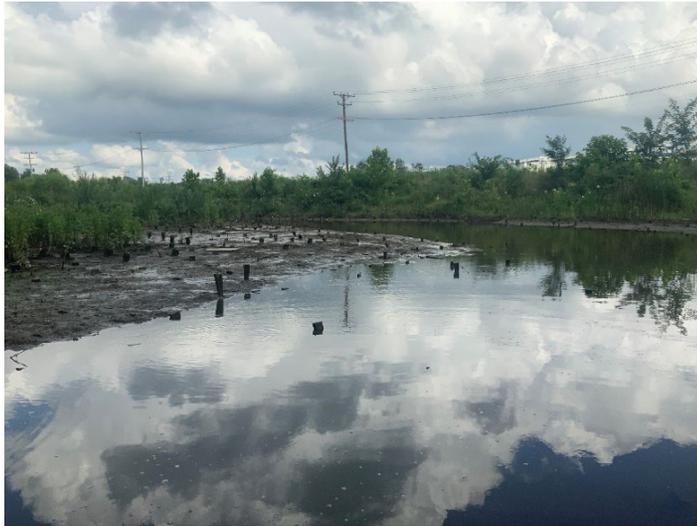
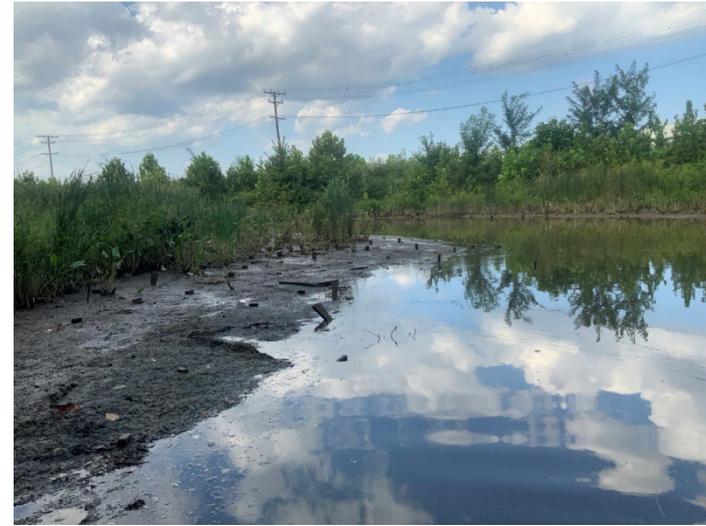
Photo A-105. Inundated tree tubes from 2018 on tidal flat, with new vegetation, on the right streambank at station 09+09, 2018 (A), 2019 (B), 2020 (C), and 2021 (D).

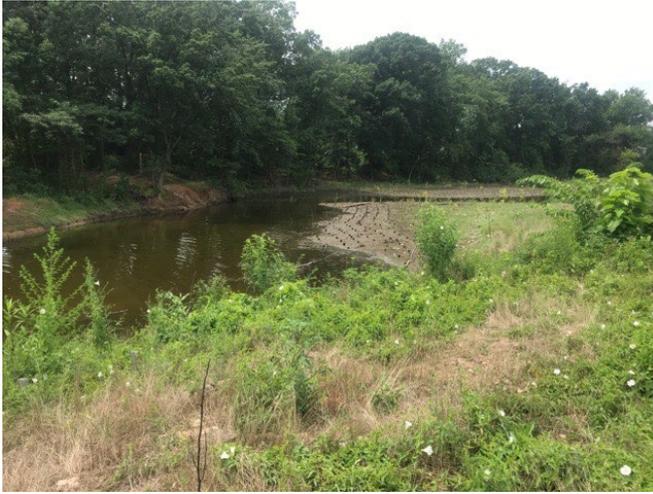
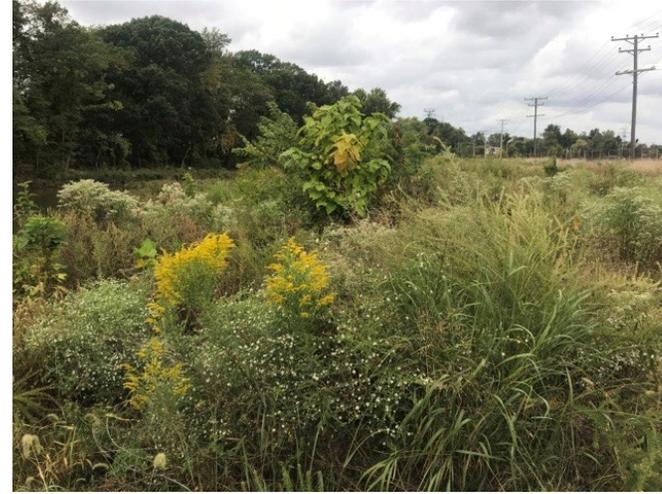
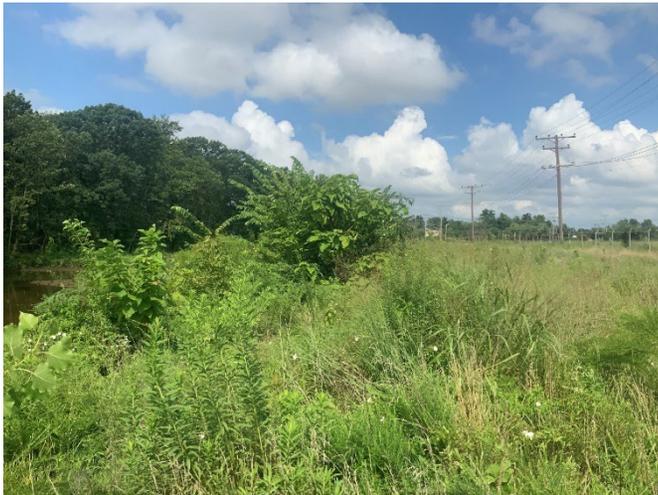
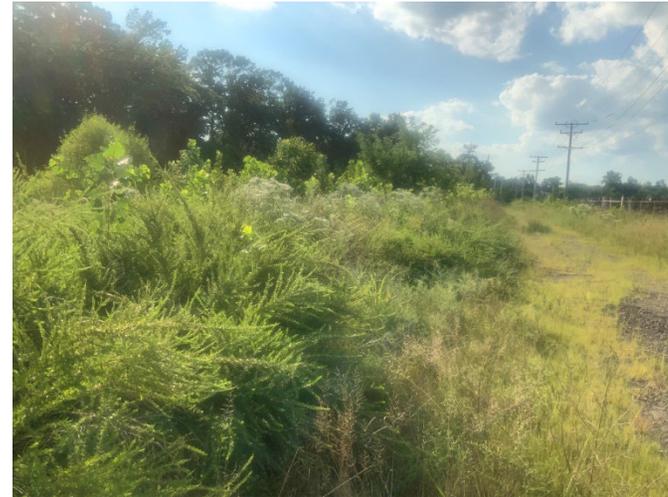
Photo A-106. Upstream view of wetland area at station 10+00, 2018 (A), 2019 (B), 2020 (C), and 2021 (D).

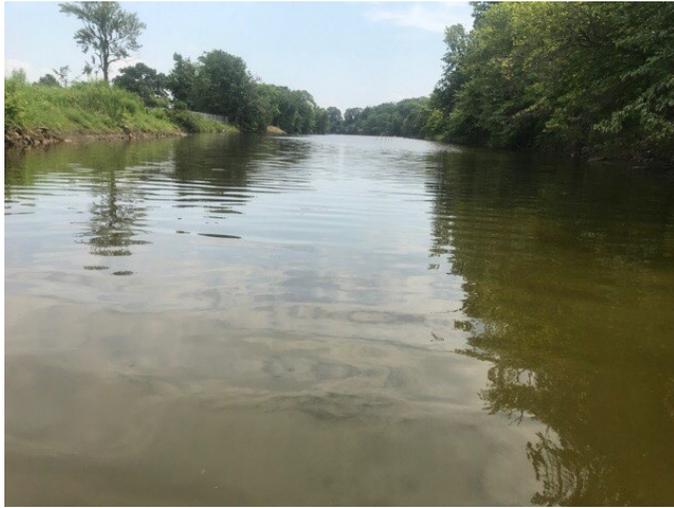
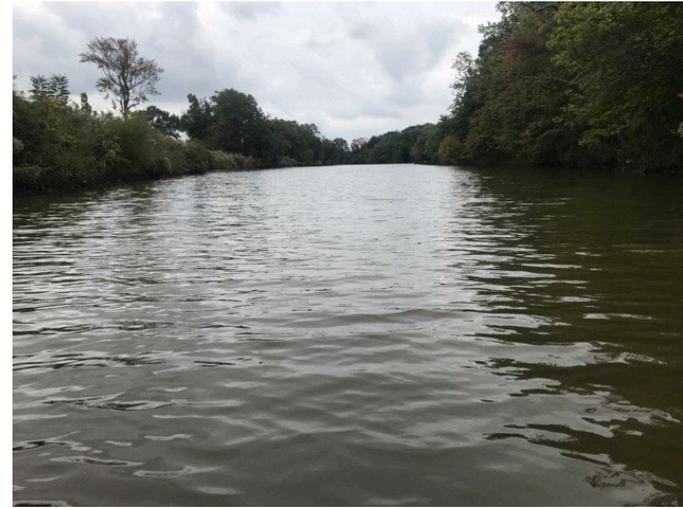
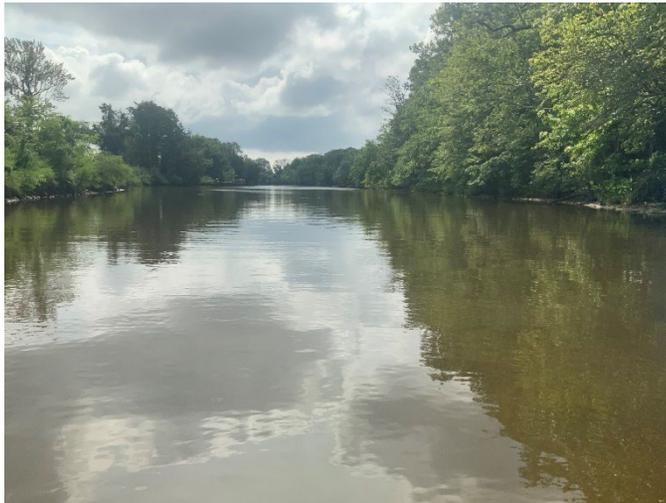
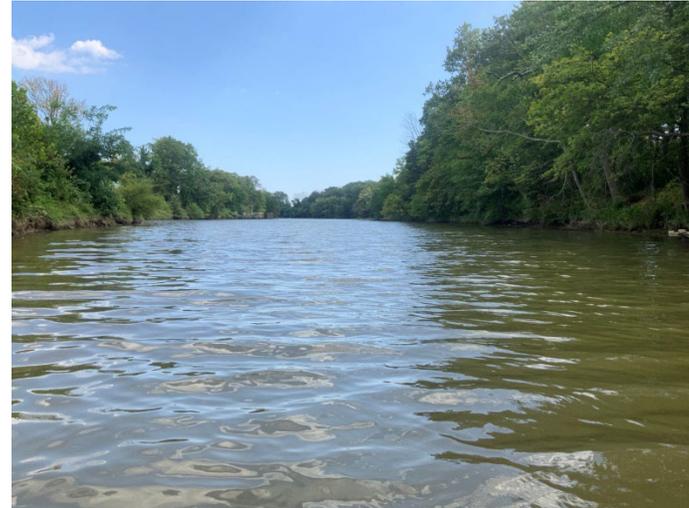
Photo A-107. Downstream view from thalweg at station 11+00, 2018 (A), 2019 (B), 2020 (C), and 2021 (D).

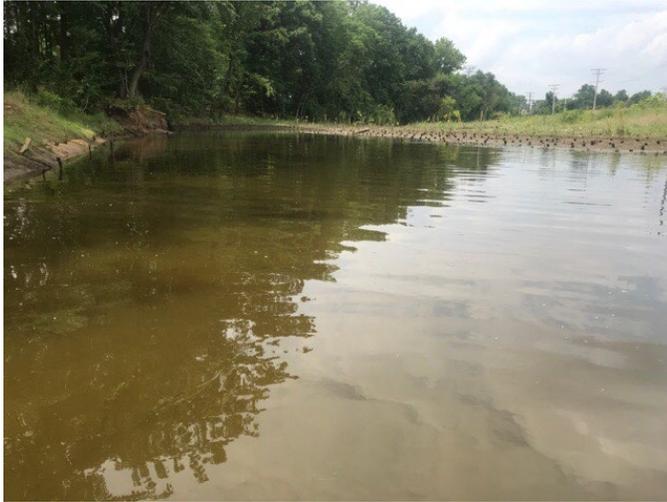
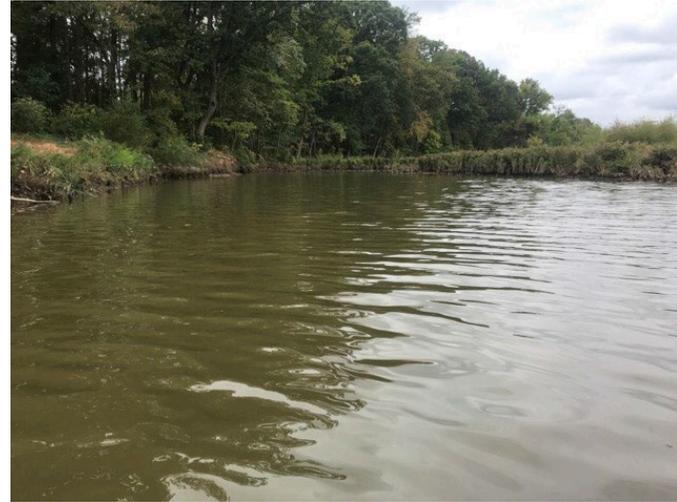
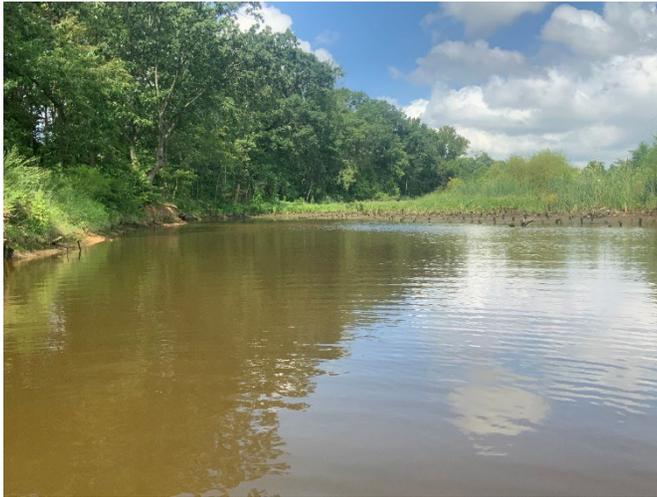
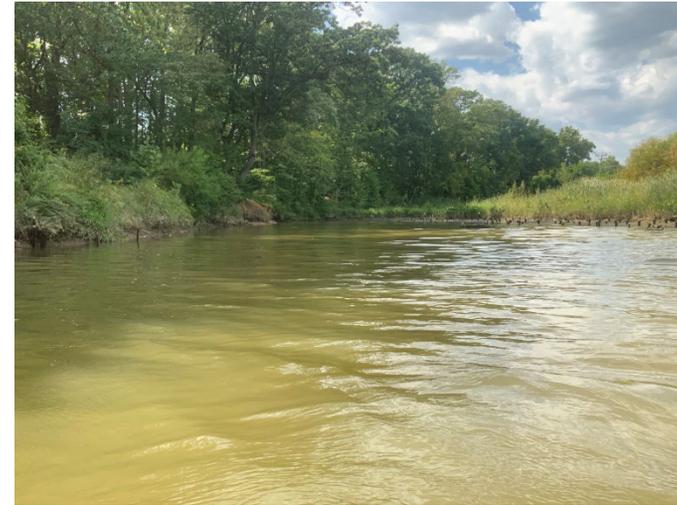
Photo A-108. Upstream view from thalweg at station 11+00, 2018 (A), 2019 (B), 2020 (C), and 2021 (D).

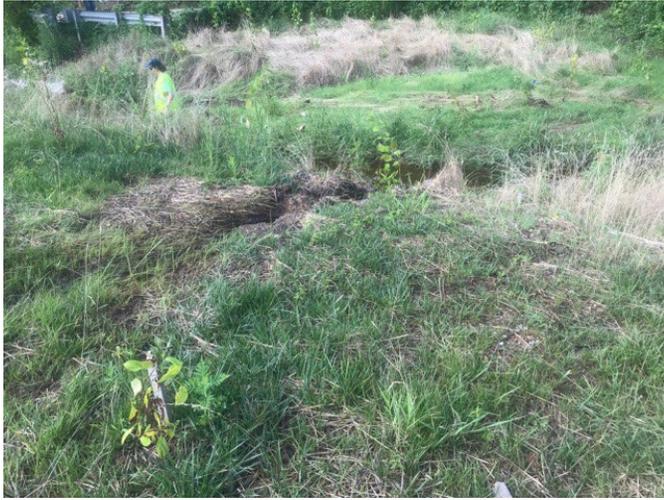
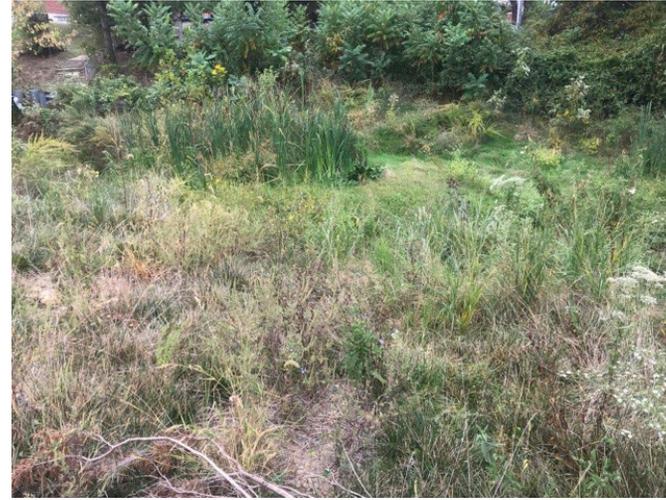
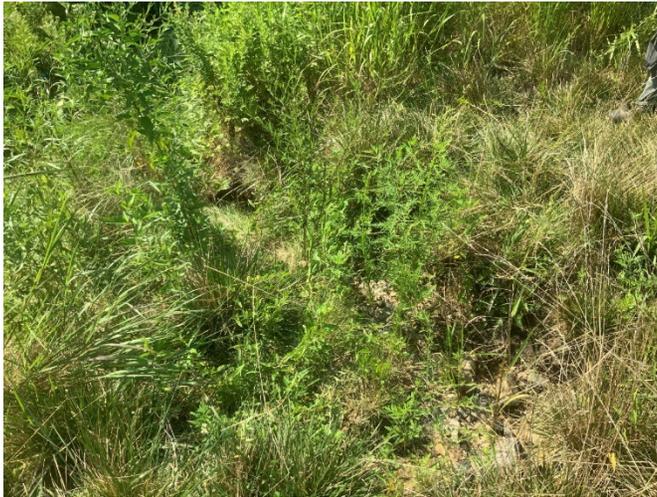
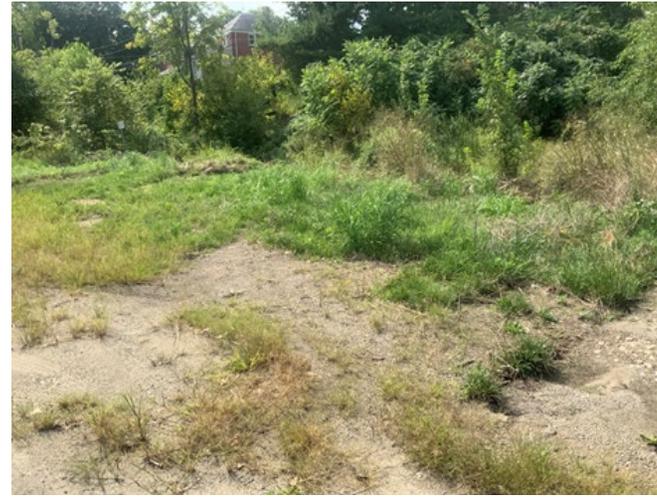
Photo A-109. View from top of floodplain, left streambank at station 01+00, 2018 (A), 2019 (B), 2020 (C), and 2021 (D).

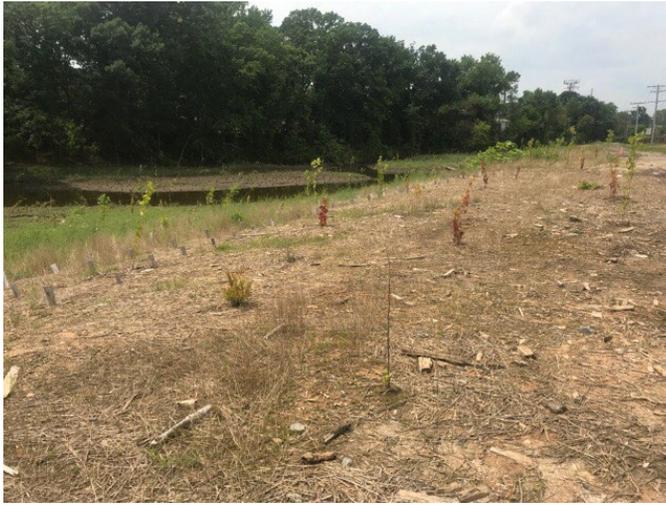
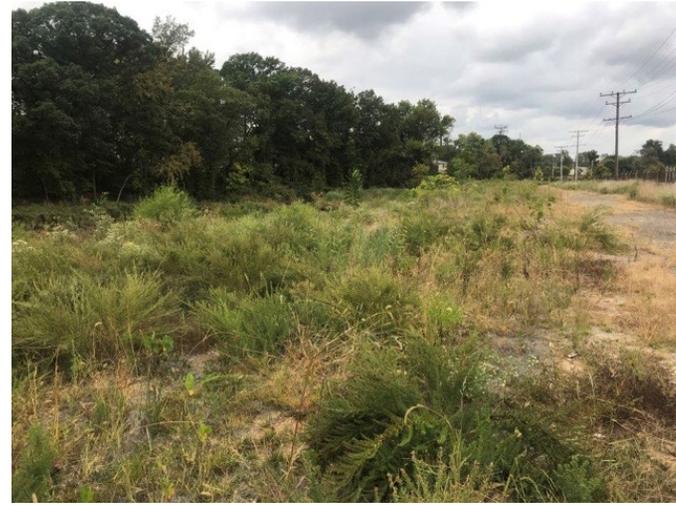
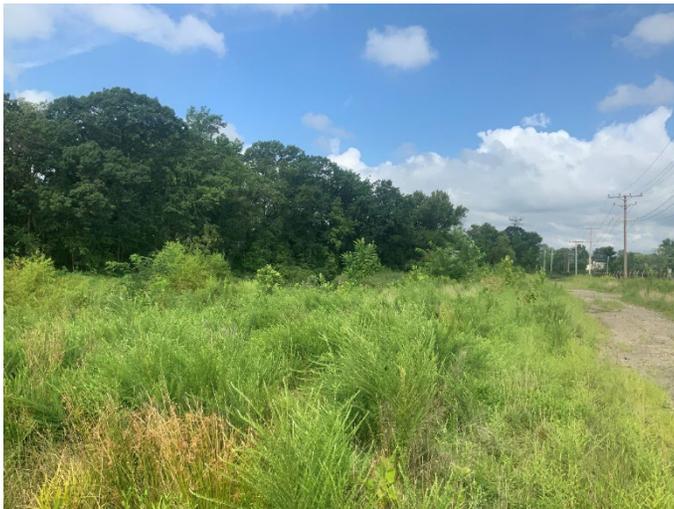
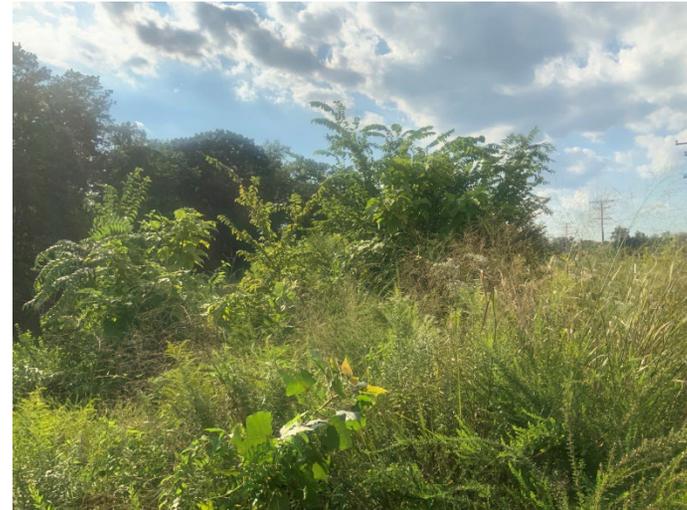
Photo A-110. Upstream view from top of floodplain, left streambank at station 10+95, 2018 (A), 2019 (B), 2020 (C), and 2021 (D).

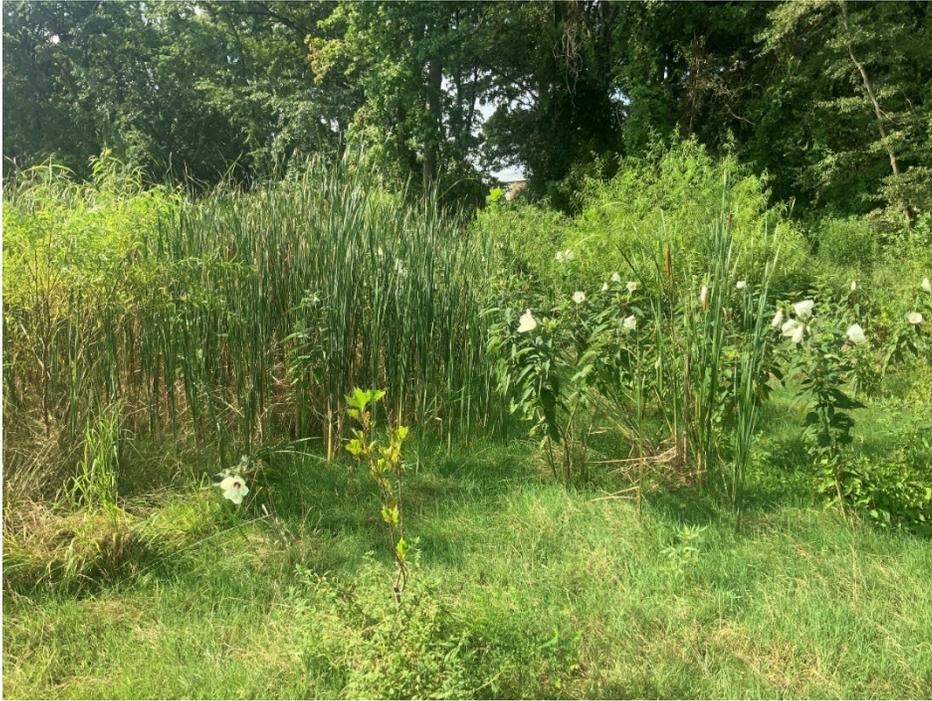
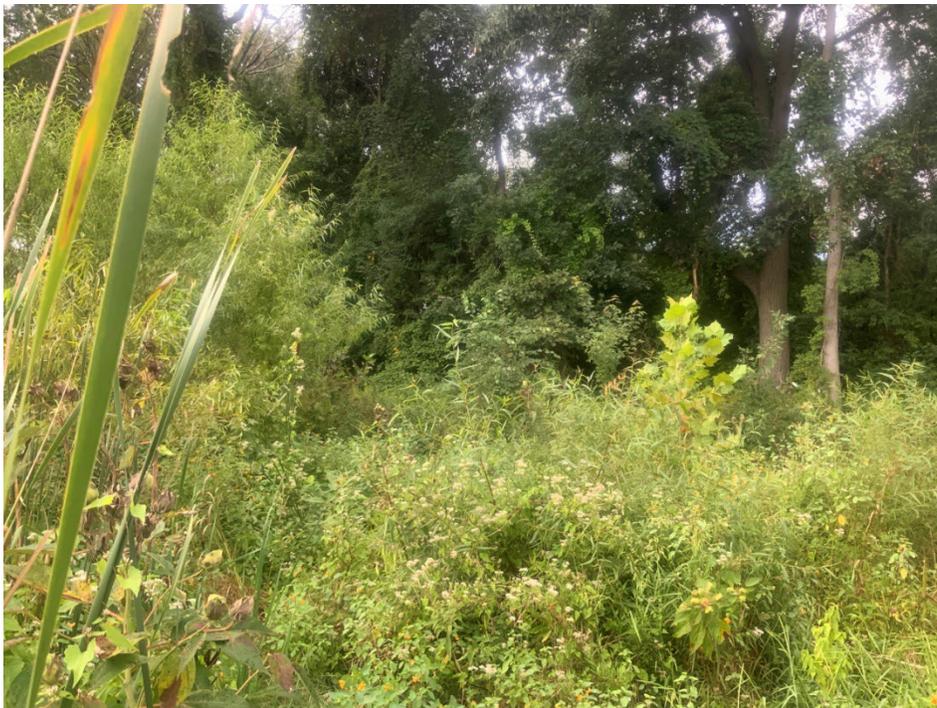
Photo A-111. Well-vegetated wetland area on left side of stream (facing toward stream from middle of wetland) at station 05+63, 2020 (A) and 2021 (B).

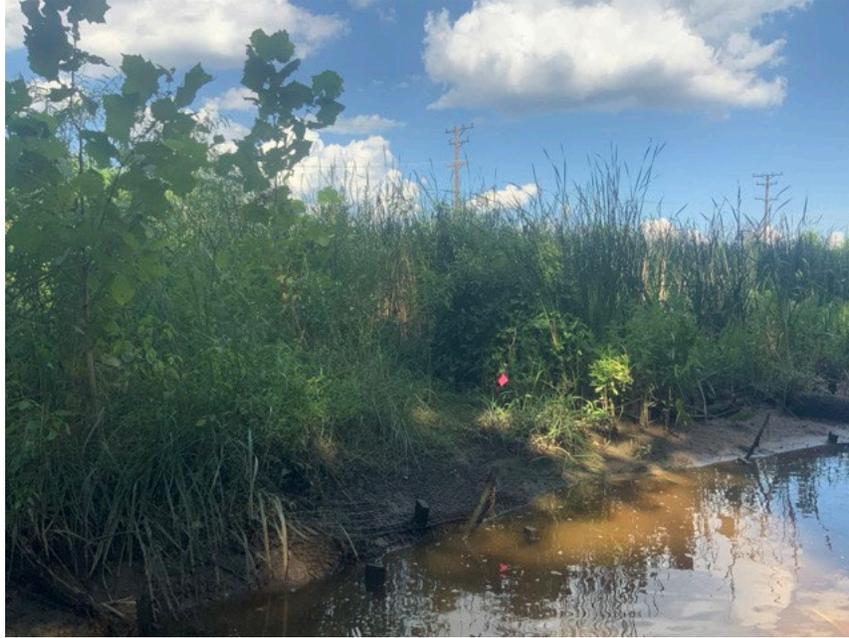
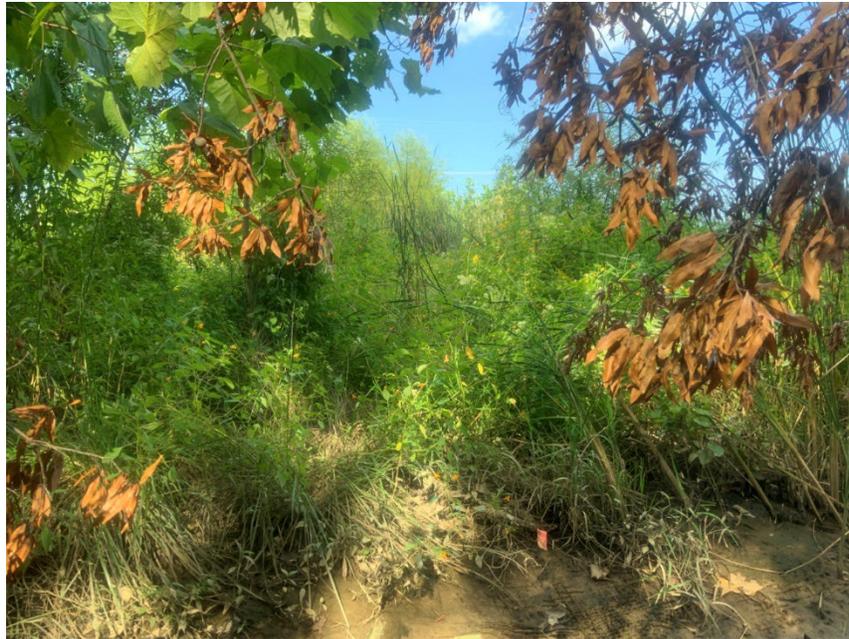
Photo A-112. Lower streambank lacking vegetation due to tidal influence, left streambank at station 05+92, 2020 (A) and 2021 (B).

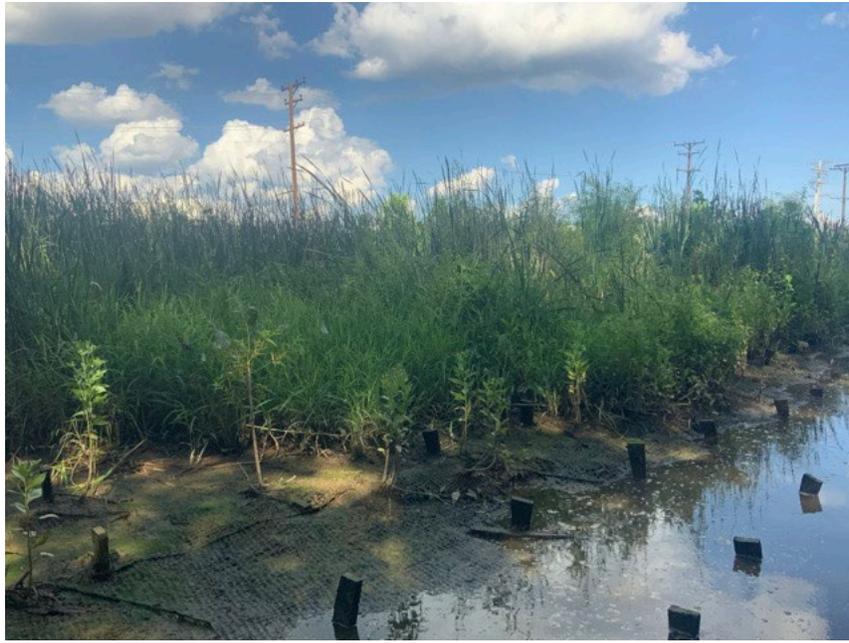
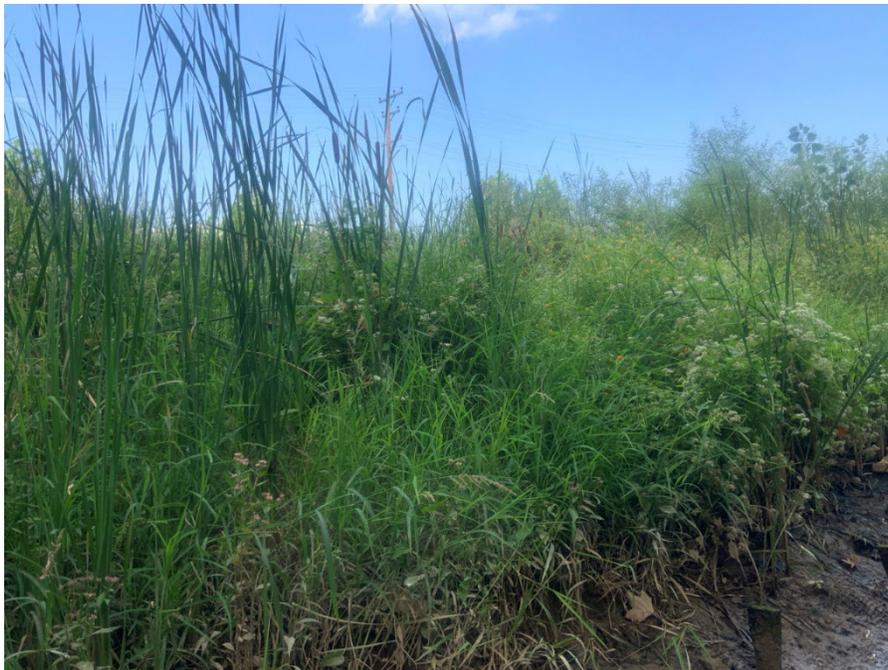
Photo A-113. Lower streambank lacking vegetation due to tidal influence, left streambank at station 06+22, 2020 (A) and 2021 (B).
