Subject: Transmittal of the Cow Pen Creek Bank Stabilization and Floodplain Reconstruction Monitoring:
2021 Report
Lockheed Martin Corporation – Middle River Complex
2323 Eastern Boulevard, Middle River, Baltimore County, Maryland

**COW PEN CREEK
BANK STABILIZATION AND FLOODPLAIN
RECONSTRUCTION MONITORING: 2021 REPORT
LOCKHEED MARTIN MIDDLE RIVER COMPLEX
2323 EASTERN BOULEVARD
MIDDLE RIVER, MARYLAND**

Prepared by:
Tetra Tech, Inc.

January 2022

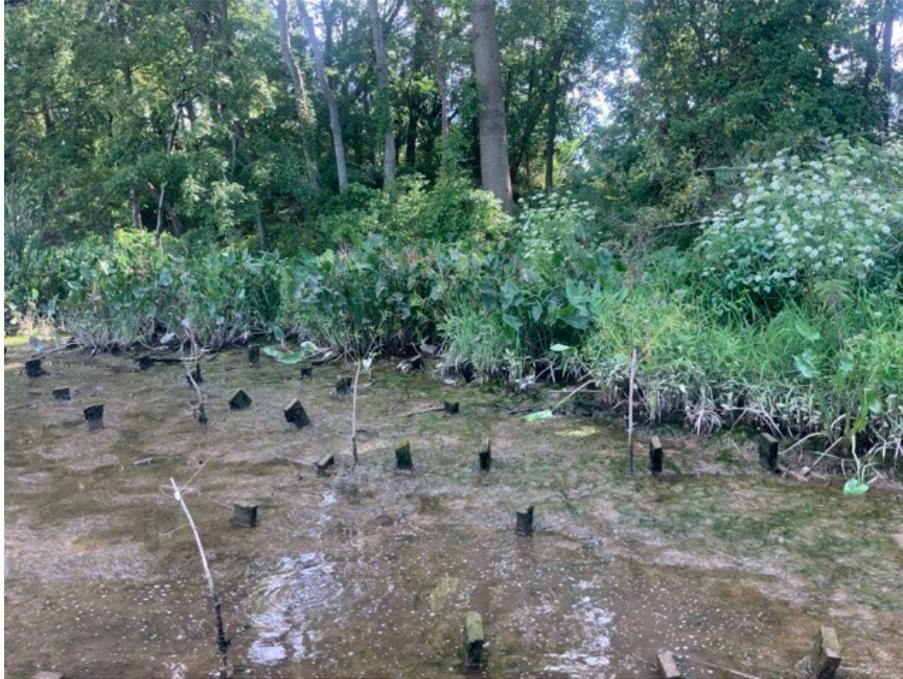
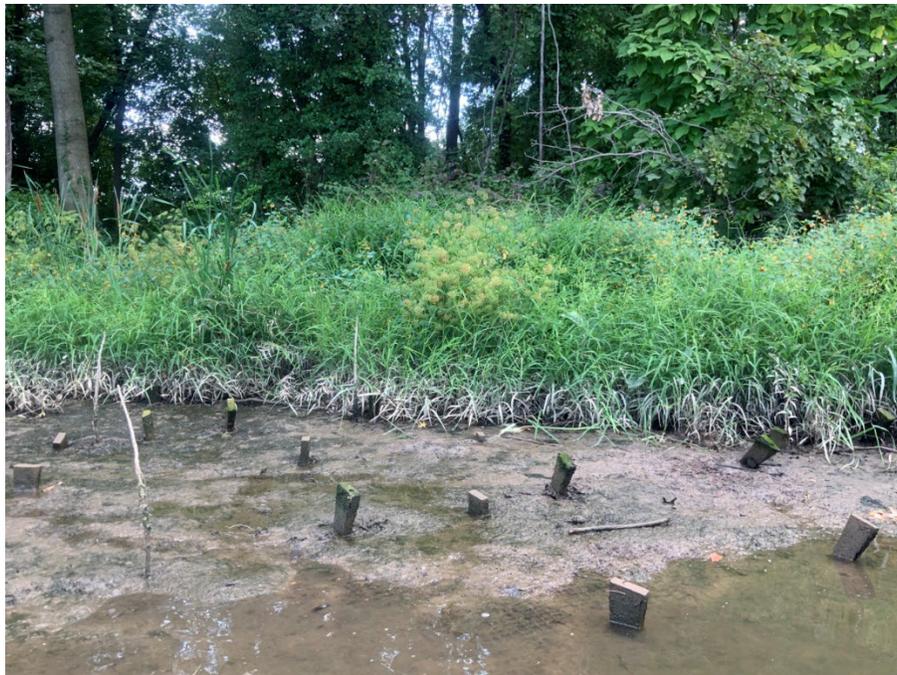
Photo A-114. Lower streambank lacking vegetation due to tidal influence, right streambank at station 07+22, 2020 (A) and 2021 (B).

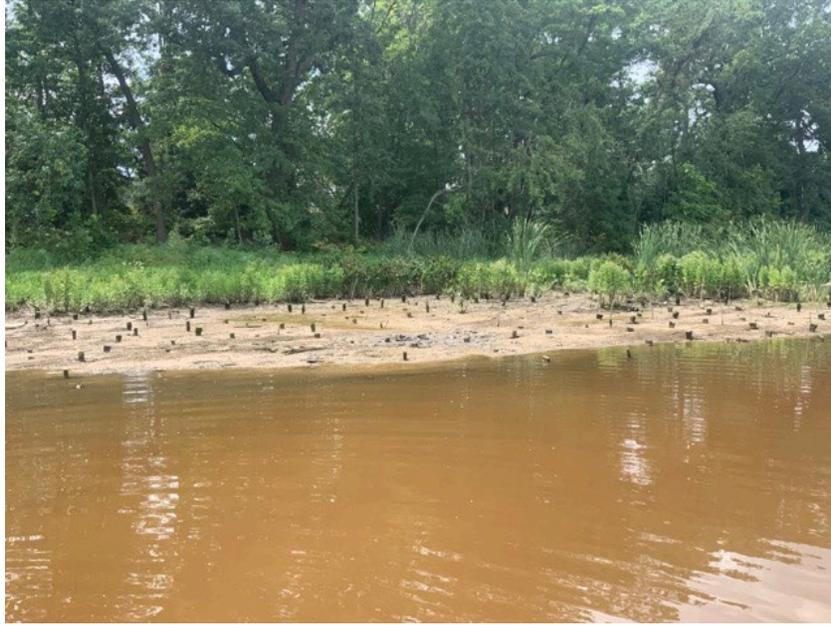
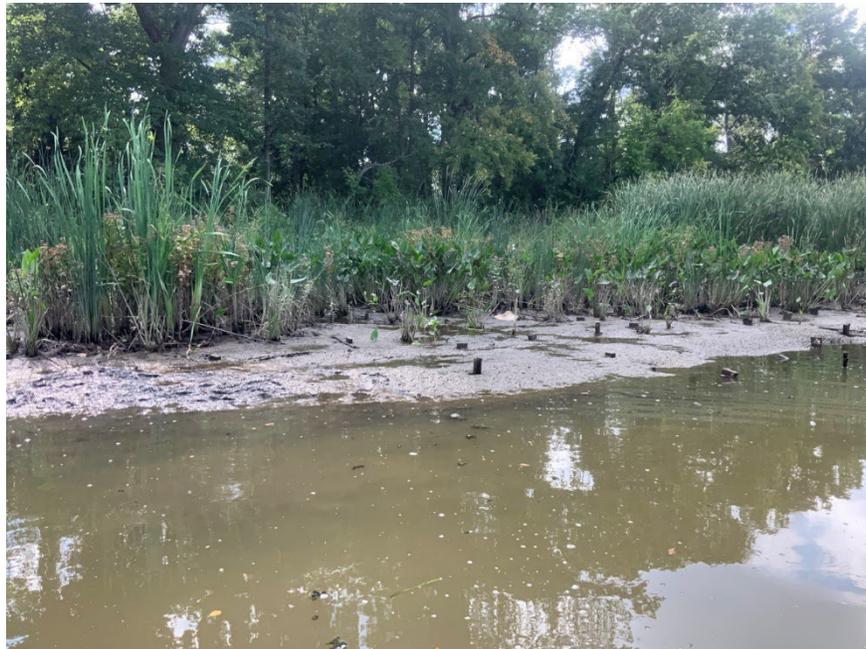
Photo A-115. Lower streambank showing tidal influence, right streambank at station 08+55, 2020 (A) and 2021 (B).

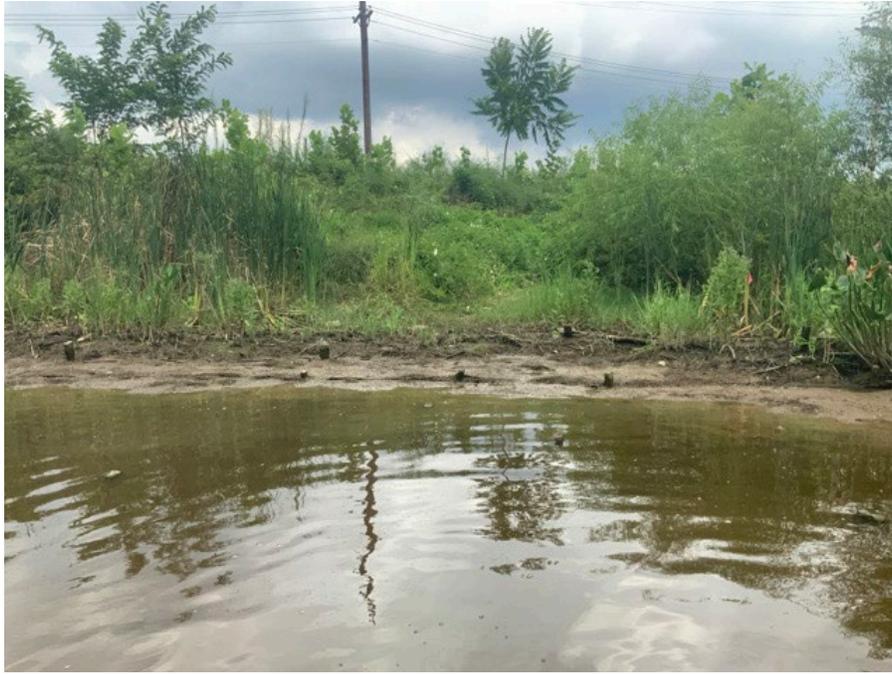
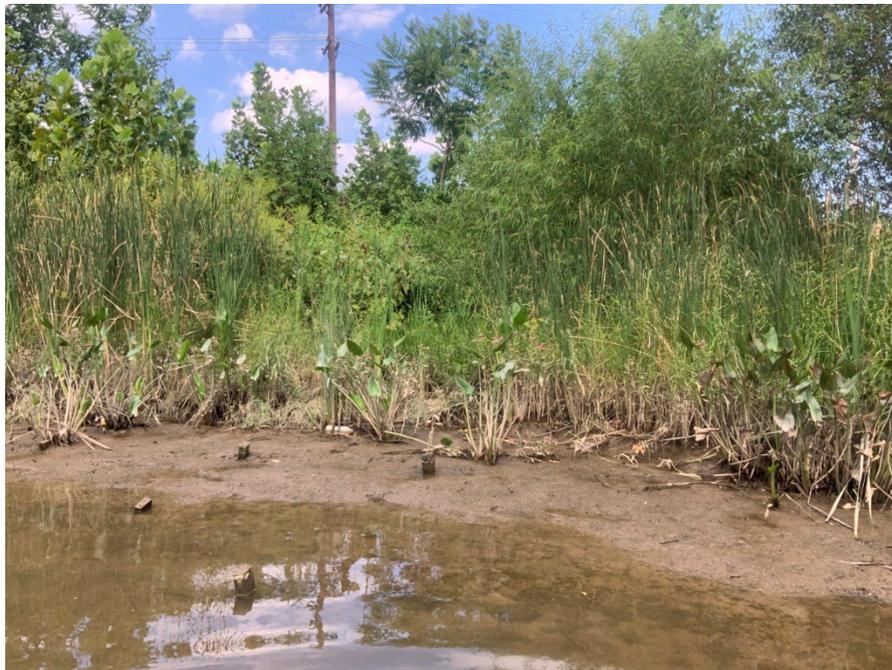
Photo A-116. Lower streambank showing tidal influence, left streambank at station 08+55, 2020 (A) and 2021 (B).

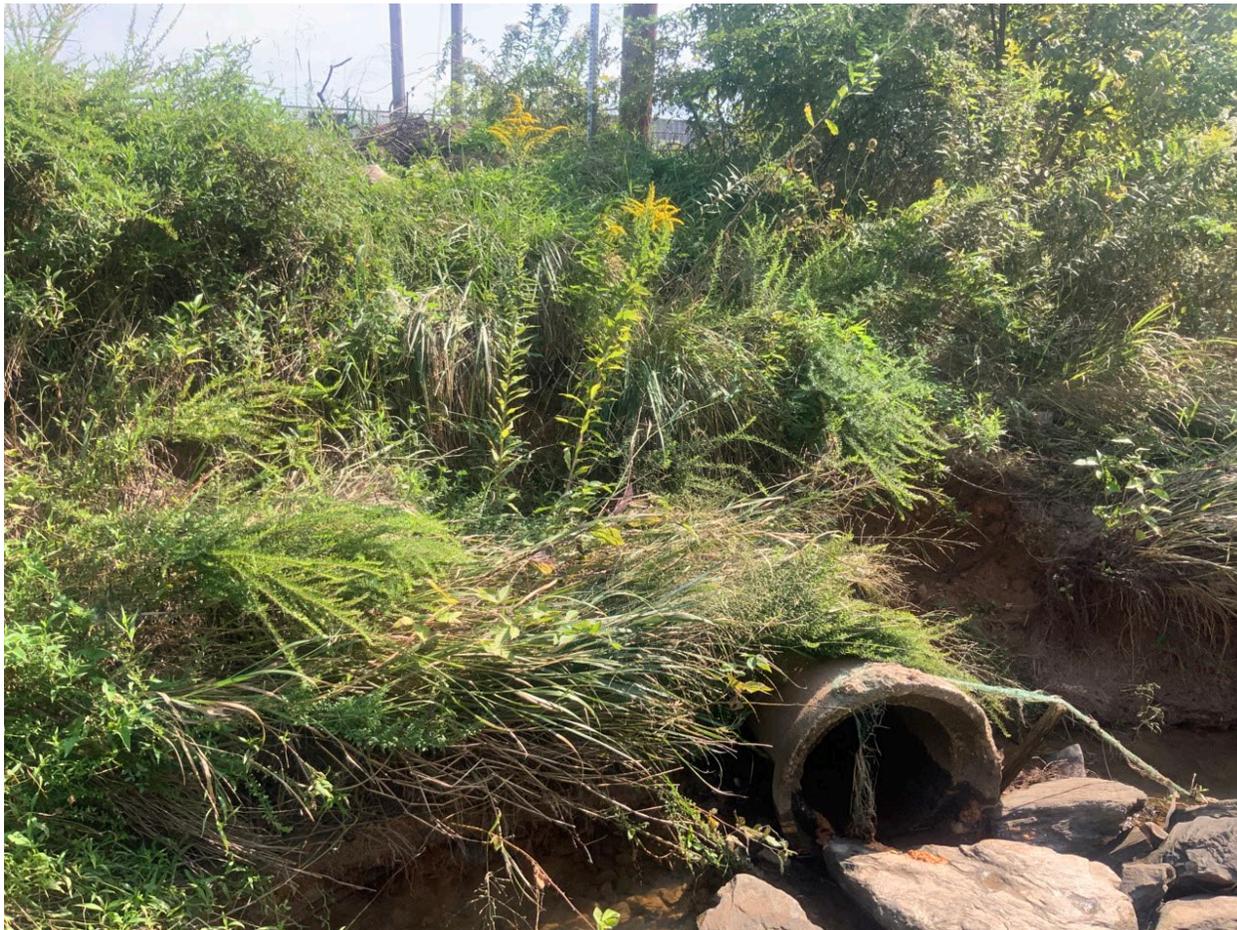
Photo A-118. Outfall pipe with erosion, left streambank at station 01+64, September 2021.

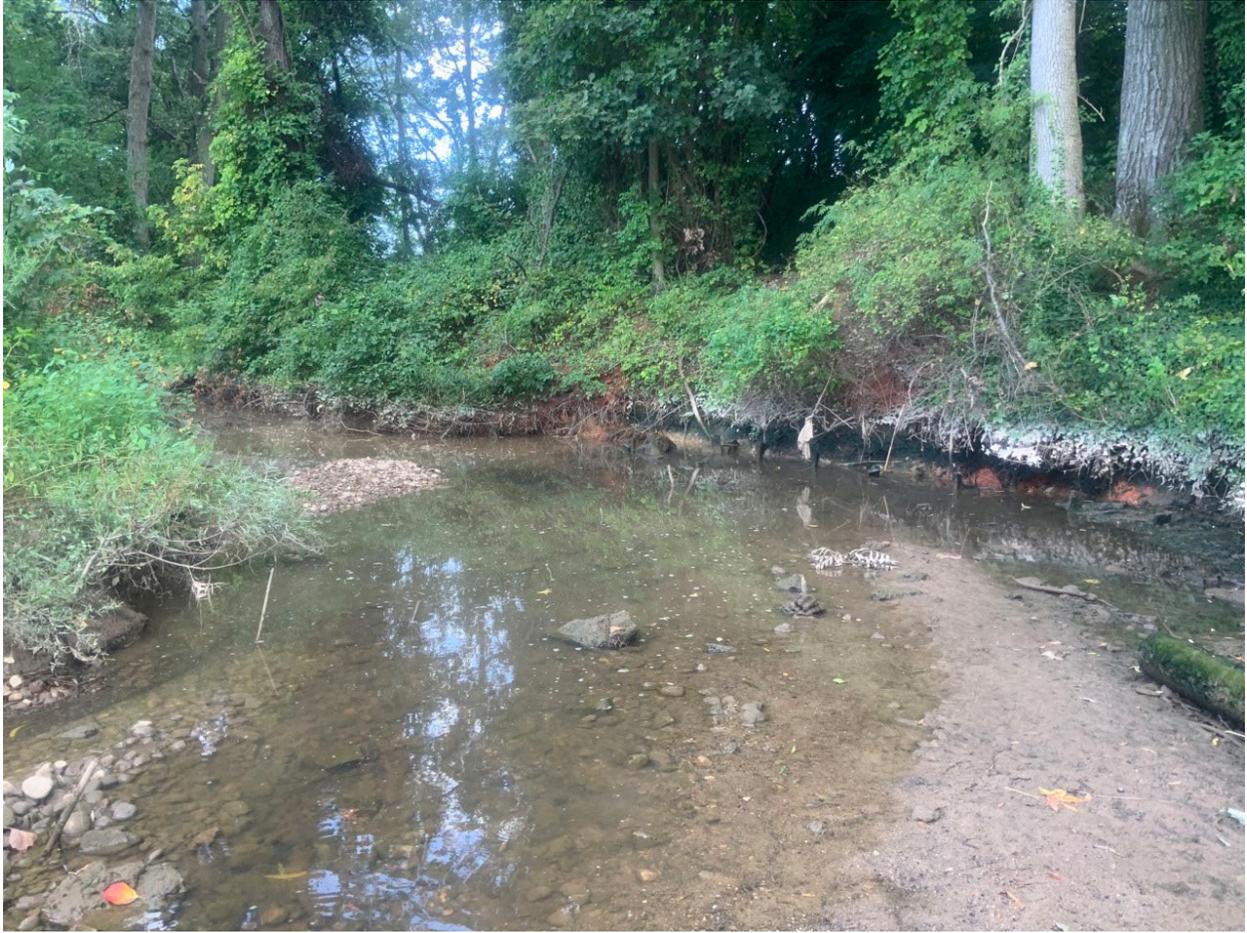
Photo A-119. Gravel bars in stream at station 05+10, September 2021.

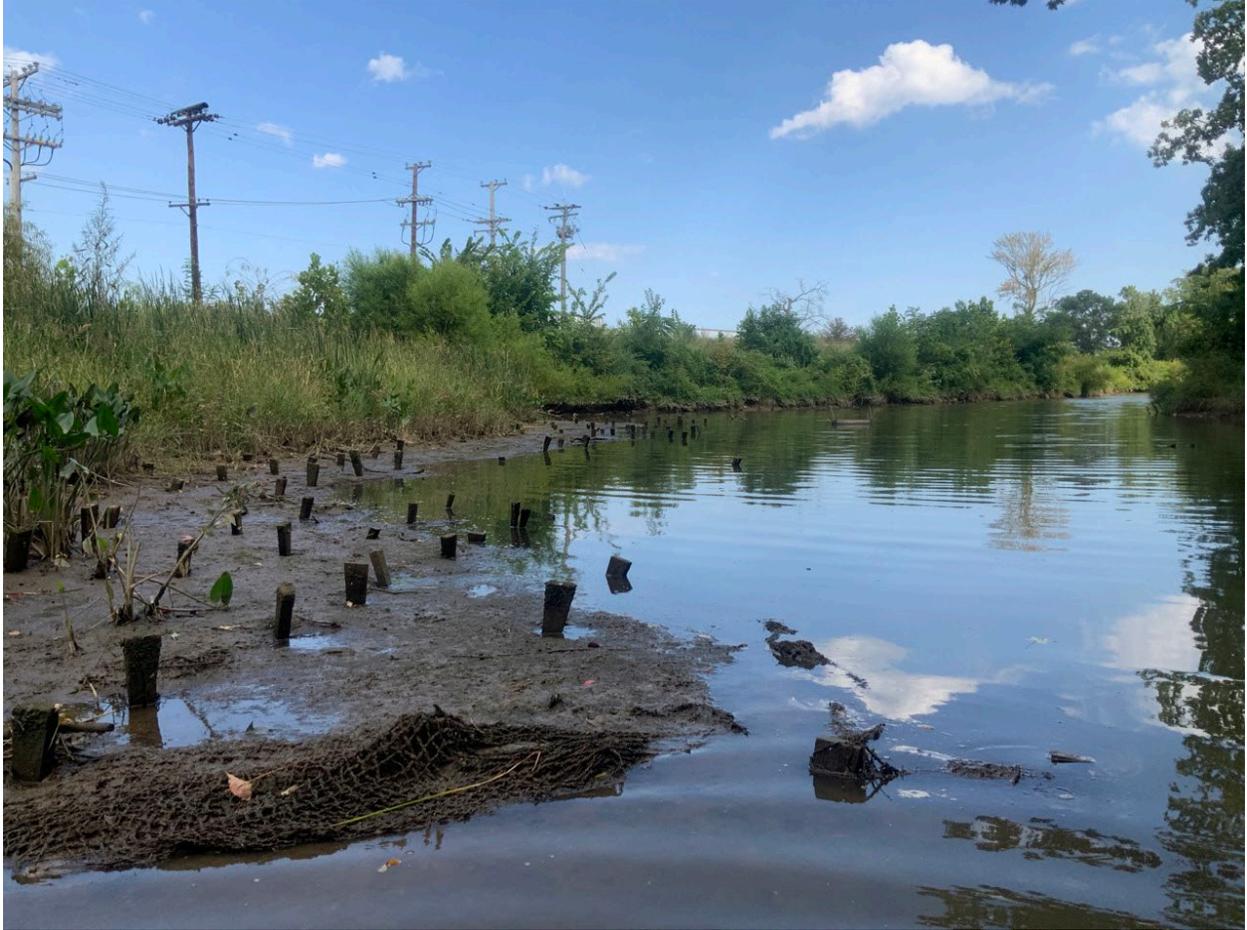
Photo A-120. Matting and tidal wetland area, left streambank, at station 09+20, September 2021.

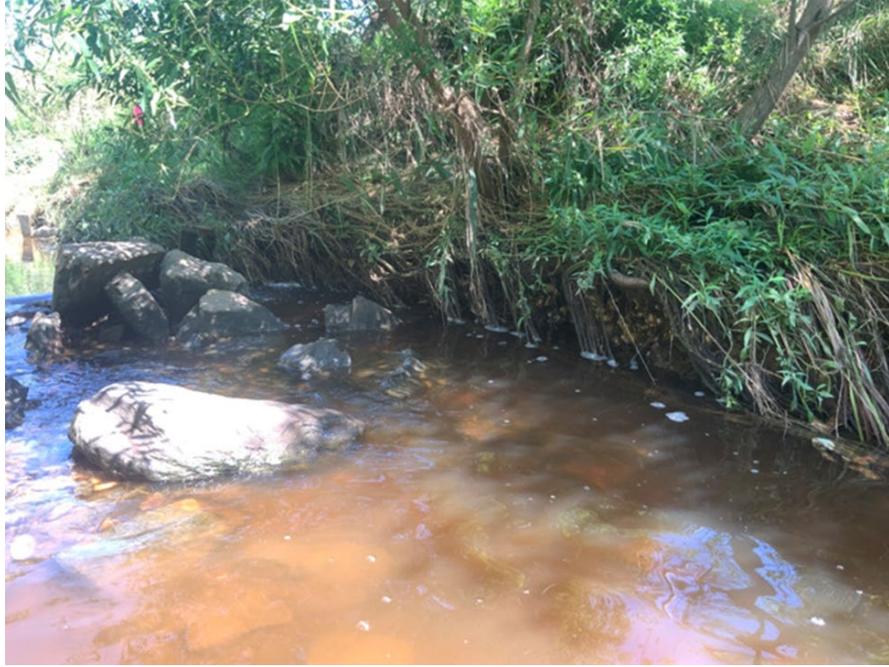
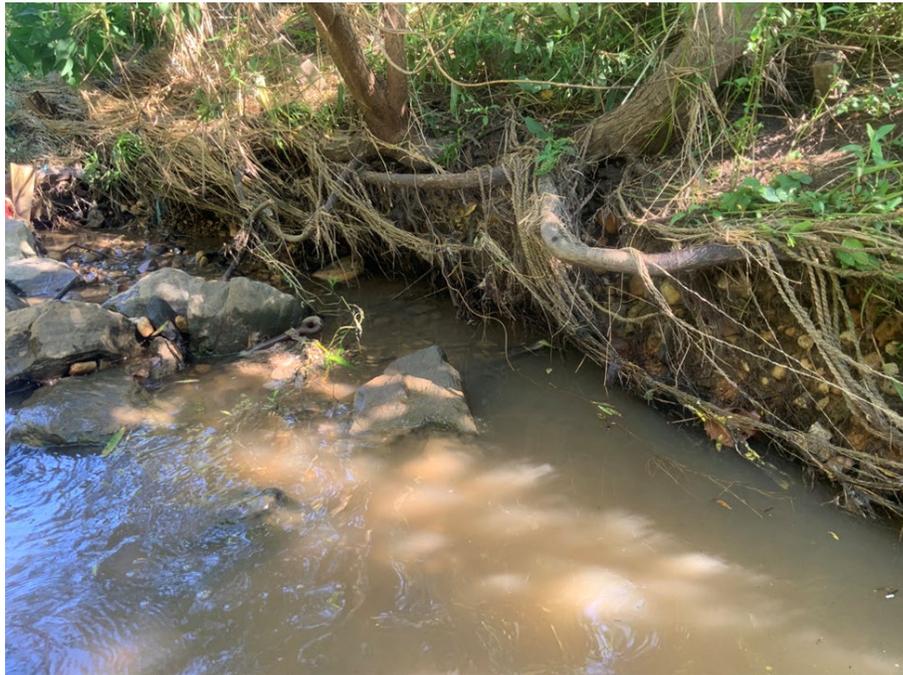
Photo A-121. Erosion below tree roots, left streambank above station 02+18 in 2020 (A) and 2021 (B)

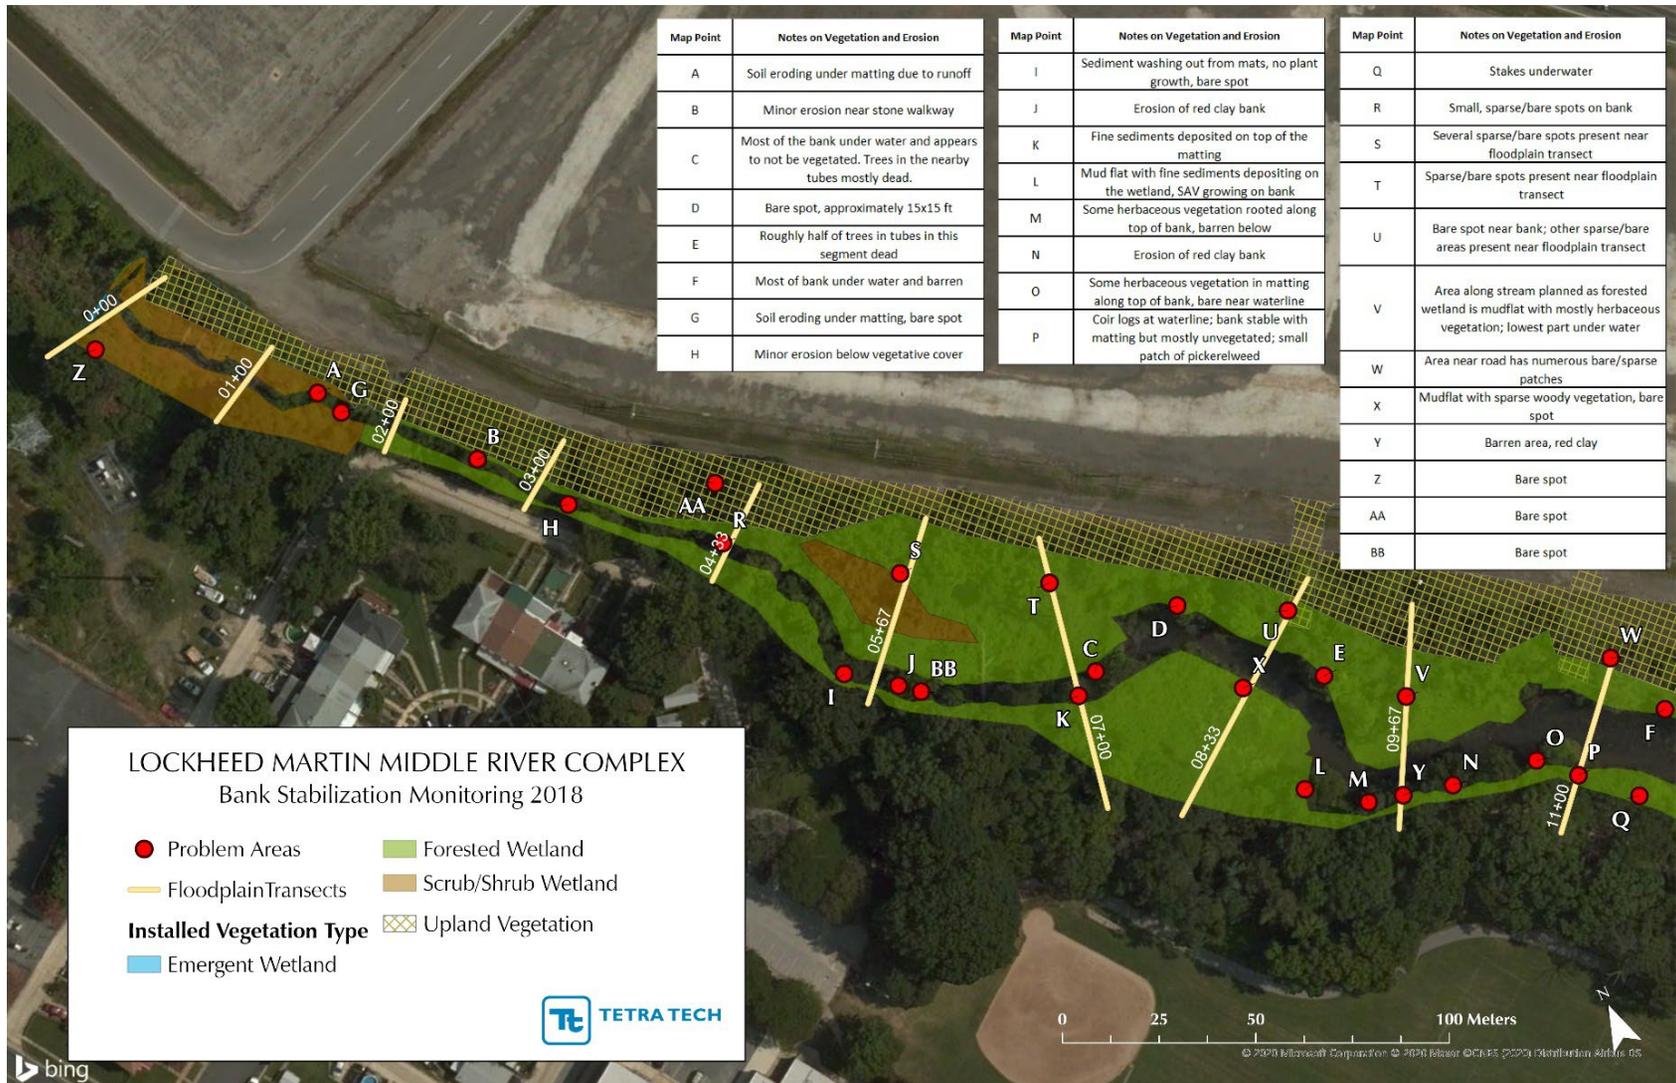
Figure C – 19. Noted areas of concern for erosion/vegetative cover along Cow Pen Creek–2018
